# **CLIMATE CHANGE STRESSORS/EARTH WARMING**

## Higher Temperatures, Higher Rainfall Intensities, More Frequent Flooding

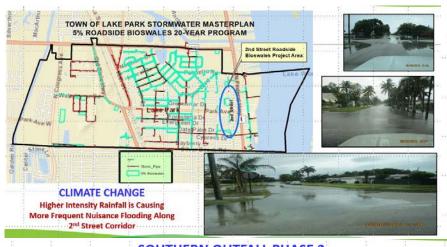
**Nuisance Flooding Hazard Adaptation**

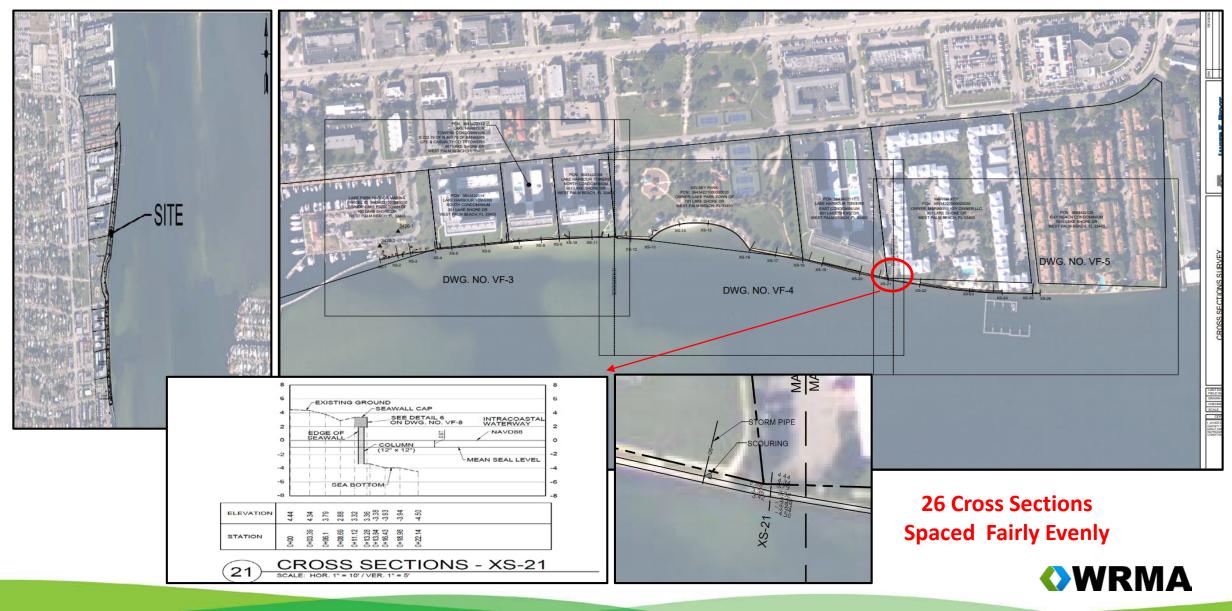
## STRUCTURAL CONDITION ASSESSMENT - FIELD INVESTIGATION

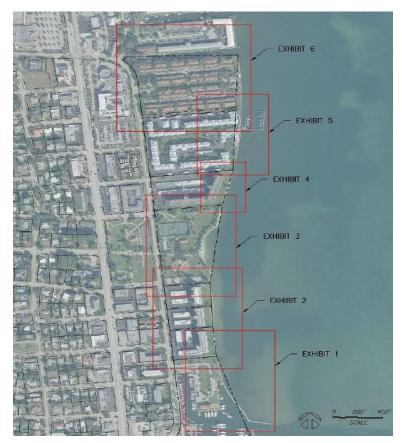
Exhibit 1 - Lake Park Marina

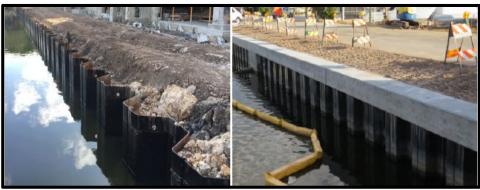
**Concrete Sheet Pile Bulkhead**

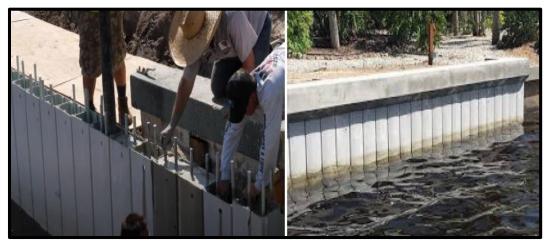
#### **Truline Bulkhead**

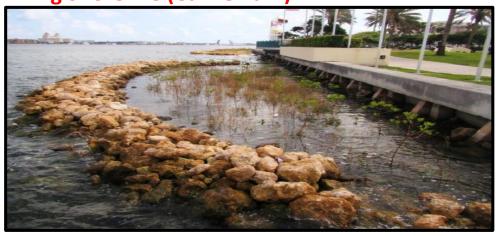
#### **Bio-enhanced Concrete Forms**

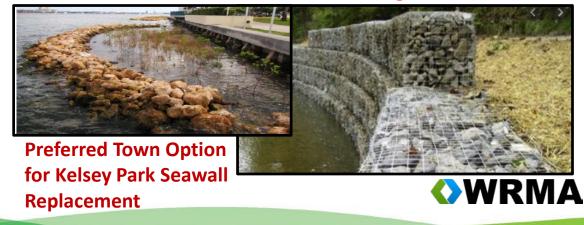
#### STRUCTURAL & SUSTAINABLE REPLACEMENT OPTIONS COST

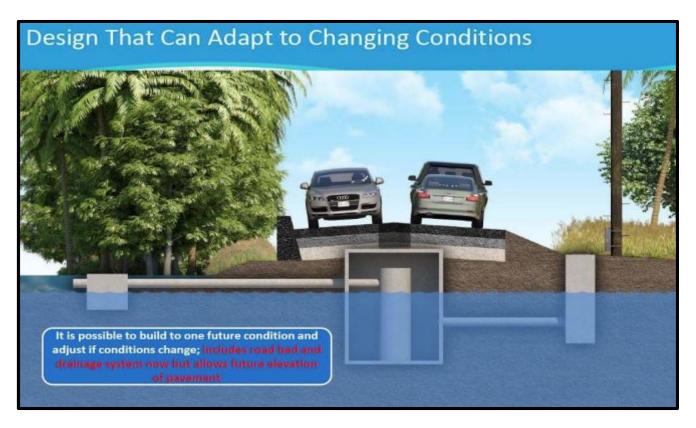
- ✓ Build road base to accommodate additional wearing surface layers later
- ✓ Elevate culverts or provide in-line valves
