**Minutes**  
**Town of Lake Park, Florida**  
**Marina Site Tour Workshop**  
**Saturday, April 27, 2019, 10:00 AM**  
**Lake Park Harbor Marina, 105 Lake Shore Drive**

# MARINA BUILDING DEFICIENCIES 2019

Re: Engineering Inspection

For: Lake Park Marina Building  
103 / 105 Lake Shore Drive  
Lake Park, FL 33403

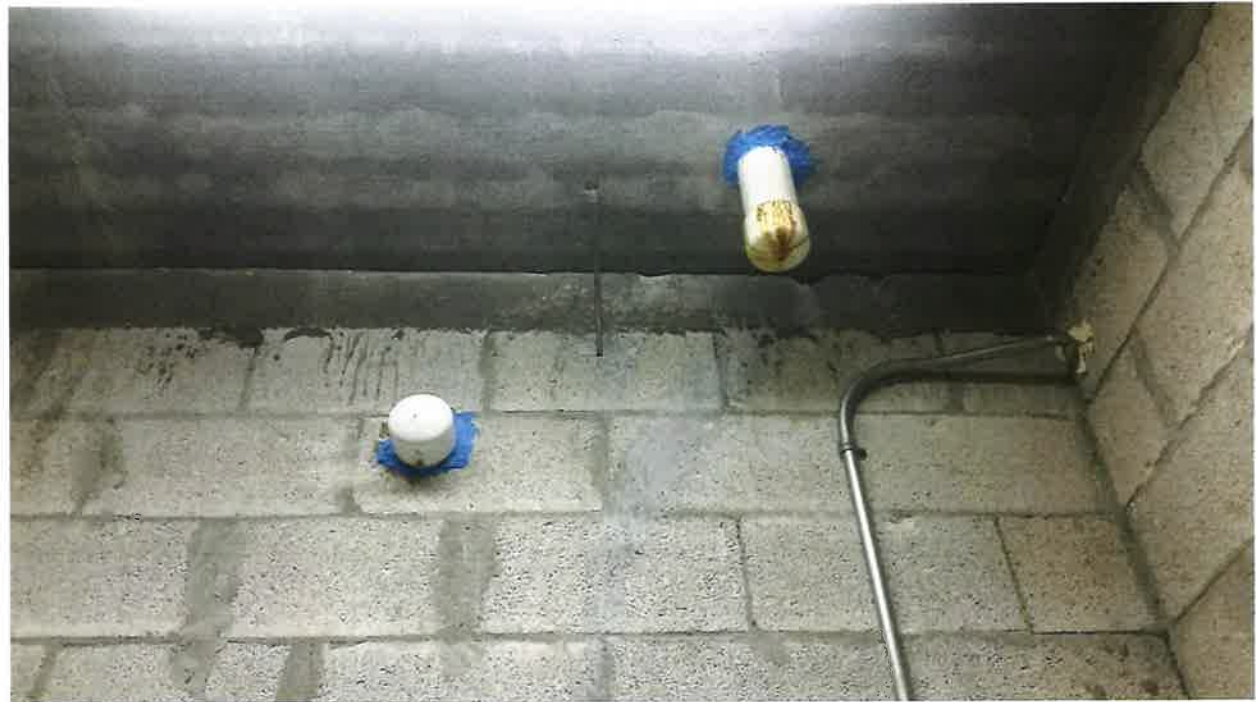
The floor drain from the second floor bathroom is not connected at all.

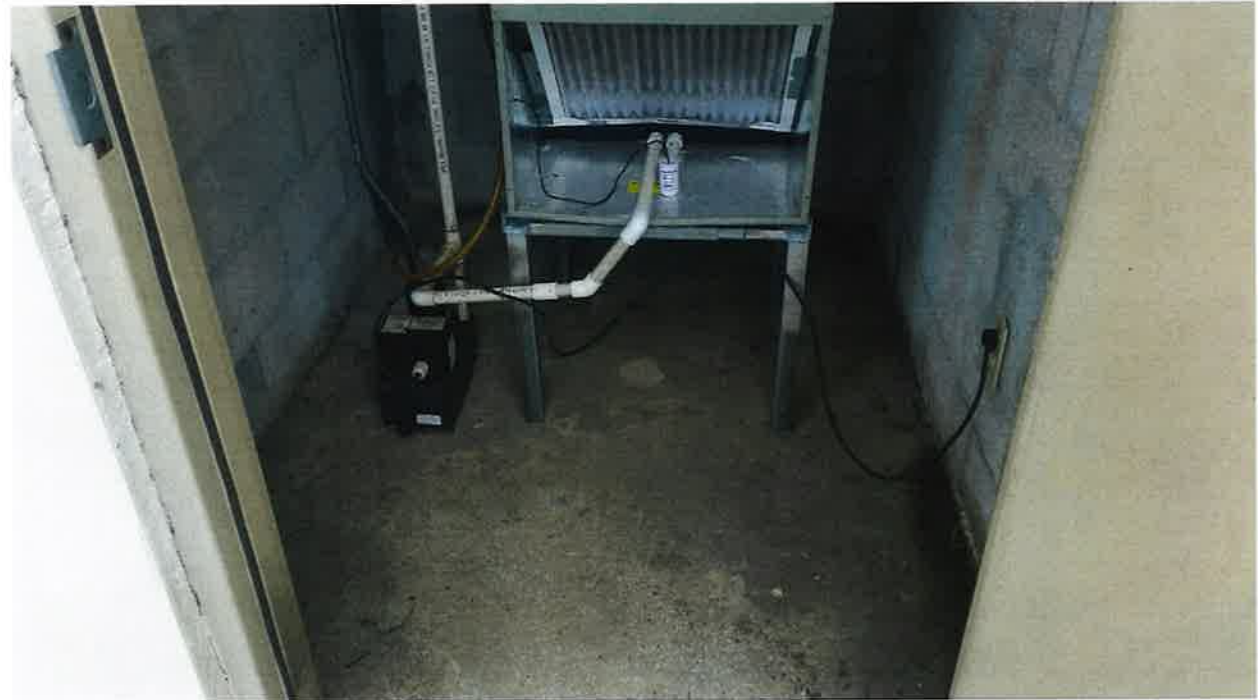
No drain for west wing first floor HVAC unit. A sump pump is being used to pump the AC condensation up to second floor to get rid of the water. If you notice the damp floor, the sump pump does not a good job of moving the water, and the floor gets wet from time to time.

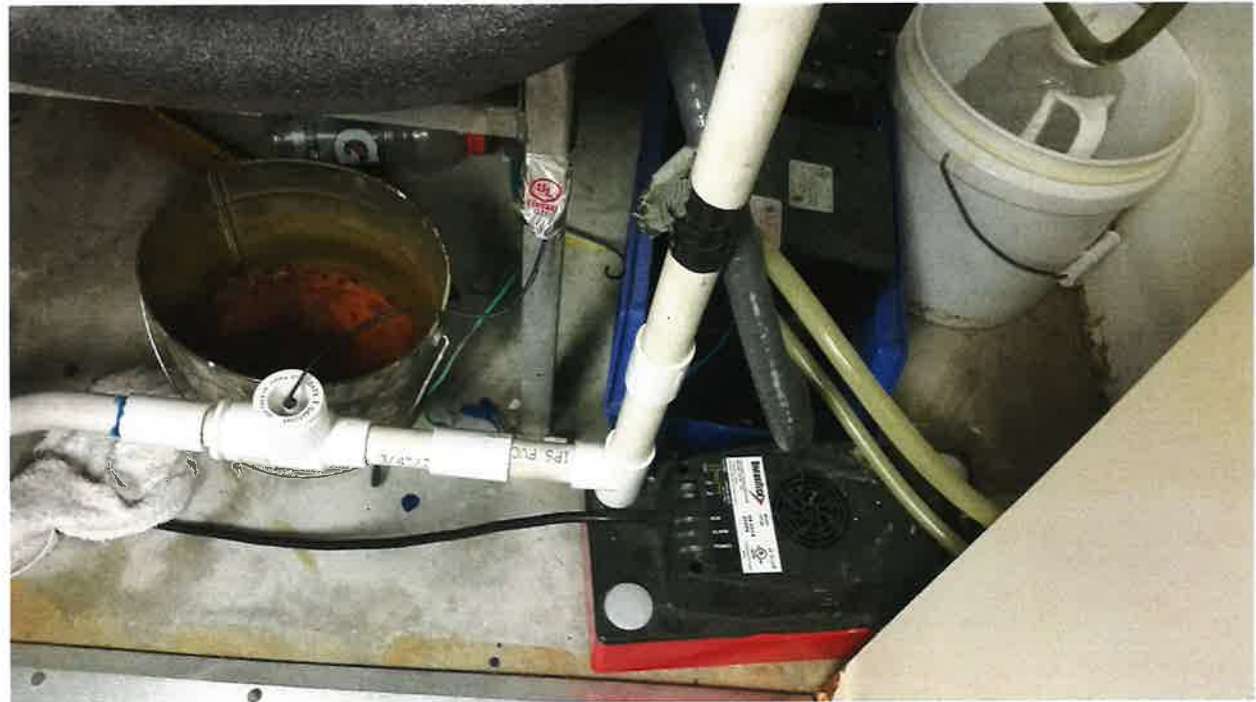
No drain for the ship's store HVAC unit either. It also is using a sump pump to pump the AC condensation up to second floor to get rid of it's water.

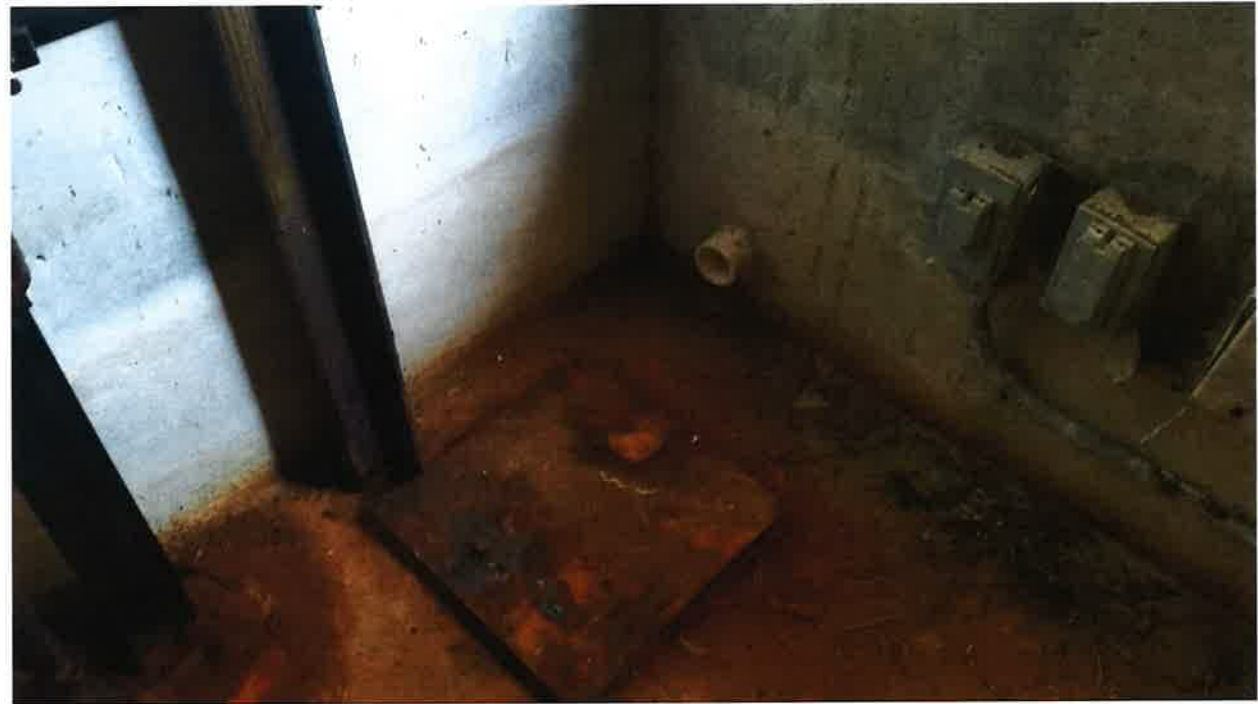
Drain is in the wrong place in the elevator shaft. It is located 4 inches from the bottom of the elevator shaft, on the wall. Instead, it should be in the floor, so there will not be any standing water in the elevator shaft well area at all. This is causing safety issues with the mechanical operations of the elevator.

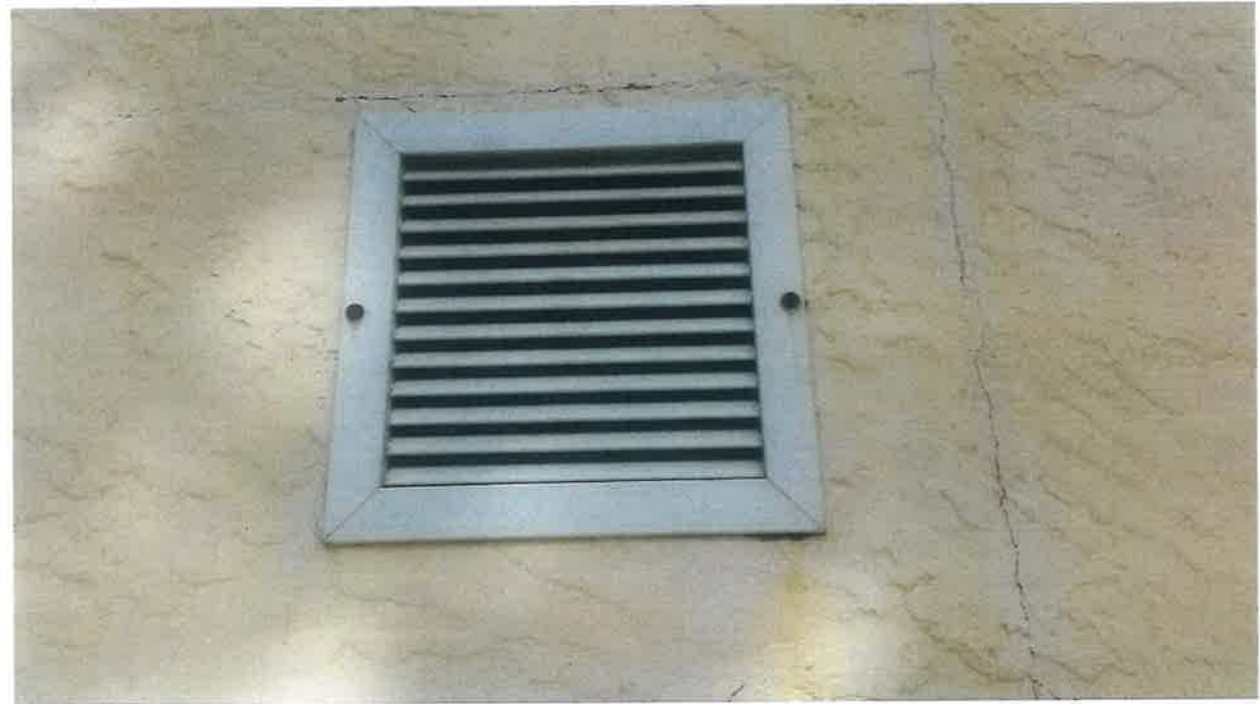
There are 3 vents that are mounted on south side of the building. All of these vents are INDOOR vents. These vents are allowing the water to infiltrate the building.

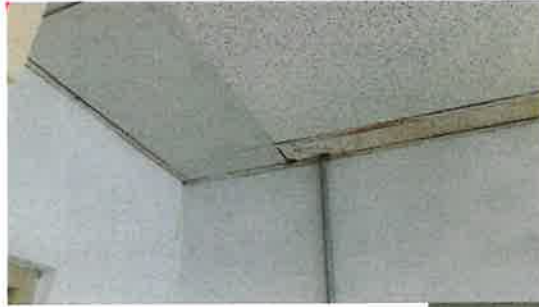
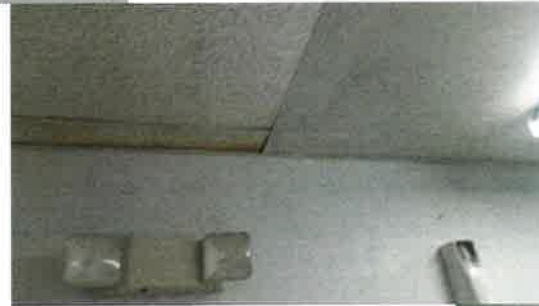
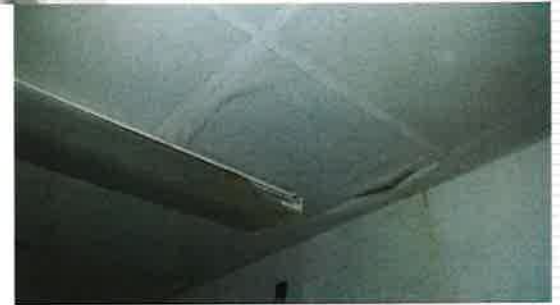
The building leaks.....

These pictures  
are from the  
men's shower  
room ceiling on  
the first floor.

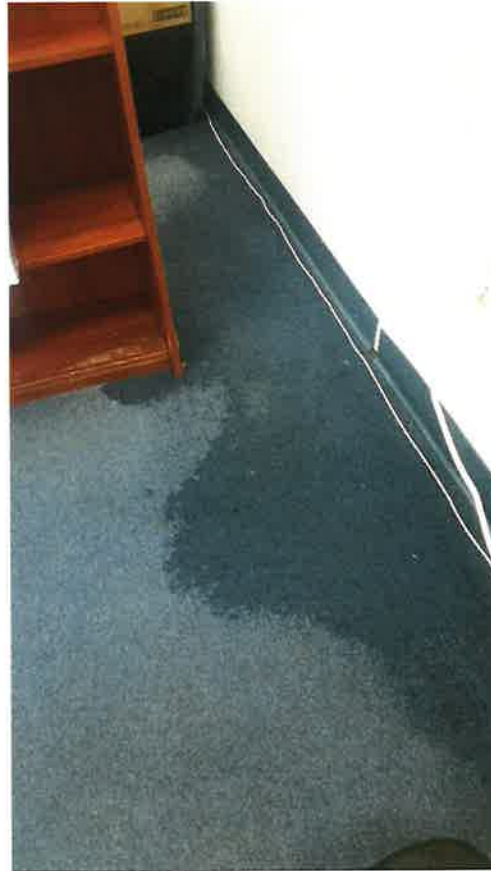
It is leaking in  
second floor  
office.

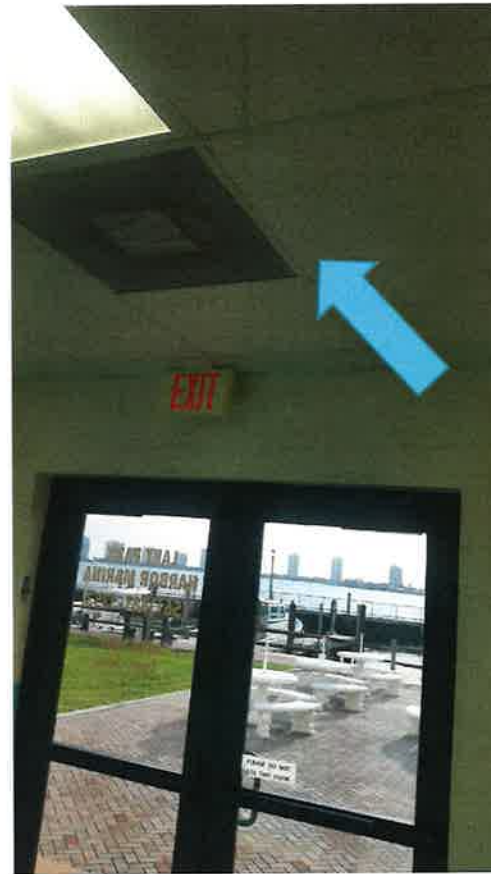
It is also leaking through the ceiling tiles in the ship's store.

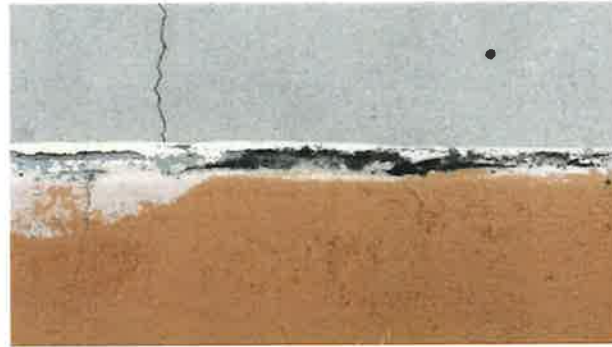
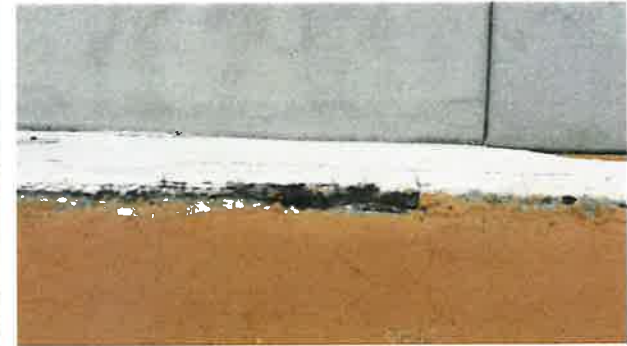
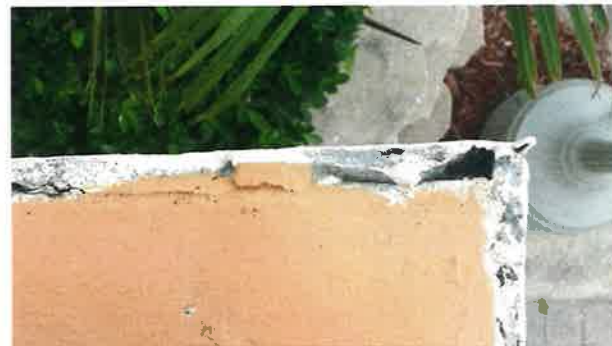
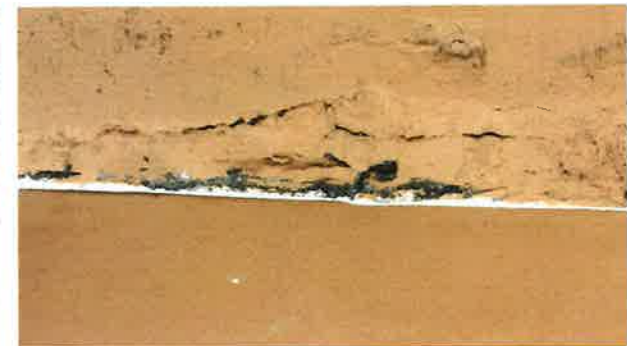
After investigating the source of all the leaking. It comes down to the delamination of the stucco at the transition point between the second floor balcony and the first floor exterior wall. This gap is allowing water to seep behind the wall. It is then finding it's way between the tongue and groove joints in the second floor concrete planks and ultimately this water is ending up getting into the interior spaces of the building.

Note: Images are being taken while standing on the second floor looking down at the edge of the concrete floor and stucco wall.

1. We recommend a serious crack, stucco repair and waterproofing project.
2. Stucco should be added at all the slab edges where the open cold joint seams are exposed.

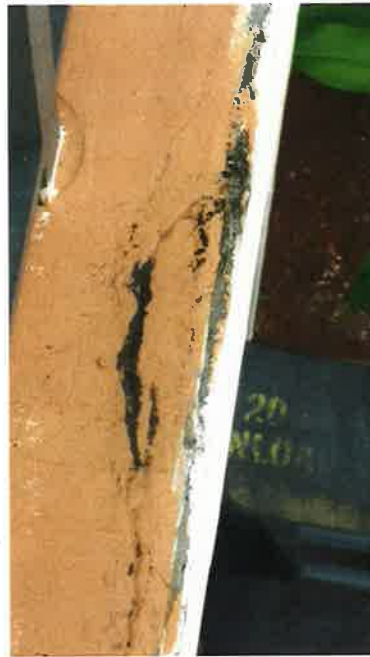
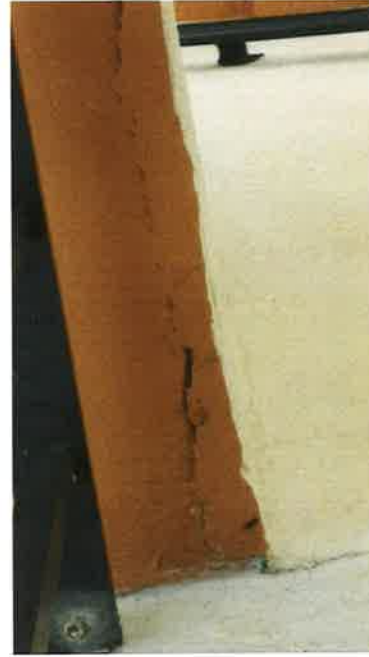
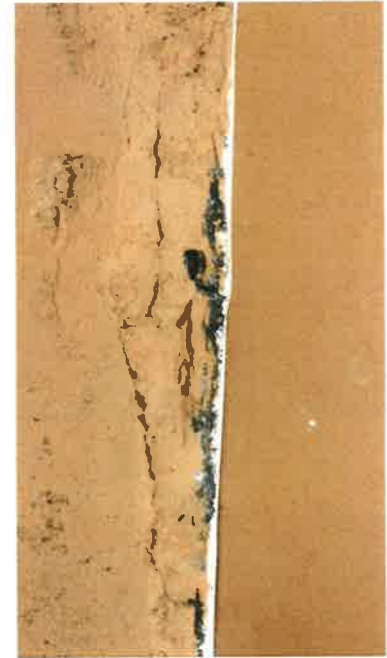
Some more pictures showing the delamination of the stucco and concrete at the edge of the second floor balcony.

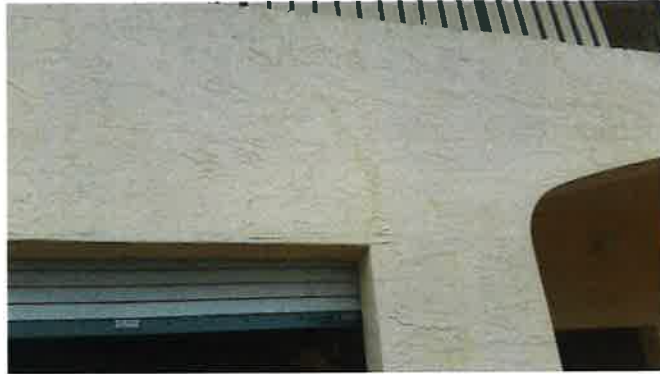
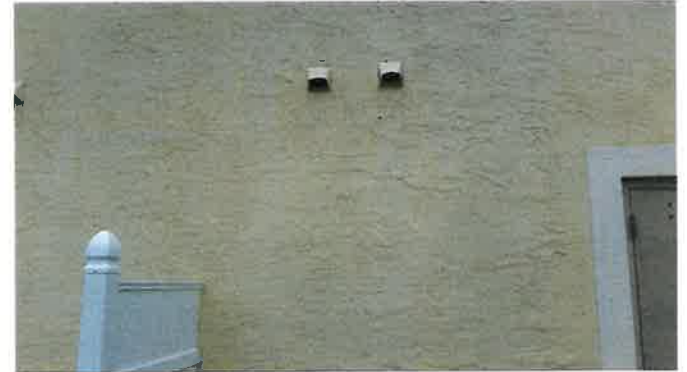
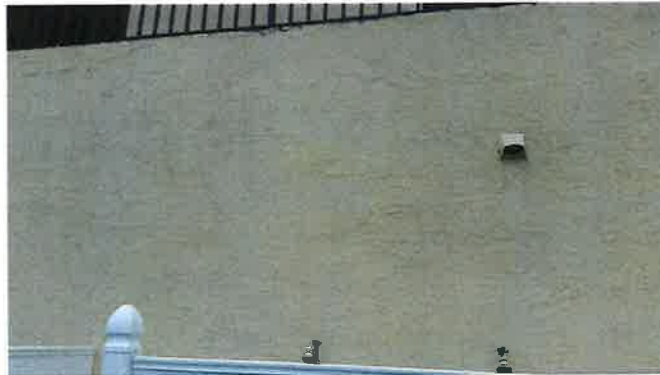
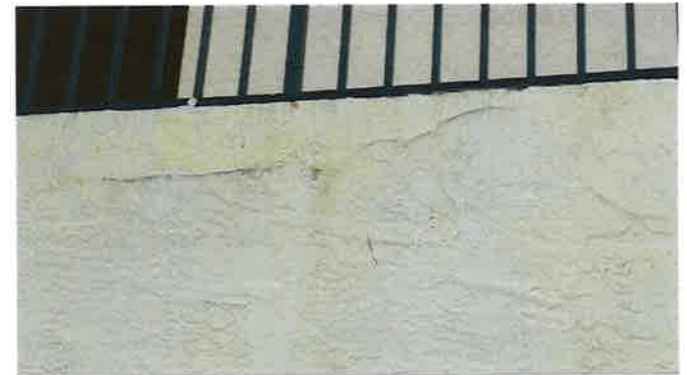
As you move around the building you will see a lot of cracks in the stucco. Some of the cracks are repairable and a lot of them are not, which will require the stucco to be replaced.

Starting at the northwest side of the building on the first floor.

3. Cracks should be cleaned out and sealed where they are at well-bonded stucco areas.
4. Any mildew or mold within the cracks should be cleaned with diluted bleach solution.

5. All cracks should be sounded with tapping hammers and any loose or delaminated material on the sides of the crack should be removed. New stucco should be installed to match adjacent surfaces.

6. The cracks without any loose stucco on side of the racks should be sealed flush with pressure injected exterior grade caulking. The caulking should be wet sponge finished so the cracks can only be seen but not felt. The cracked surfaces should not be low or high.

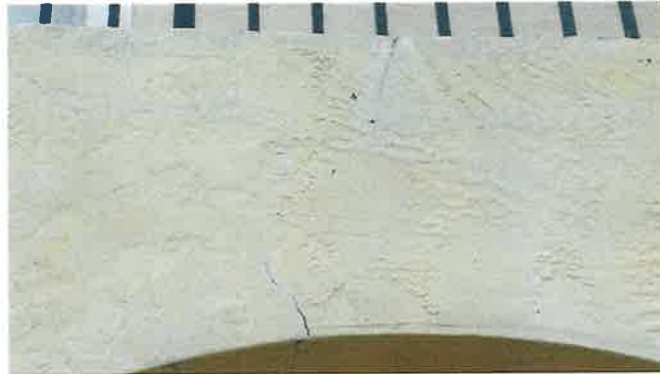
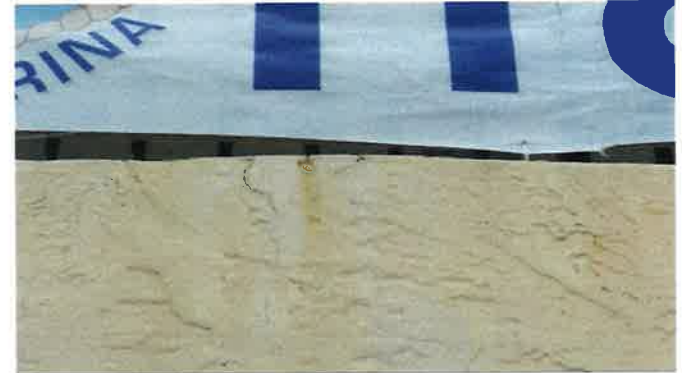
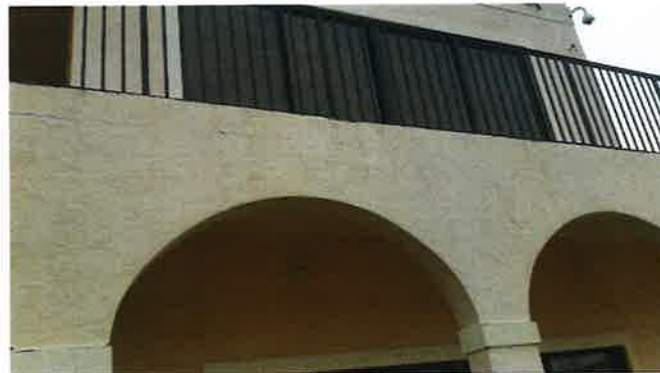
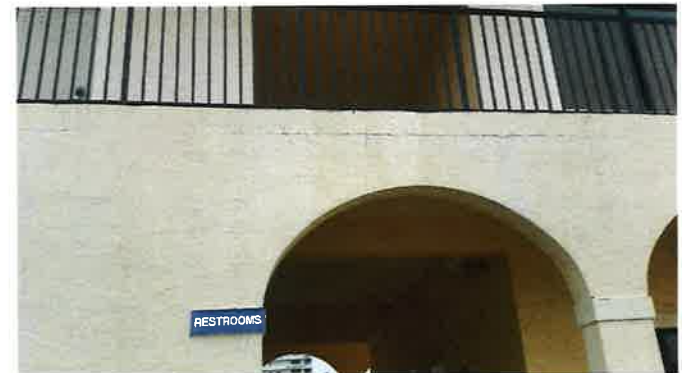
Continuing to move around the building clockwise, you will see more cracks in the stucco on the south side of the building.

Note the horizontal crack, running about 6 to 8 inches from the balcony. This is another sign of the building moving.

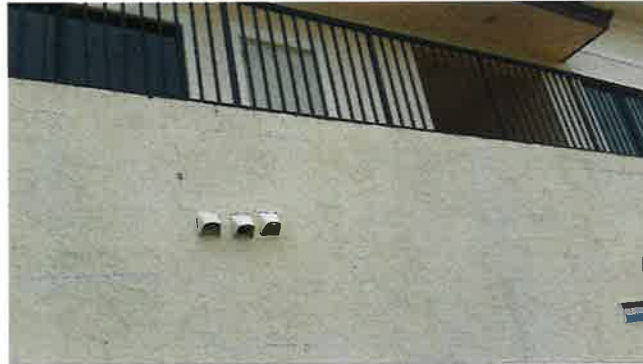
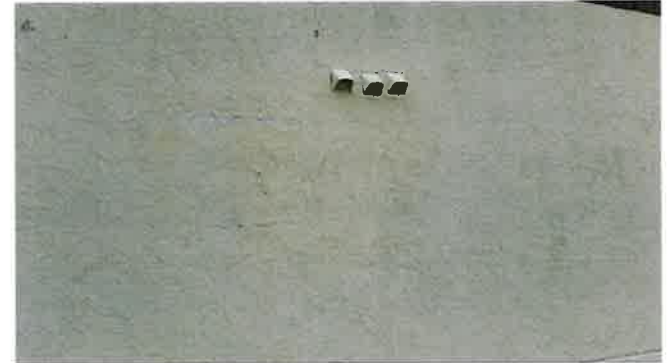
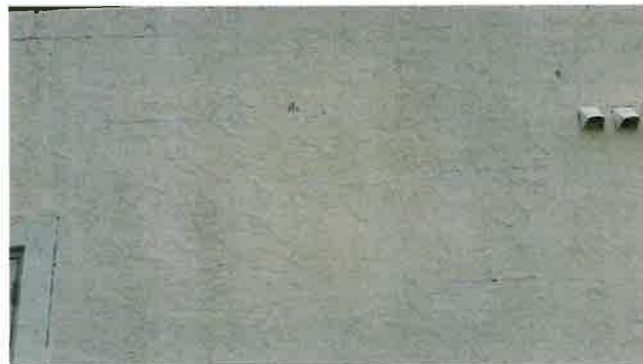
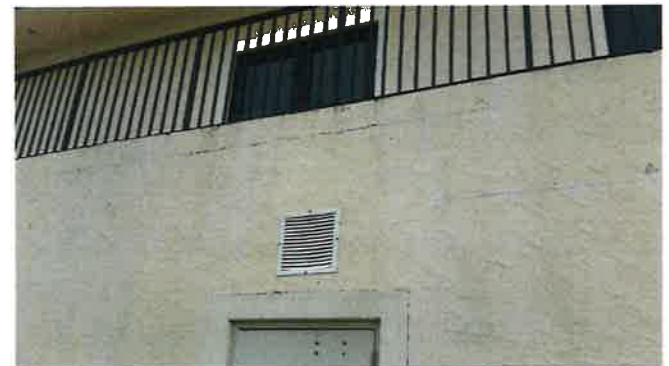
Still moving around the building on the south side, cracks are showing up all over, indicating the south wall movement.

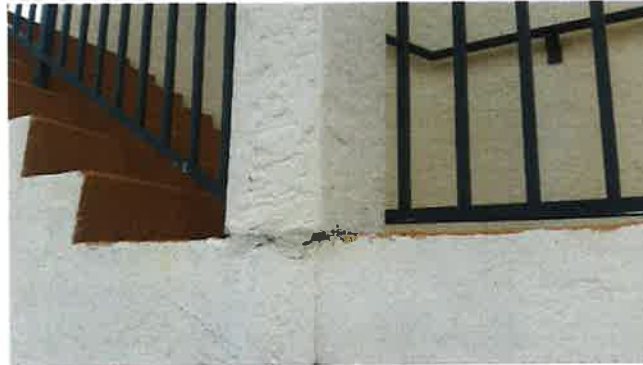
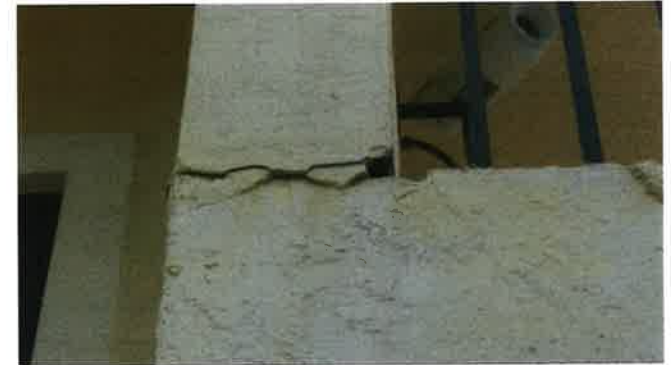
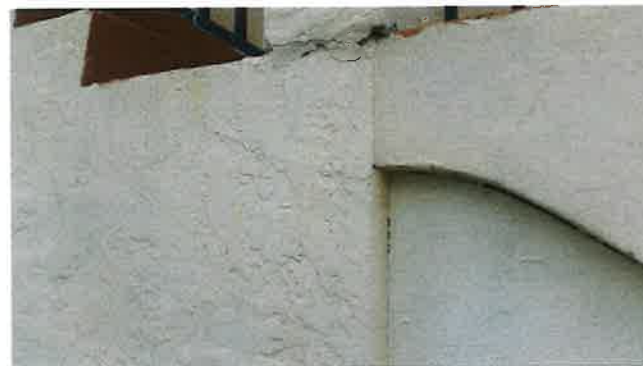
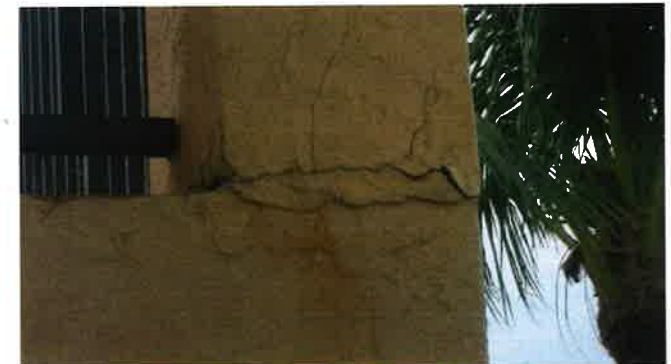
As we move to the west side of the building, more signs of movement in the support columns.

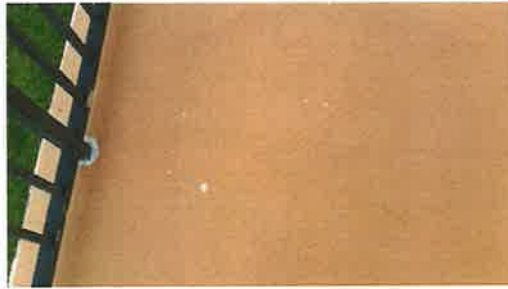
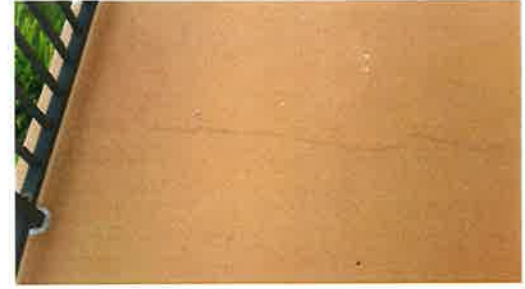
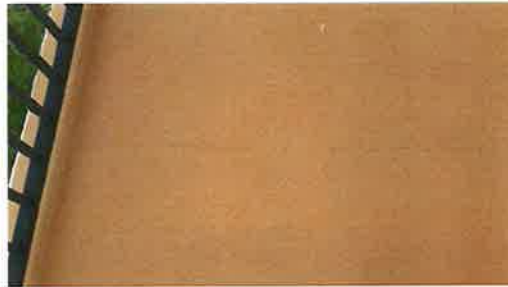
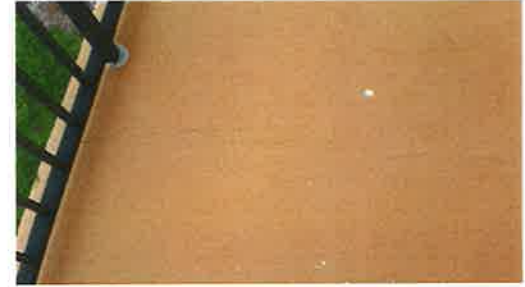
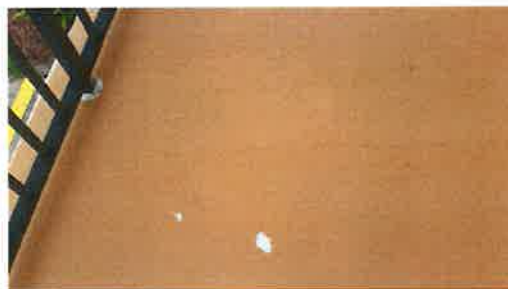
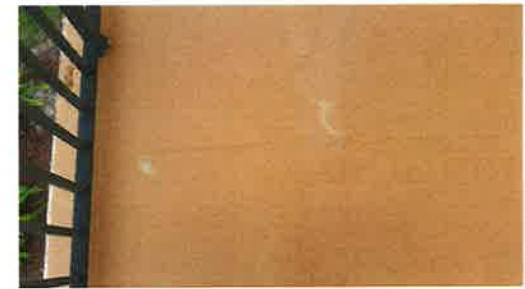
On the second floor balcony on the south side, there is a crack that appears about every 4 to 5 feet. I believe it is from the building moving and the concrete floor planks moving or flexing.

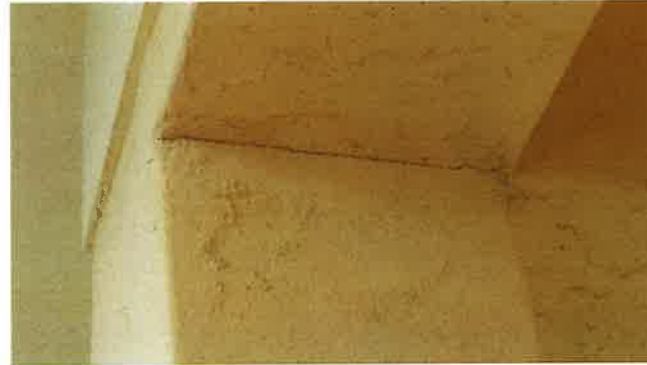
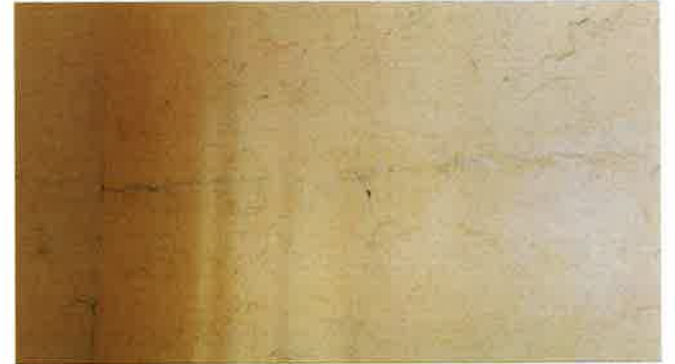
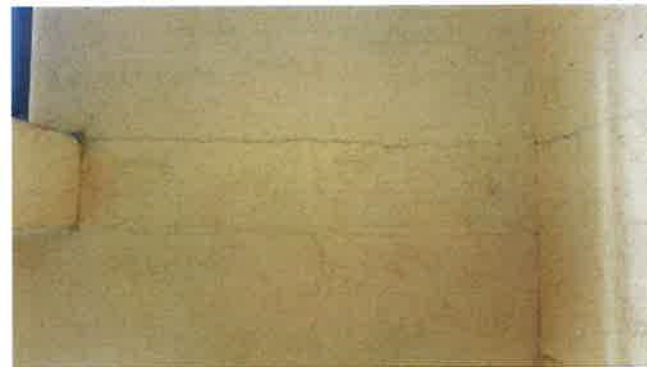
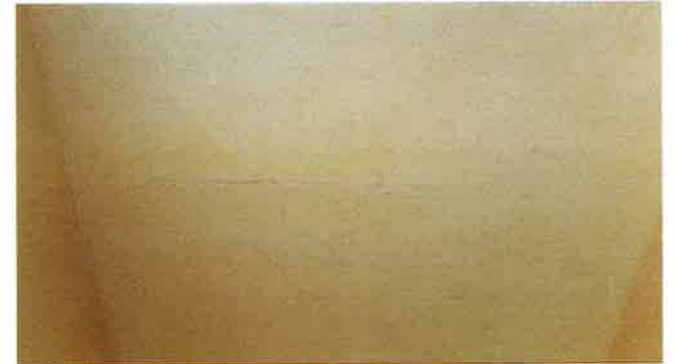
In the east stairwell area on the second floor, there are more signs of the building moving.

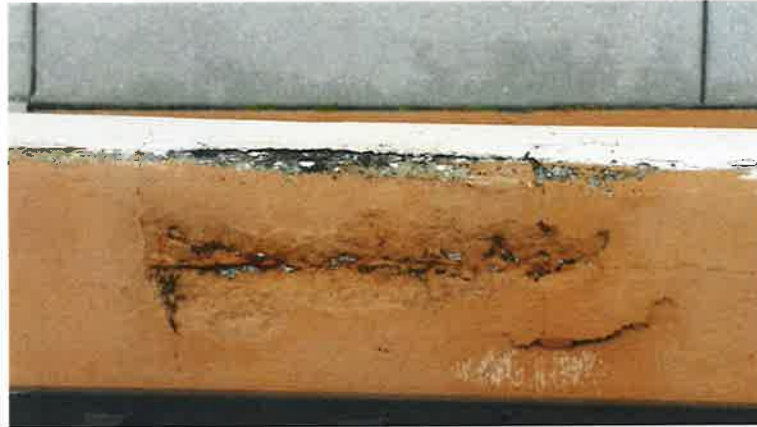
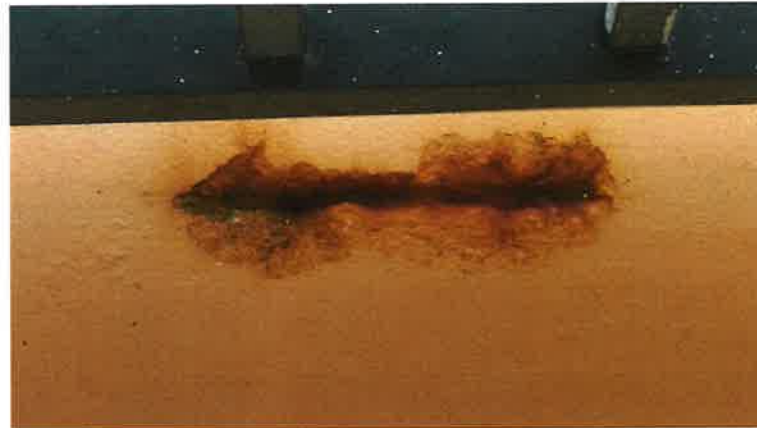
More pictures of balcony repair issues.

Also on the second floor balcony, we have some spalling going on.

7. All post pockets should be cleaned and have exterior grade grout added so that the pocket material is higher than the walkway.
8. The concrete spall areas should be excavated below the rebar and repaired according to ACI standards.

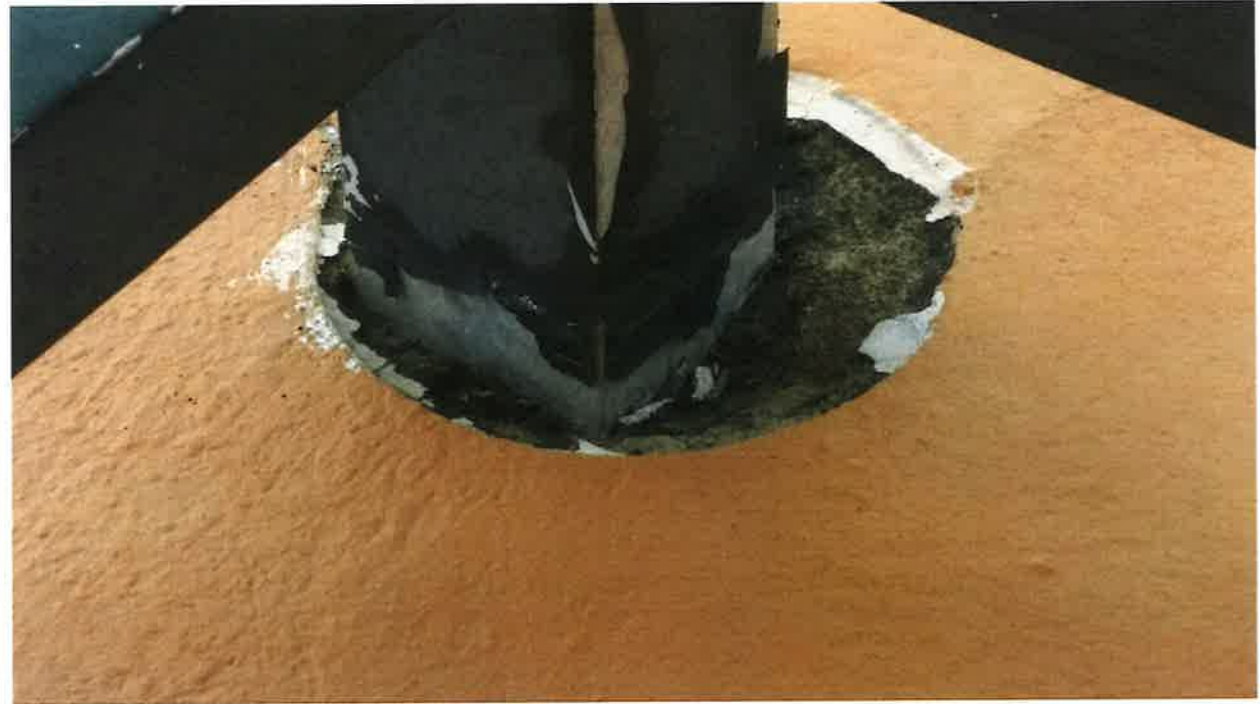
Most of the handrail post needs to be filled in and sealed.

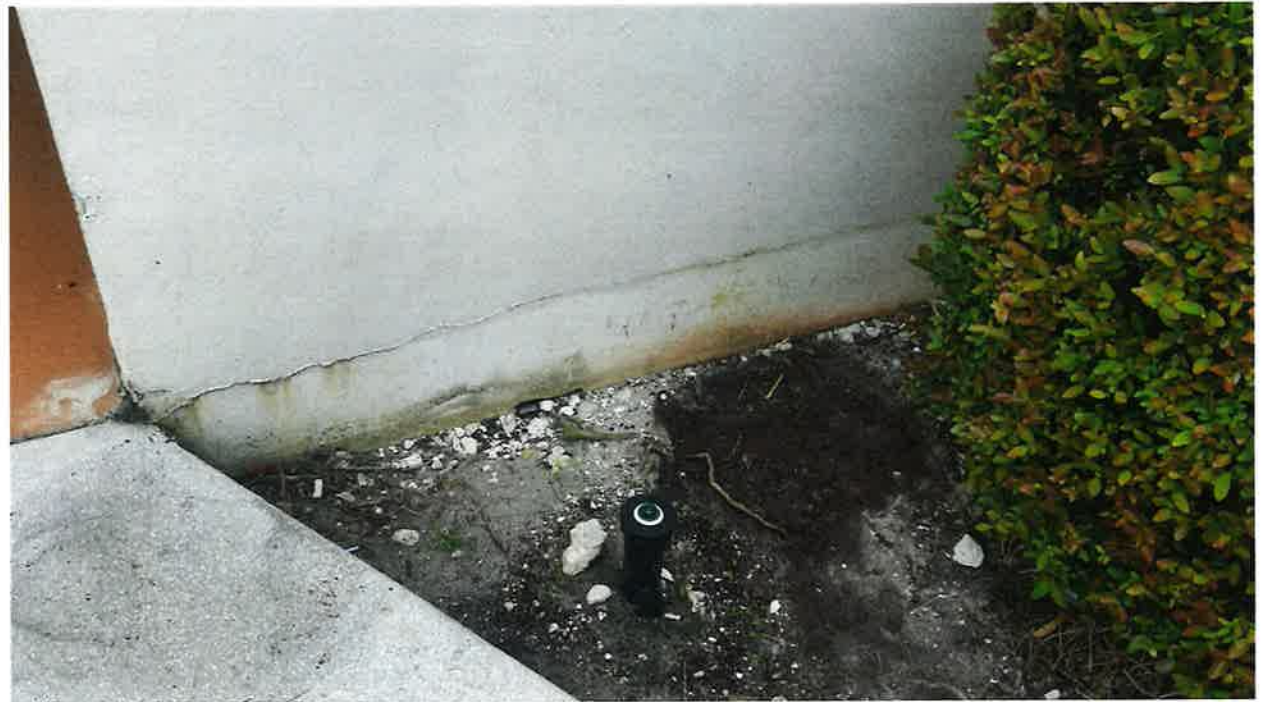
Plus the building has a foundation issue  
with a pilling.

Another on going problem is that the marina personnel has been putting gravel and soil into this area, because of a sink hole that keeps appearing every couple months.

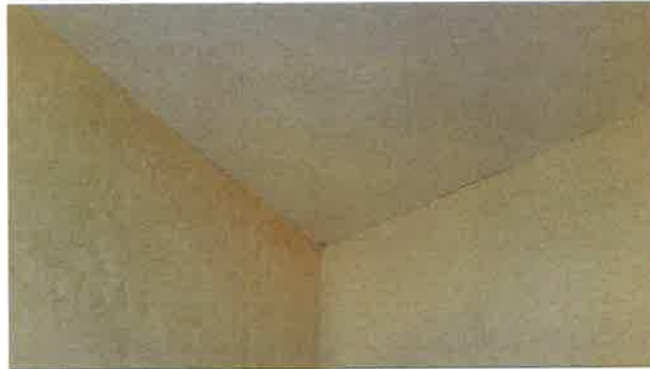
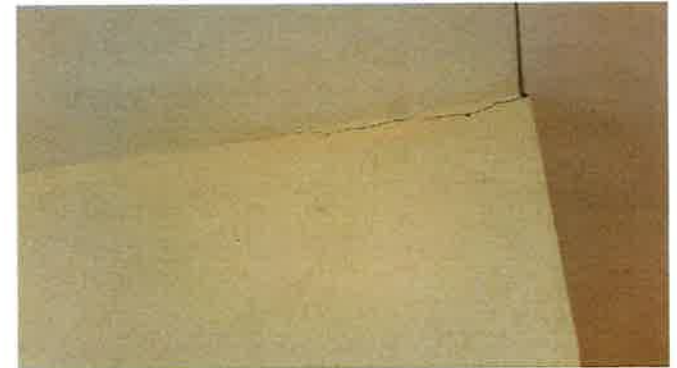
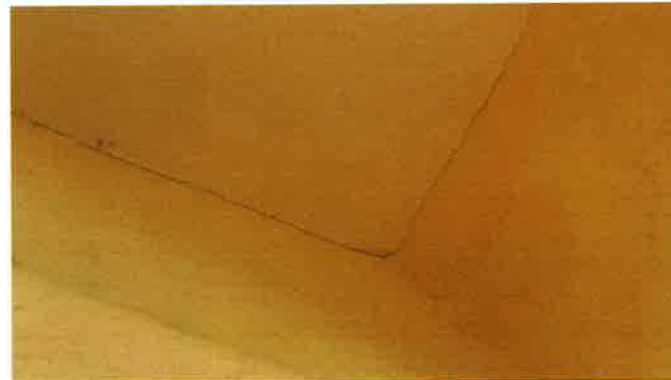
Because of the sink hole issue, there is an approximately 15 to 20 foot diameter area in the building, on both floors, that are showing signs of an improperly install pilling in the building foundation. It is likely that the pilling is floating. So that joints in the walls and ceiling areas are showing signs of separating.

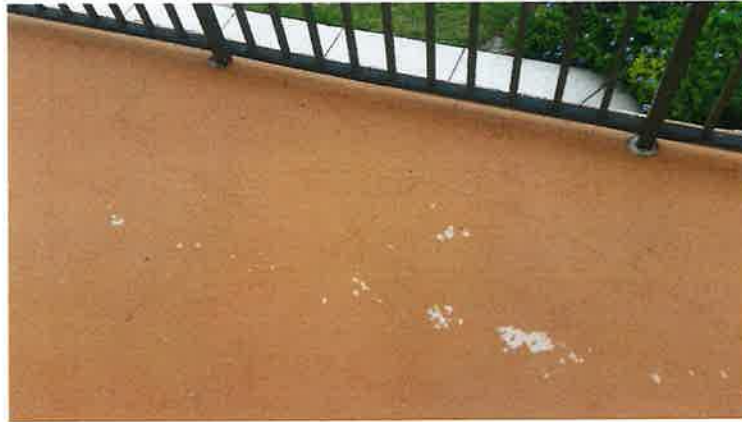
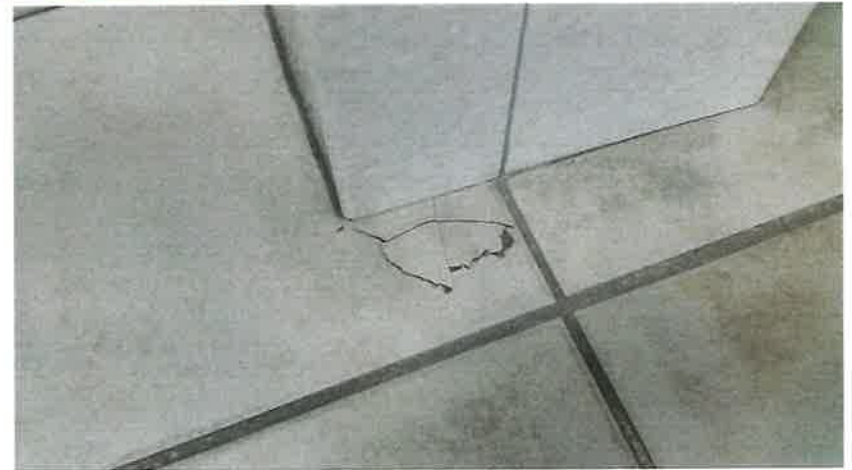
There are cracks on the second floor balcony running in different directions in that same area. There is a pop in the tile next to a column in the men's bathroom. It is like that part of the building is floating up and down, because the piling that is not installed correctly.

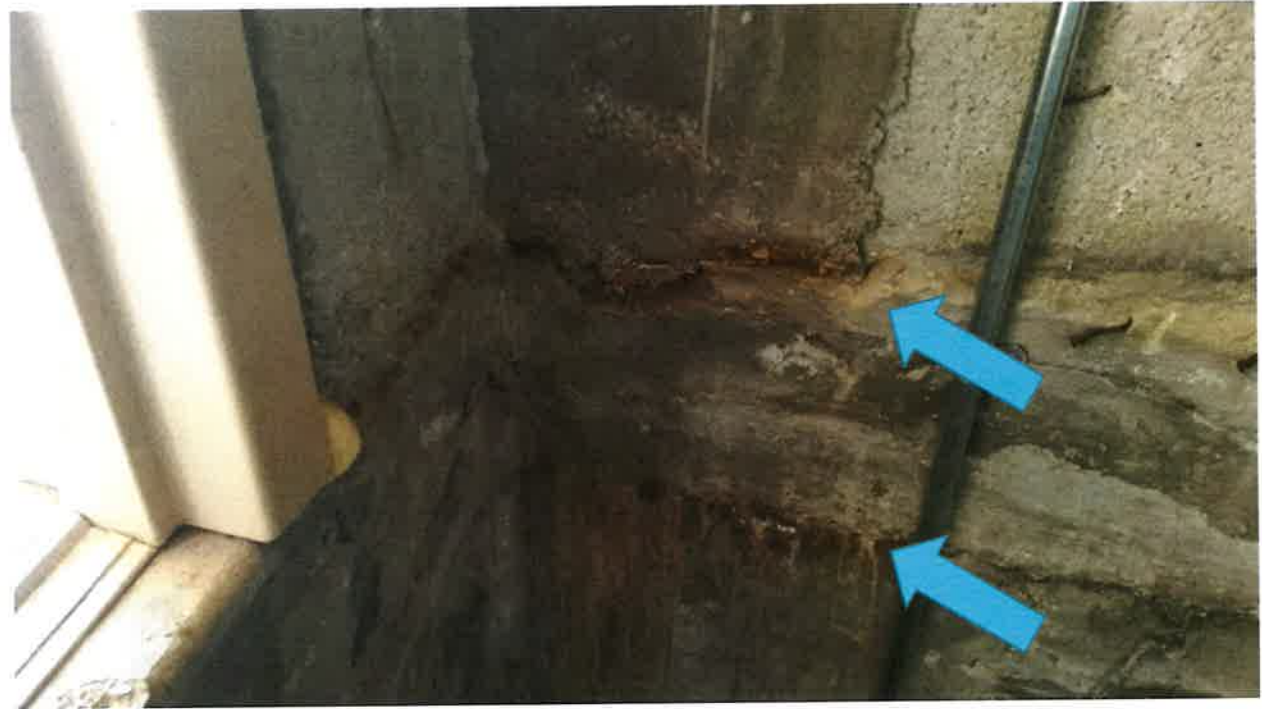
This picture shows water intrusion into the elevator shaft from the top and bottom side of the second floor concrete.

10. Water tight electric outlet covers should be installed where needed.
11. The elevator doors should be checked for wind driven water intrusion. New seals may be required.

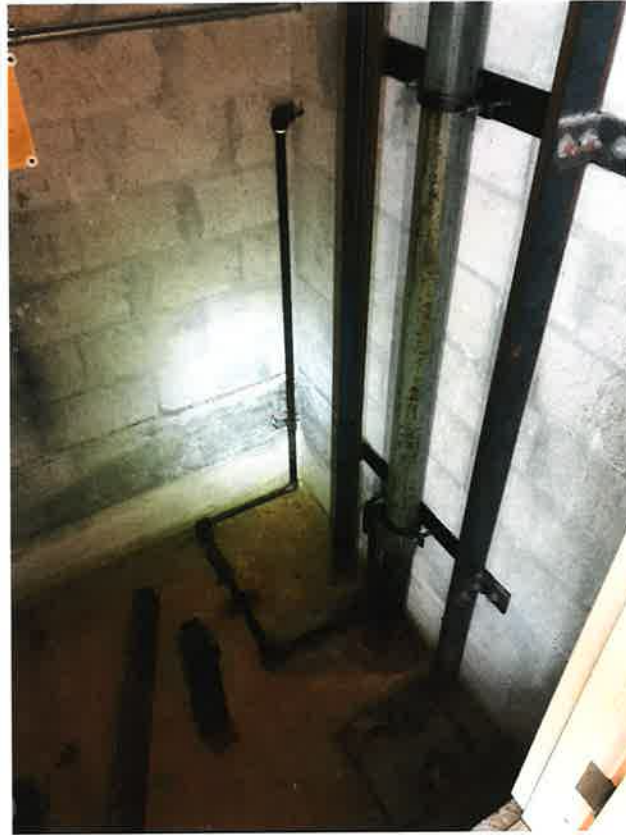
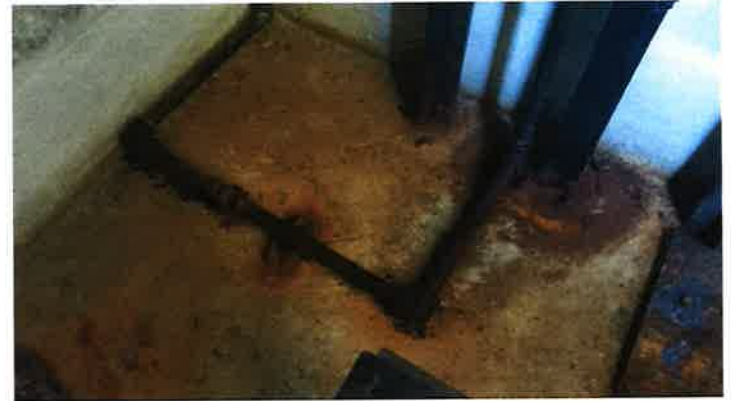
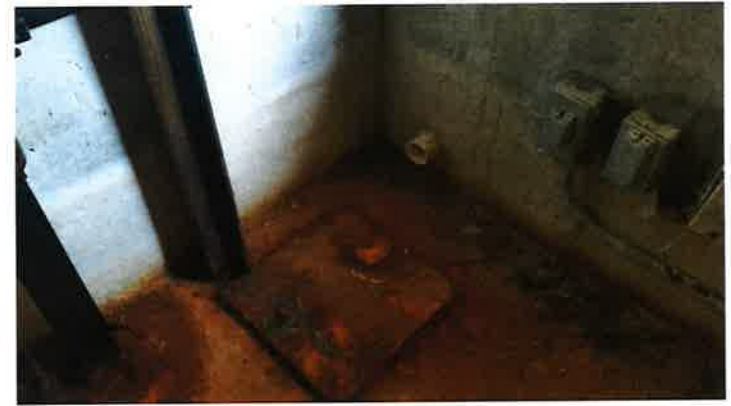
Between the water coming in from the second floor concrete, it is also coming from under the doors themselves. This water has cause the elevator to have safety issues with the rusting of the high pressure pipes for the elevator. Which could cause a lift failure and the possibility of a free fall dropping of the passenger compartment .

3. Water entering the elevator shaft caused the rusted pipes in the bottom of the shaft. The water is getting in though the doors.
4. Open electric outlets allow wind driven rain water to enter causing water intrusion at unknown conduit area in the building interior. This also causes conduit corrosion and possible grounding issues.

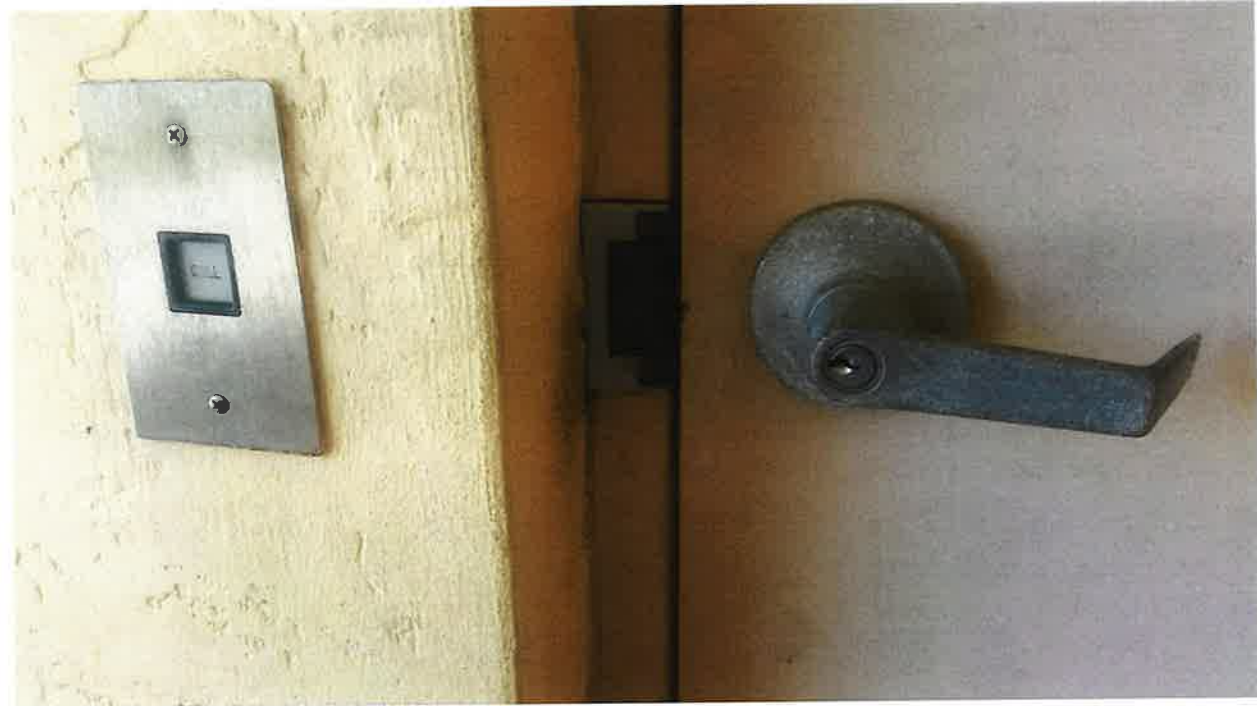
Another major problem with the elevator is that the doors doesn't meet the true ADA access requirements that is needed at the marina. Second major problem is that the door locking mechanism for the safe operation of the elevator is not reliable in the wet salty environment at the marina. Which means the elevator is out of commission most of the time. And the marina is spending a lot of money repairing it just so we can have special events on the second floor.
