# MARINA BUILDING DEFICIENCIES 2019

LPHM 4-27-19

Re: Engineering Inspection

For: Lake Park Marina Building  
103 / 105 Lake Shore Drive  
Lake Park, FL 33403

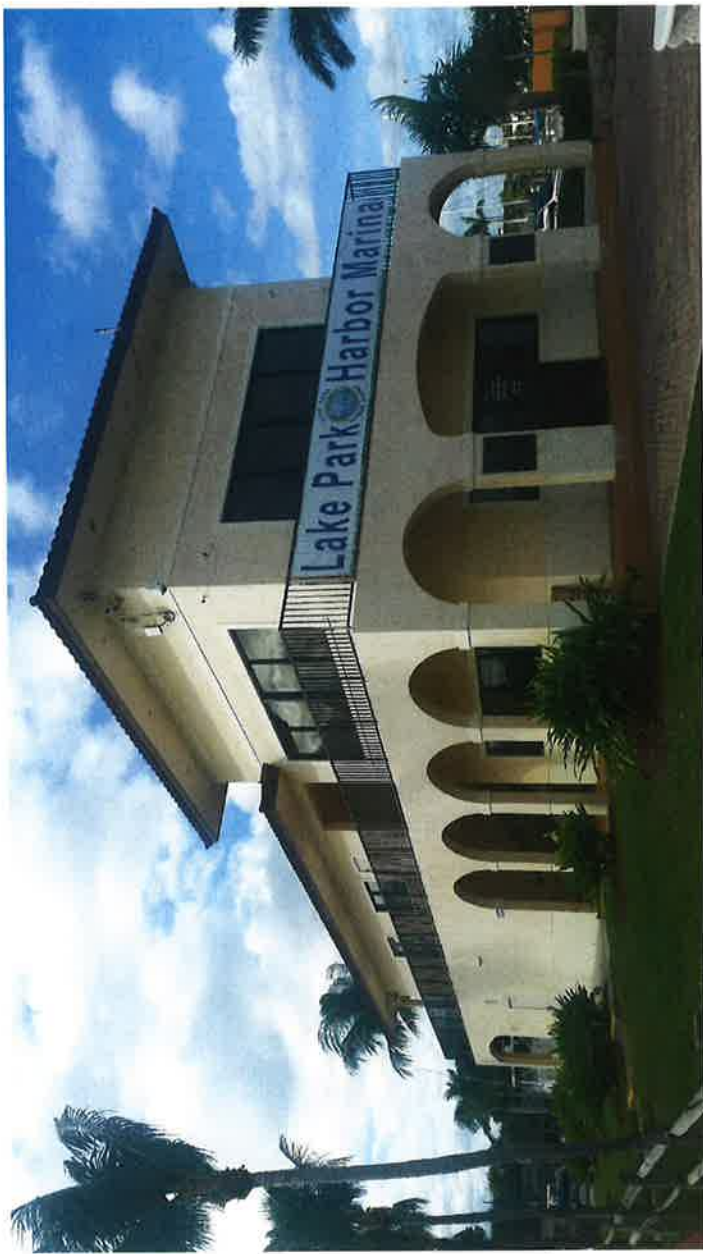
Construction deficiencies from day one.

The floor drain from the second floor bathroom is not connected at all.

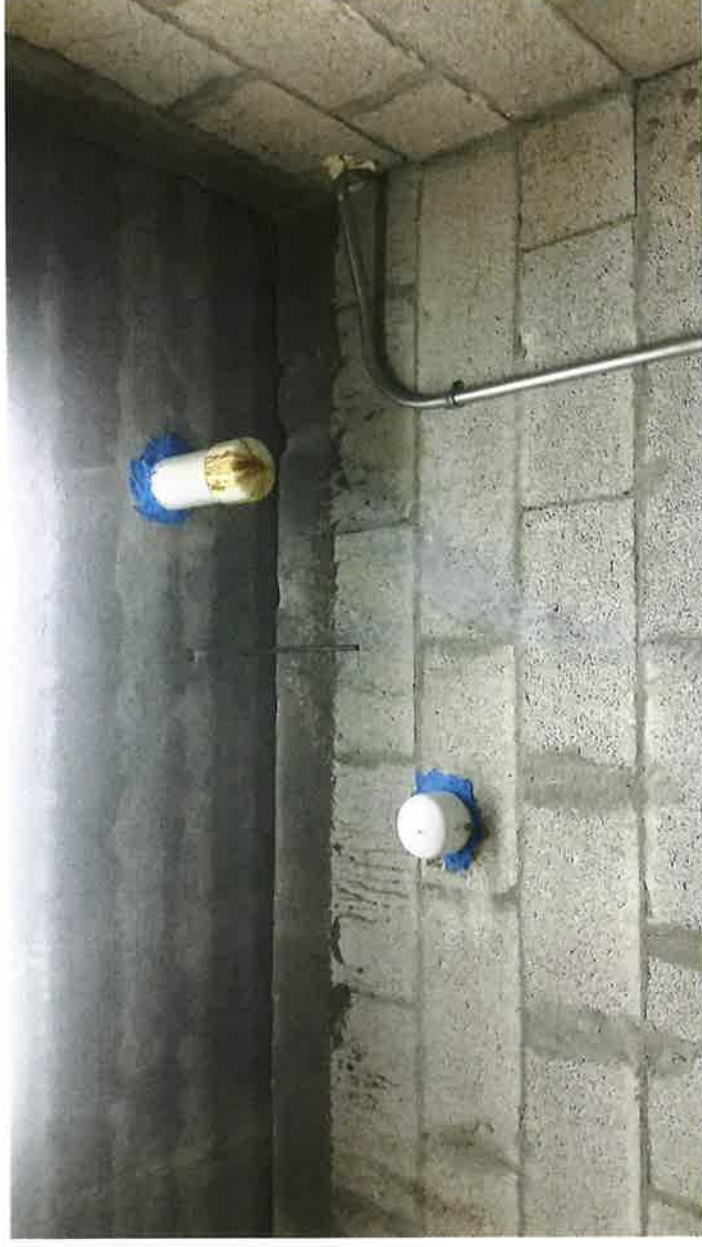
No drain for west wing first floor HVAC unit. A sump pump is being used to pump the AC condensation up to second floor to get rid of the water. If you notice the damp floor, the sump pump does not a good job of moving the water, and the floor gets wet from time to time.

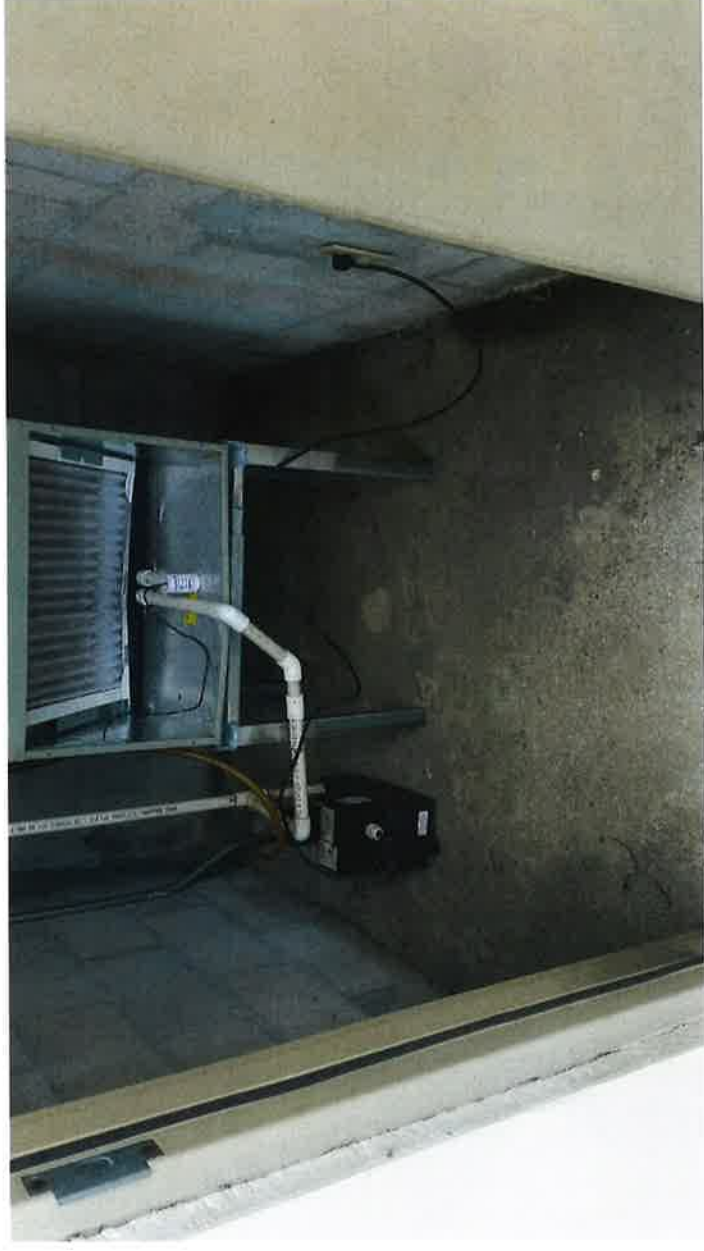
No drain for the ship's store HVAC unit either. It also is using a sump pump to pump the AC condensation up to second floor to get rid of it's water.

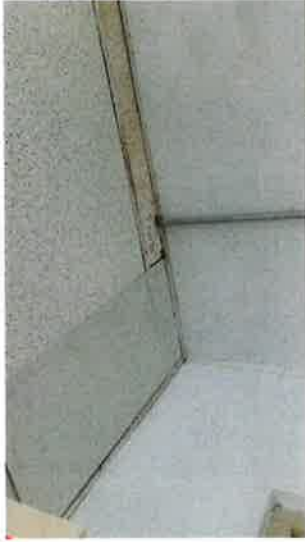
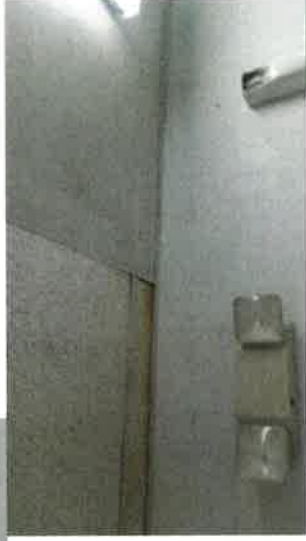
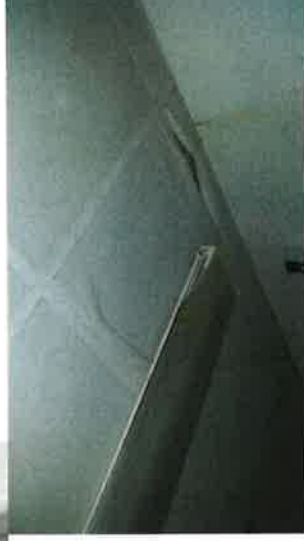
The building leaks.....

These pictures  
are from the  
men's shower  
room ceiling on  
the first floor.

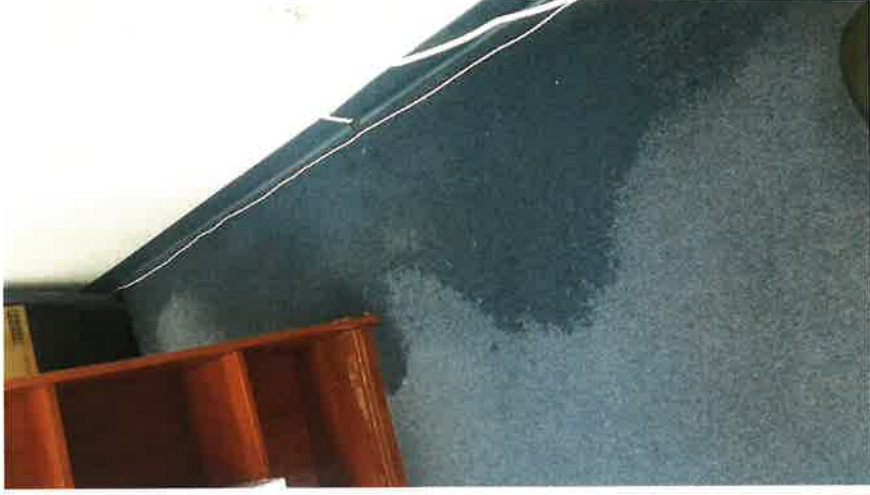
It is leaking in  
second floor  
office.

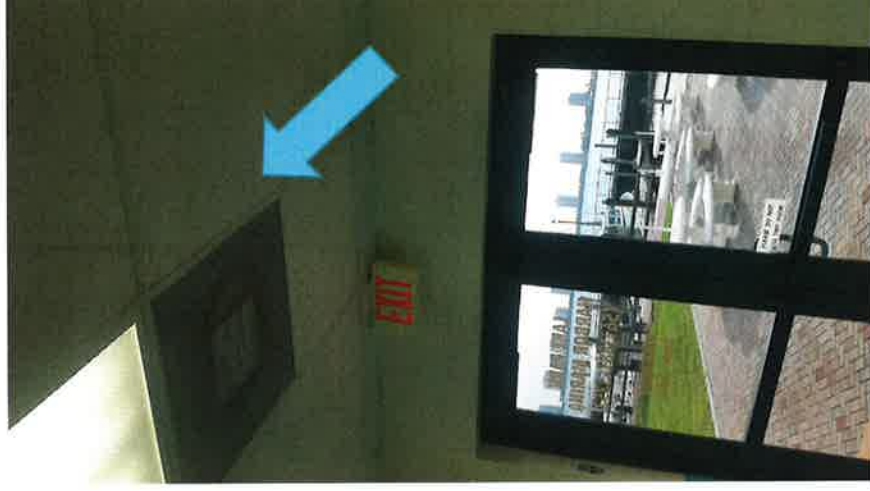
It is also  
leaking  
through the  
ceiling tiles in  
the ship's  
store.

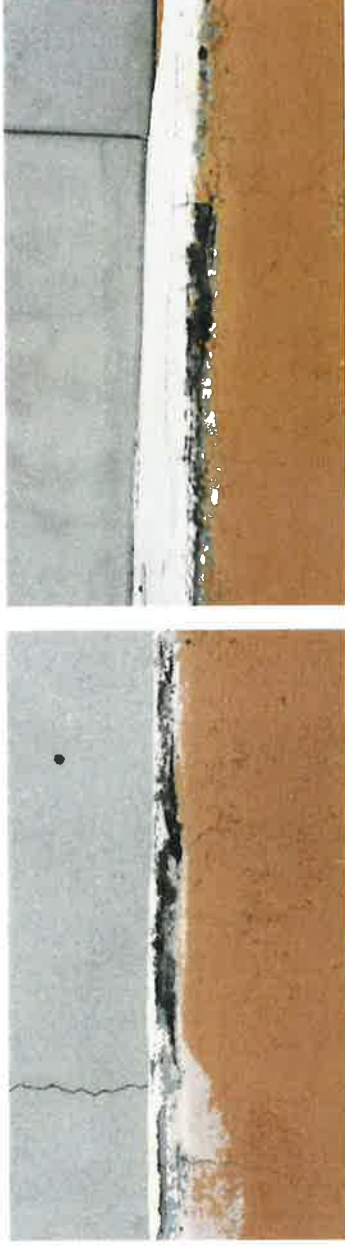
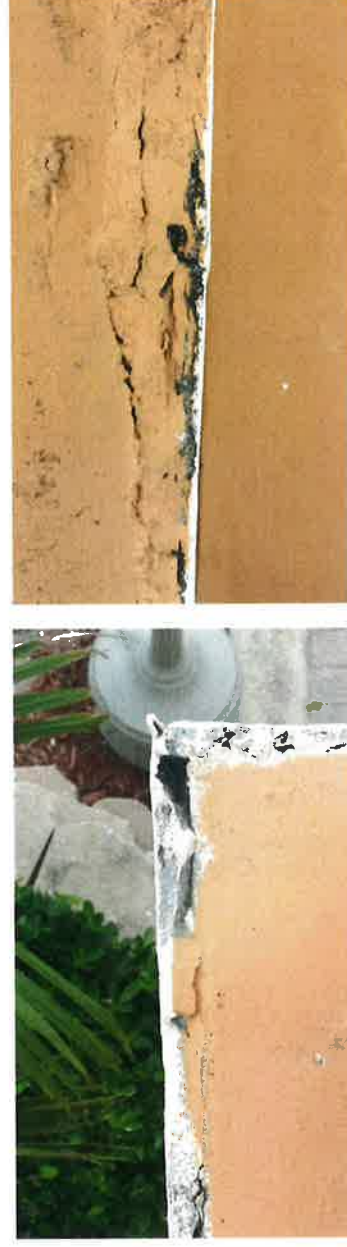
After investigating the source of all the leaking, it comes down to the delamination of the stucco at the transition point between the second floor balcony and the first floor exterior wall. This gap is allowing water to seep behind the wall. It is then finding it's way between the tongue and groove joints in the second floor concrete planks and ultimately this water is ending up getting into the interior spaces of the building.

Note: Images are being taken while standing on the second floor looking down at the edge of the concrete floor and stucco wall.

1. We recommend a serious crack, stucco repair and waterproofing project.
2. Stucco should be added at all the slab edges where the open cold joint seams are exposed.

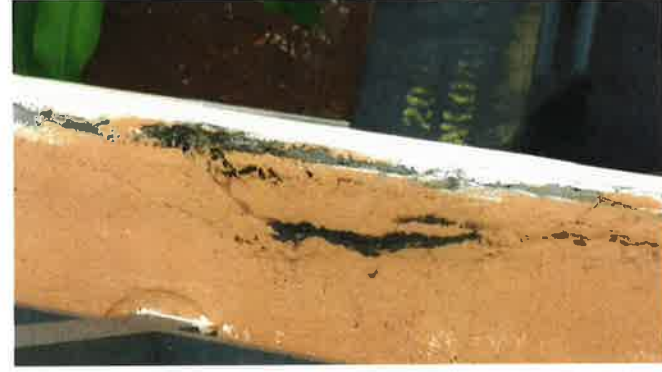
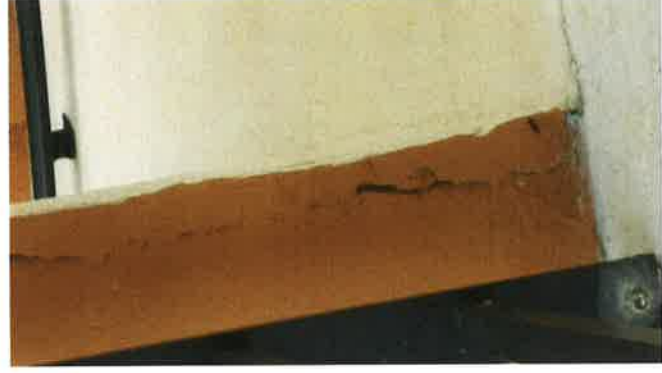
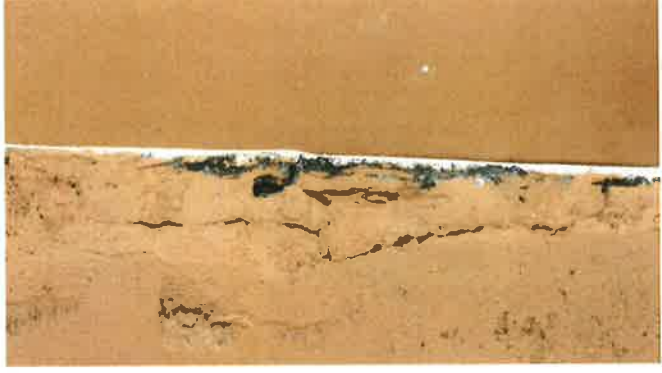
Some more pictures showing the delamination of the stucco and concrete at the edge of the second floor balcony.

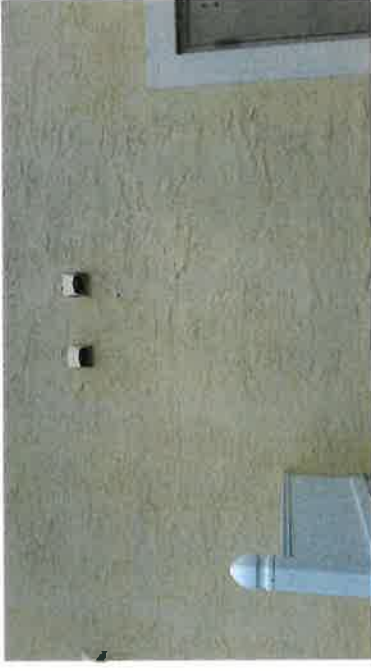
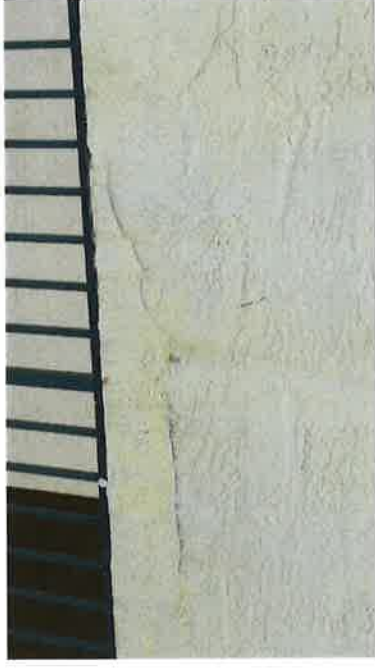
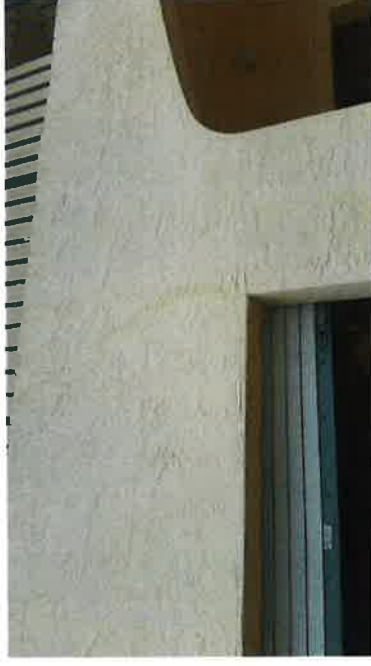
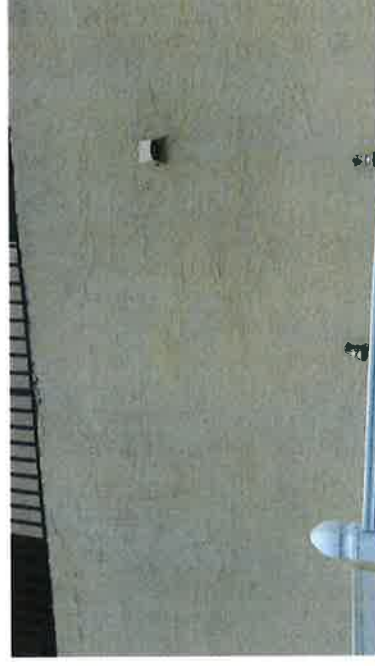
As you move around the building you will see a lot of cracks in the stucco. Some of the cracks are repairable and a lot of them are not, which will require the stucco to be replaced.

Starting at the northwest side of the building on the first floor.

5. All cracks should be sounded with tapping hammers and any loose or delaminated material on the sides of the crack should be removed. New stucco should be installed to match adjacent surfaces.

6. The cracks without any loose stucco on side of the racks should be sealed flush with pressure injected exterior grade caulking. The caulking should be wet sponge finished so the cracks can only be seen but not felt. The cracked surfaces should not be low or high.

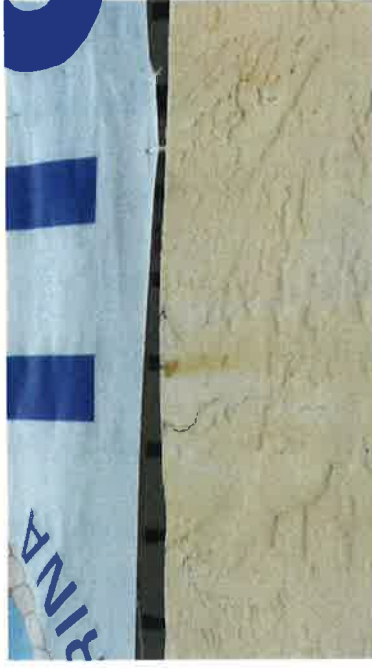
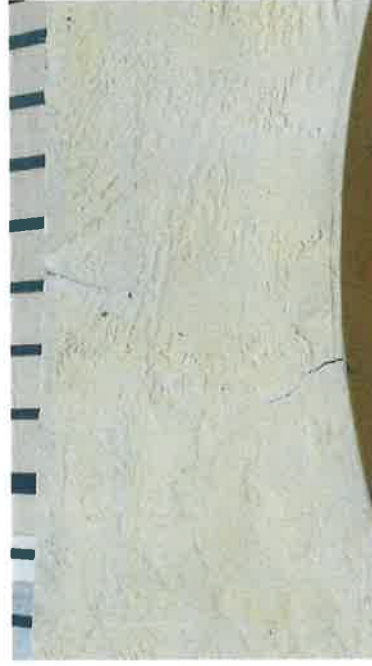
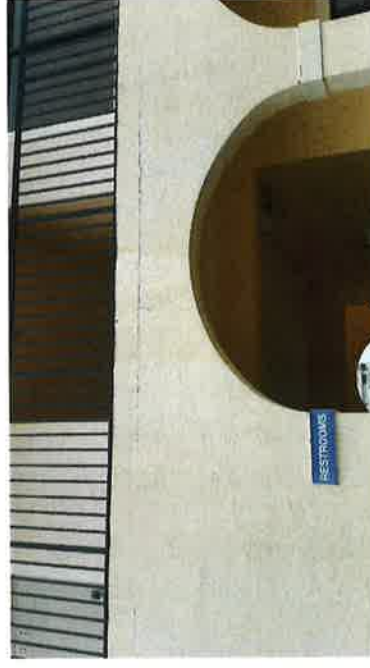
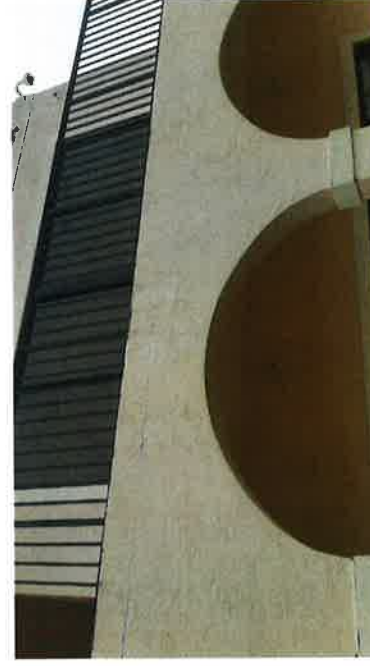
Continuing to move around the building clockwise, you will see more cracks in the stucco on the south side of the building.

Note the horizontal crack, running about 6 to 8 inches from the balcony. This is another sign of the building moving.

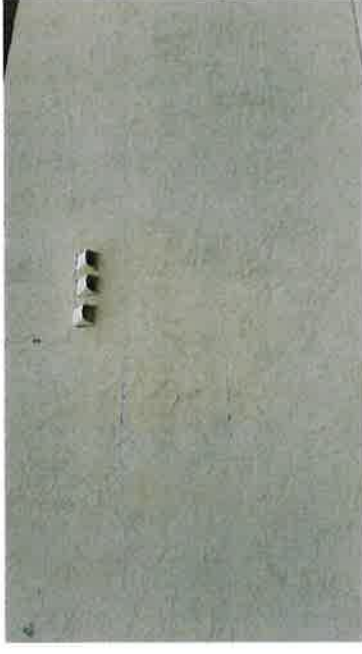
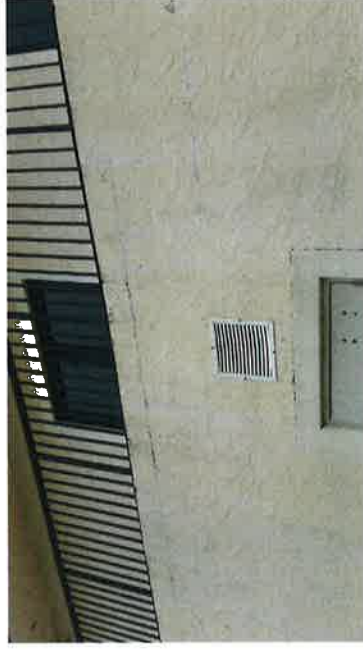
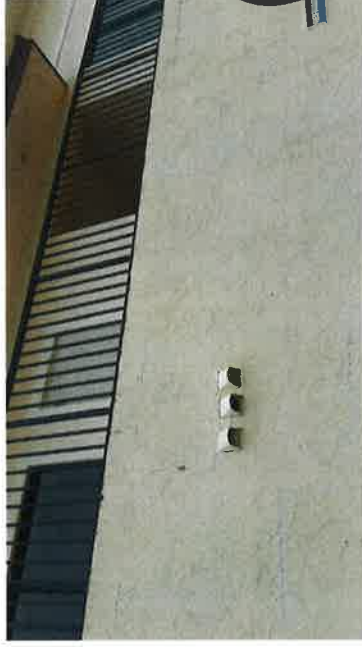
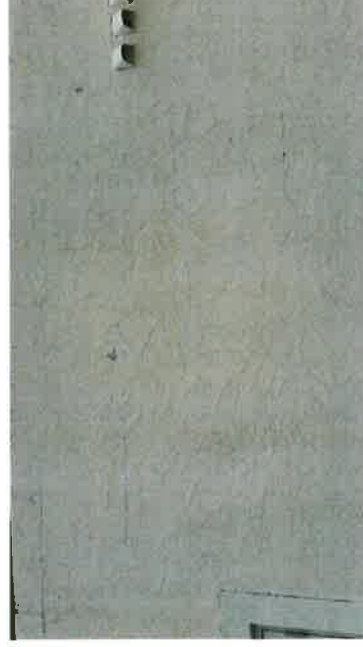
Still moving around the building on the south side, cracks are showing up all over, indicating the south wall movement.

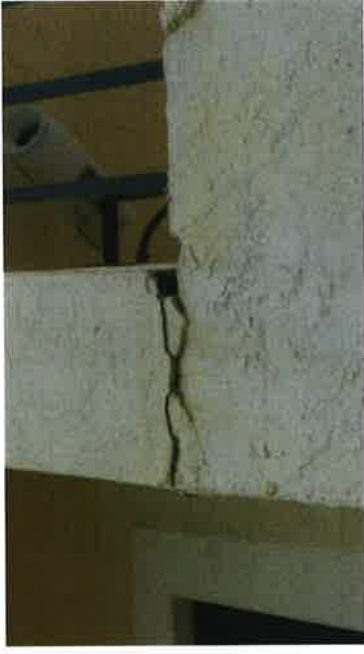
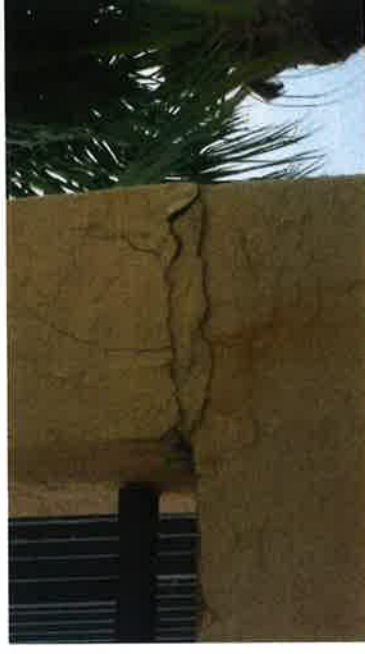
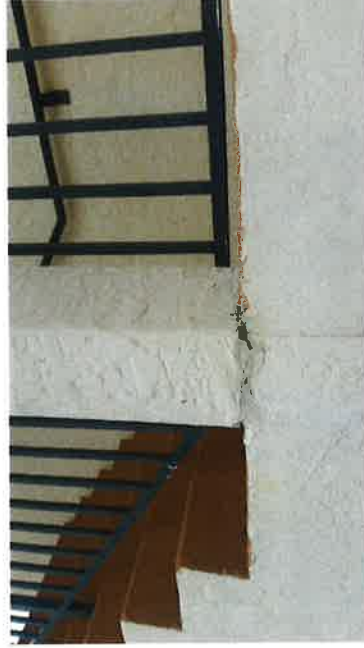
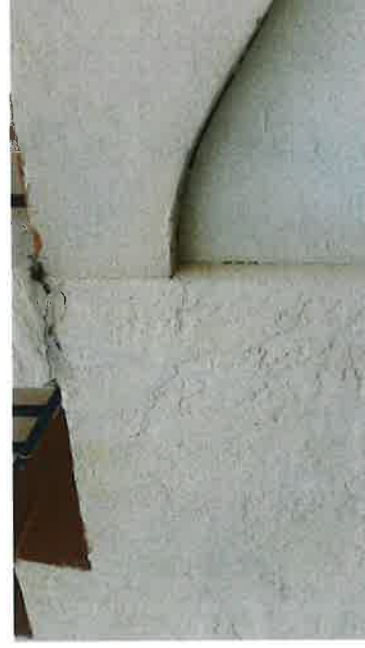
As we move to the west side of the building, more signs of movement in the support columns.

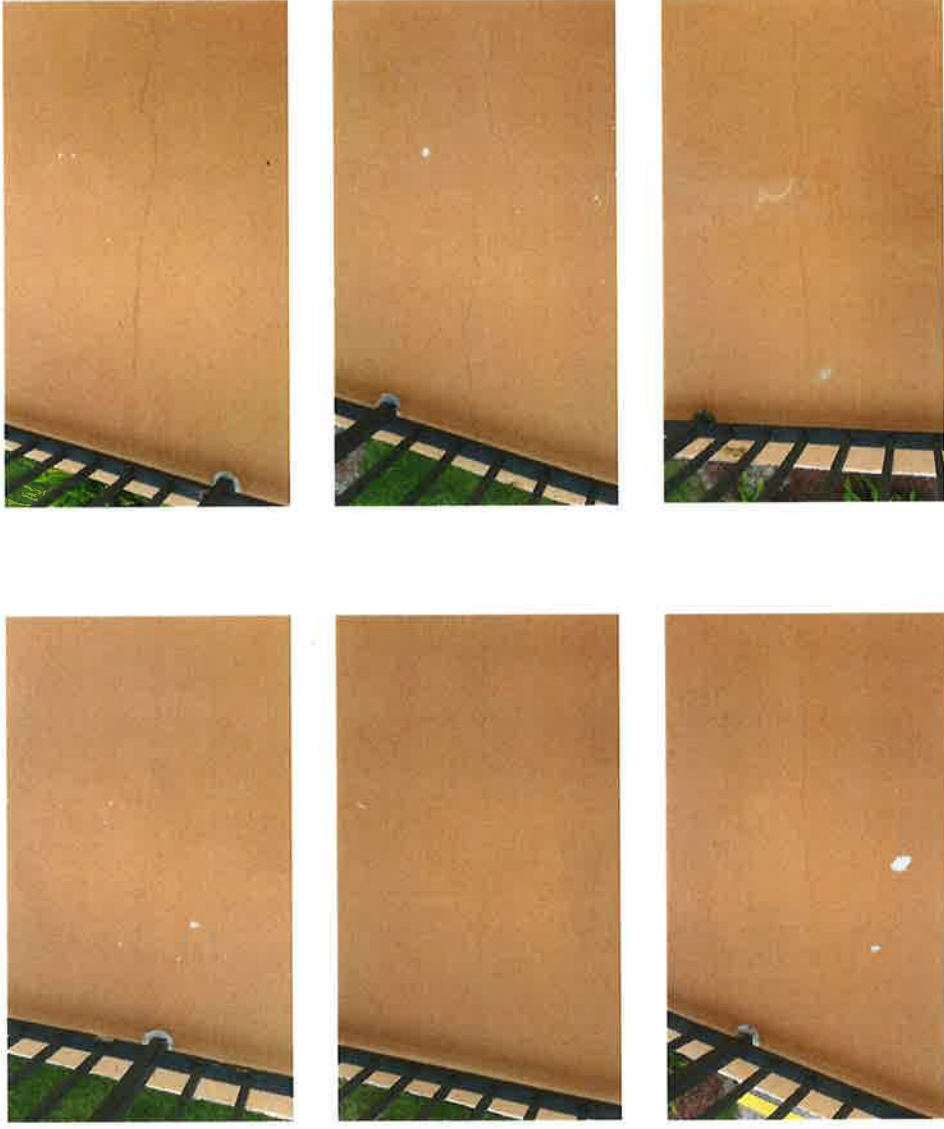
On the second floor balcony on the south side, there is a crack that appears about every 4 to 5 feet. I believe it is from the building moving and the concrete floor planks moving or flexing.

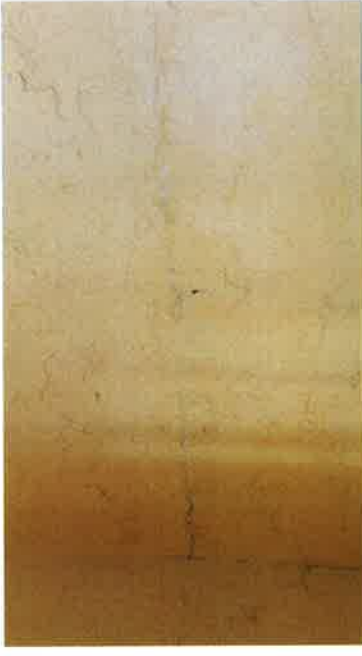
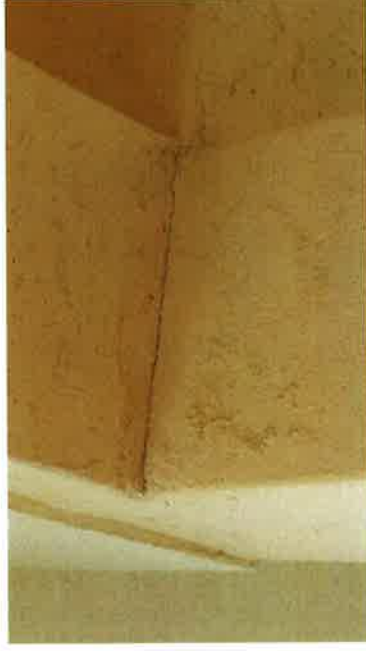
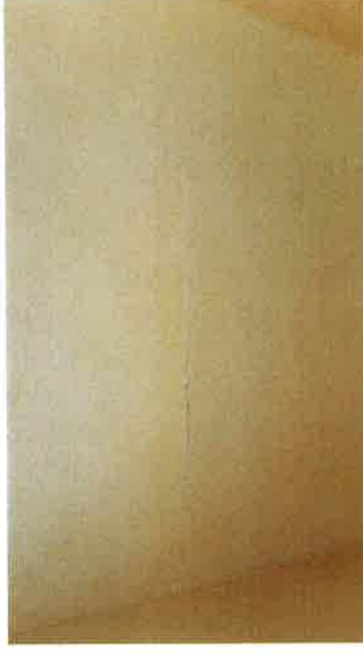
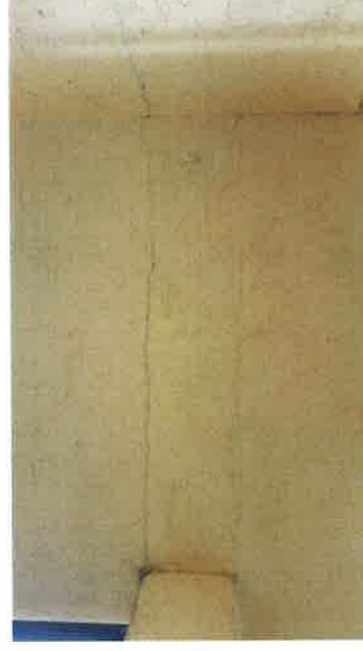
In the east stairwell area on the second floor, there are more signs of the building moving.

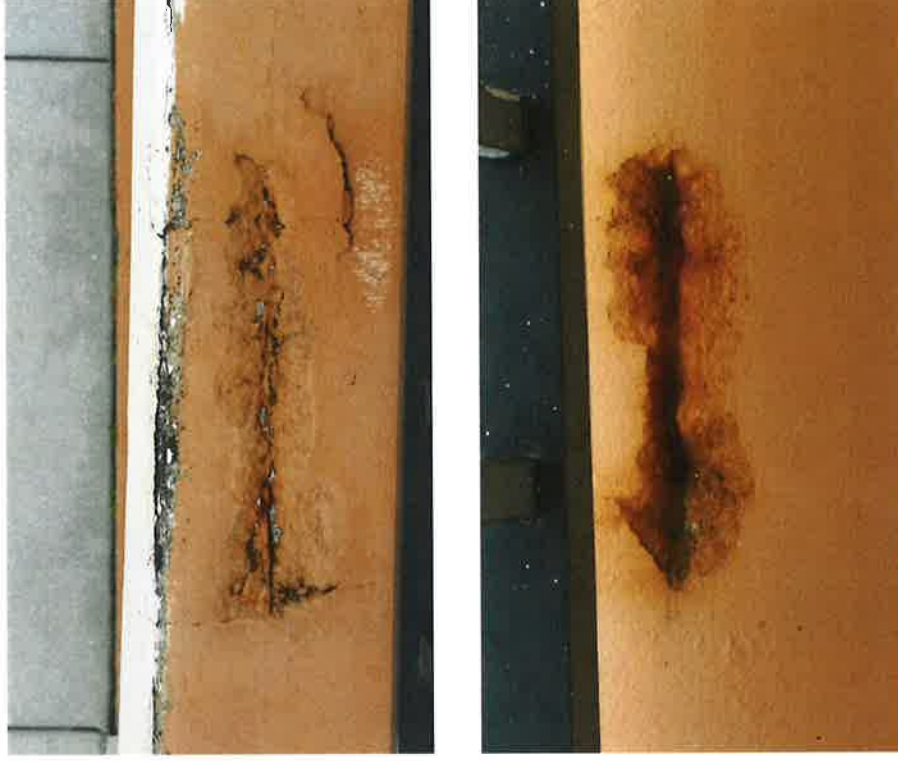
Also on the second floor balcony, we have some spalling going on.

7. All post pockets should be cleaned and have exterior grade grout added so that the pocket material is higher than the walkway.
8. The concrete spall areas should be excavated below the rebar and repaired according to ACI standards.

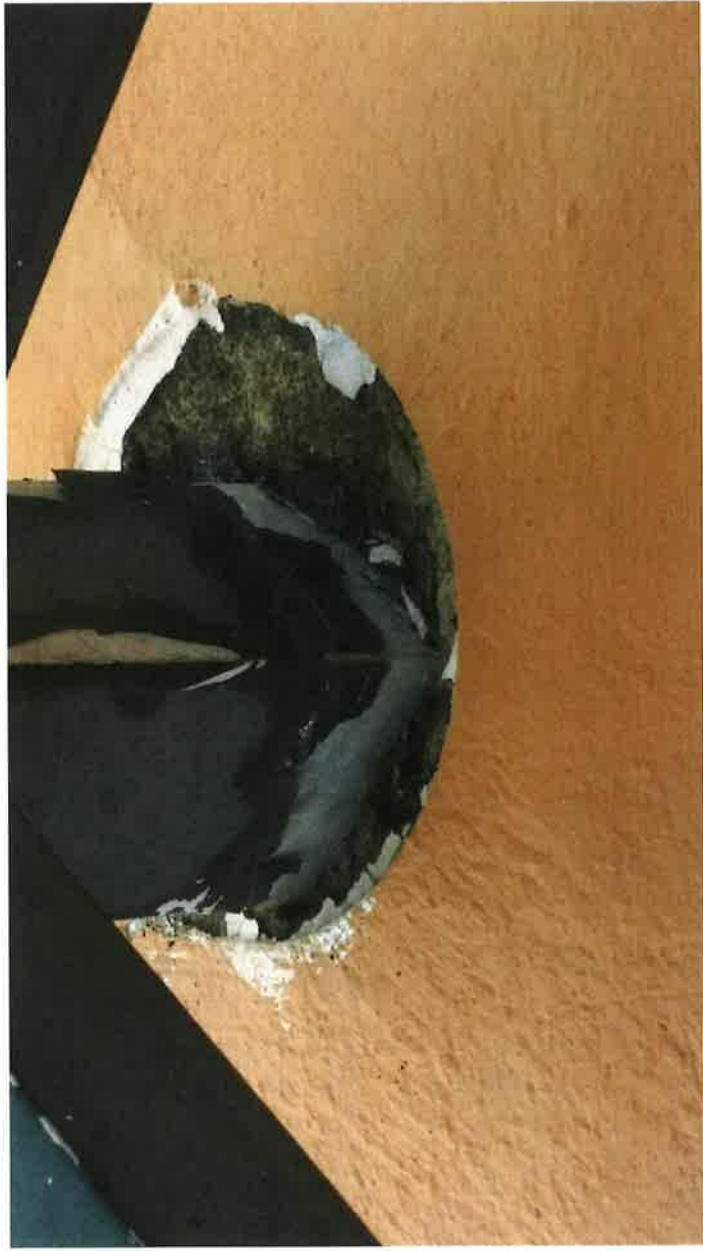
Most of the  
handrail post  
needs to be  
filled in and  
sealed.

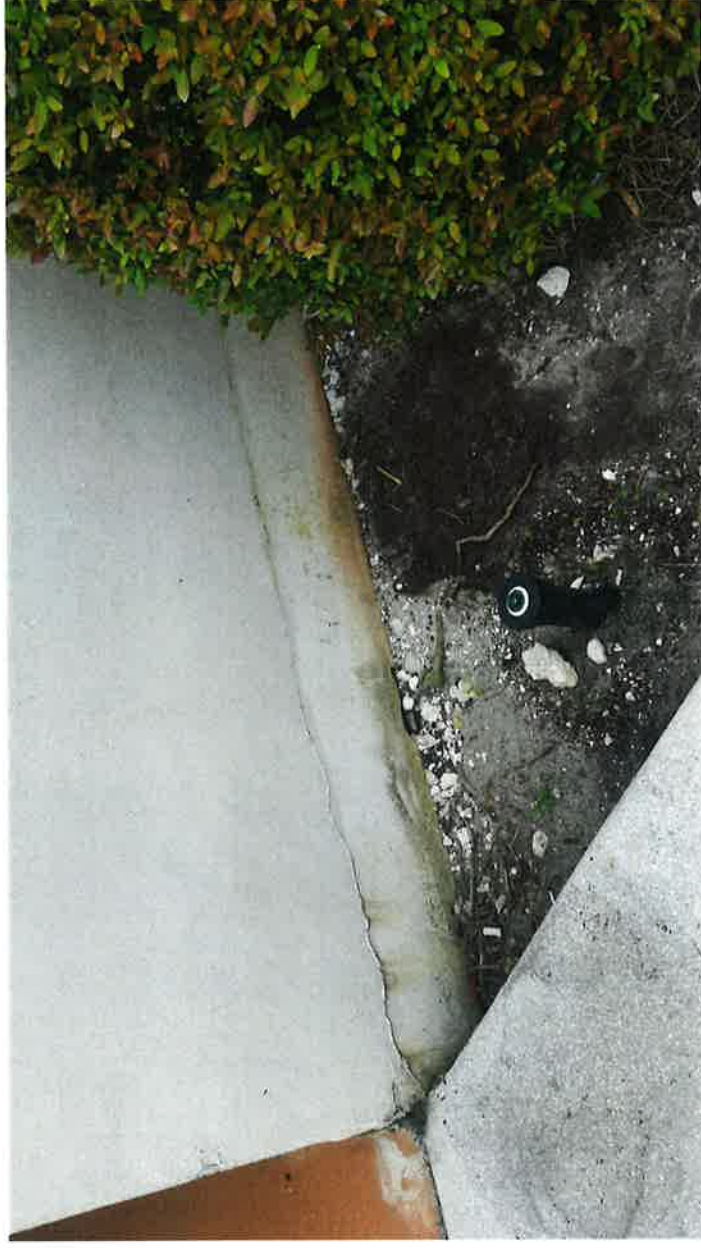
Plus the building has a foundation issue  
with a pilling.

Another on going problem is that the marina personnel has been putting gravel and soil into this area, because of a sink hole that keeps appearing every couple months.

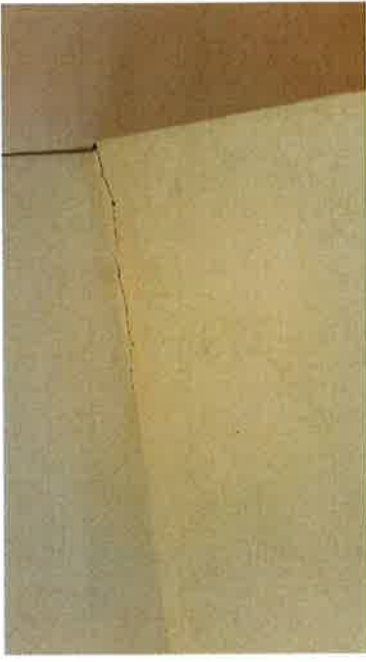
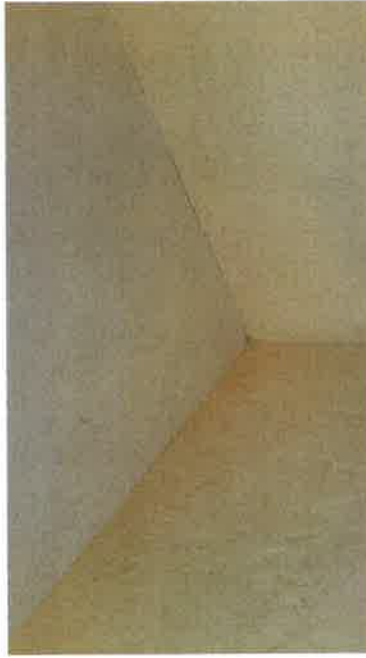
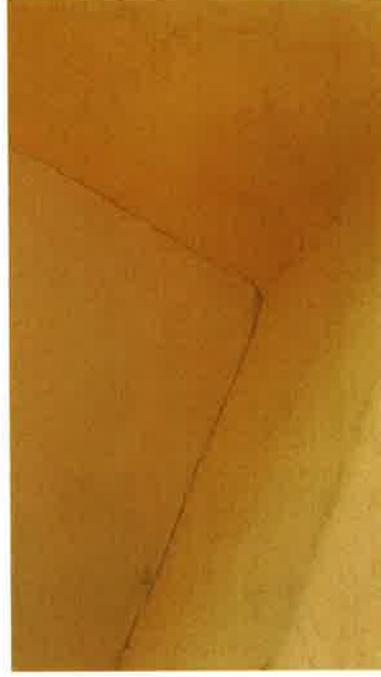
Because of the sink hole issue, there is an approximately 15 to 20 foot diameter area in the building, on both floors, that are showing signs of an improperly install piling in the building foundation. It is likely that the piling is floating. So that joints in the walls and ceiling areas are showing signs of separating.

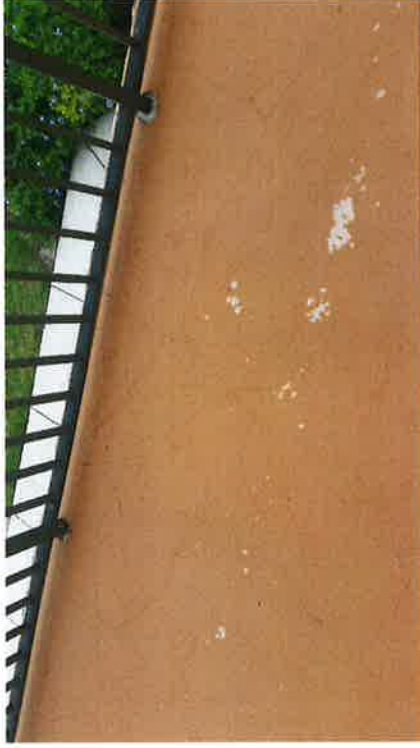
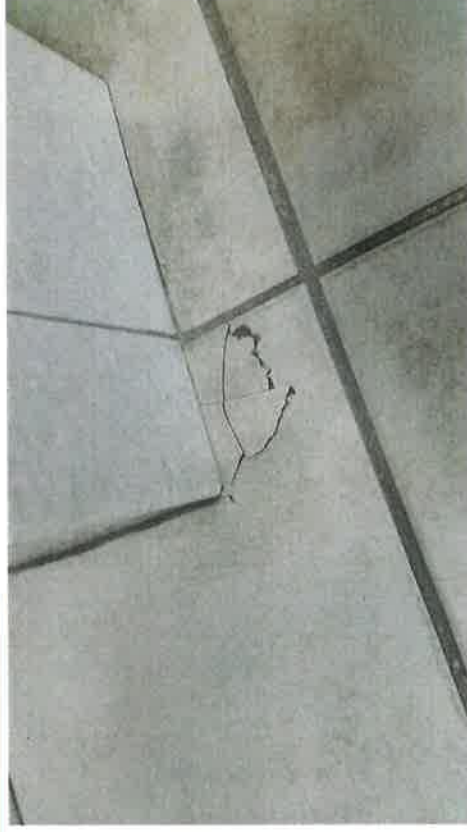
There are cracks on the second floor balcony running in different directions in that same area. There is a pop in the tile next to a column in the men's bathroom. It is like that part of the building is floating up and down, because the piling that is not installed correctly.

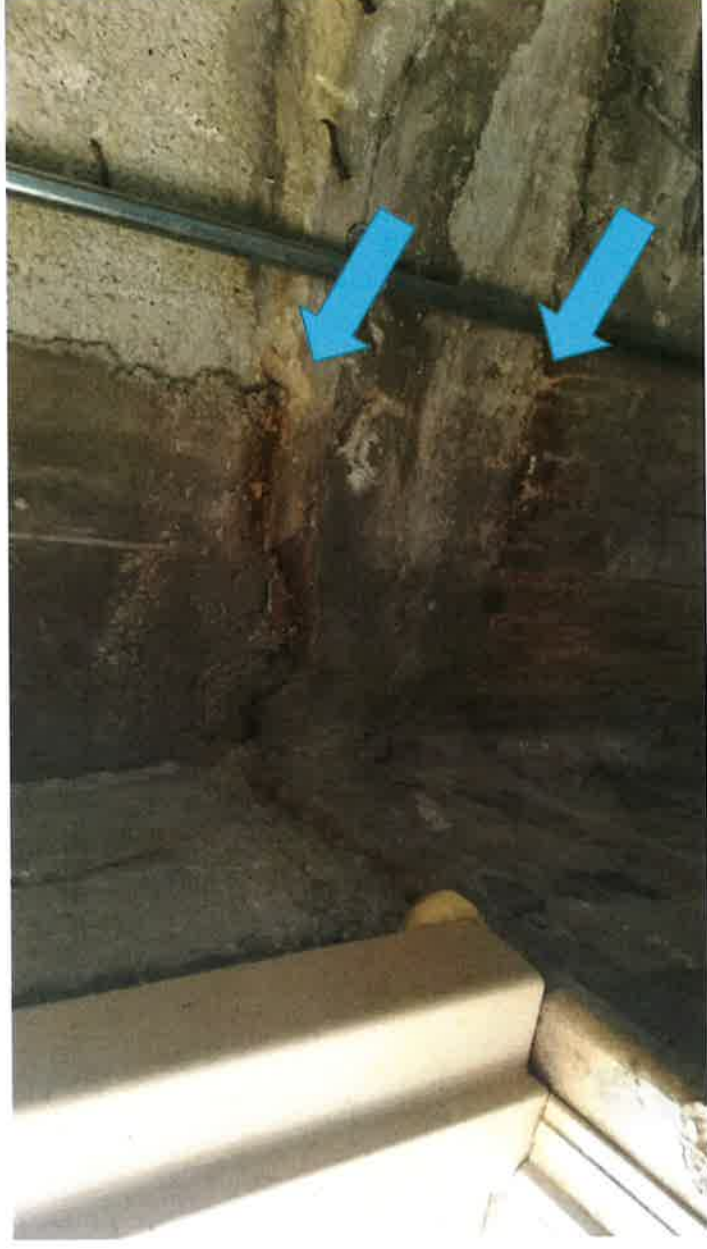
The elevator has major safety issues along with the water getting into the elevator shaft.

This picture shows water intrusion into the elevator shaft from the top and bottom side of the second floor concrete.

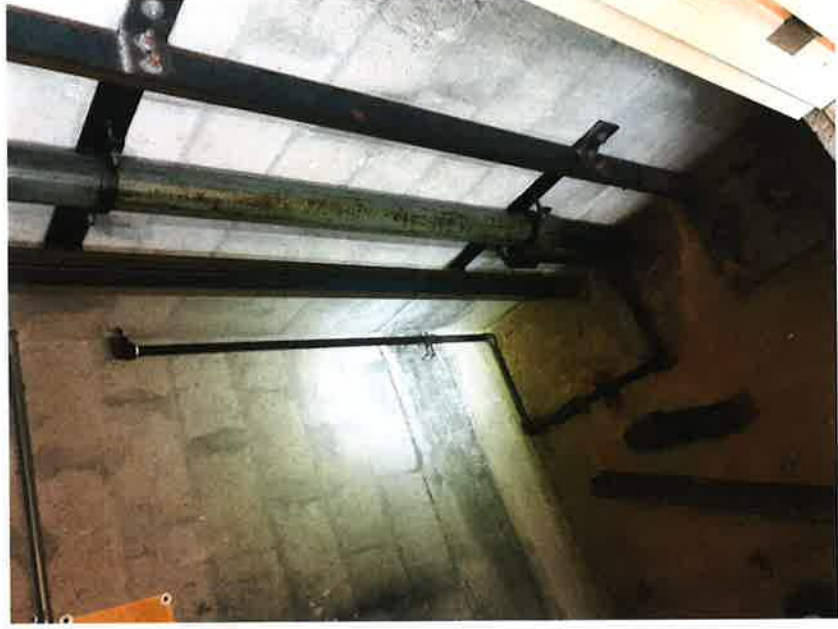
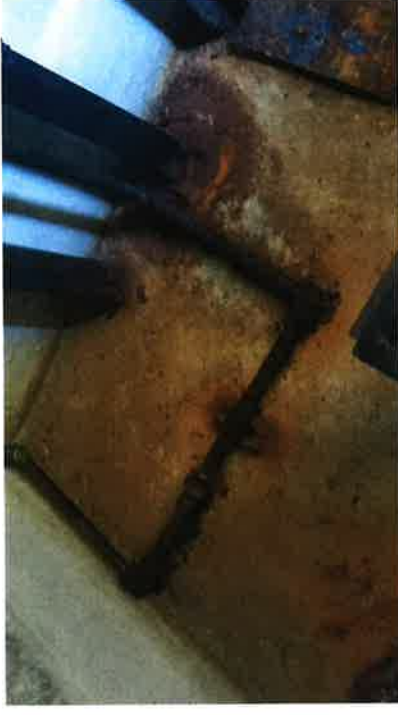
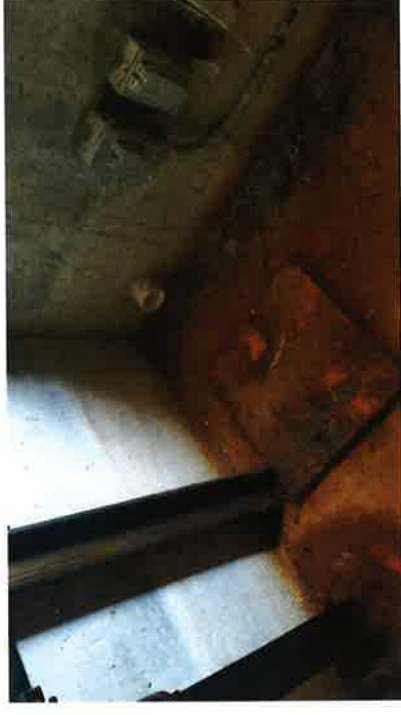
Between the water coming in from the second floor concrete, it is also coming from under the doors themselves. This water has cause the elevator to have safety issues with the rusting of the high pressure pipes for the elevator. Which could cause a lift failure and the possibility of a free fall dropping of the passenger compartment .

3. Water entering the elevator shaft caused the rusted pipes in the bottom of the shaft. The water is getting in though the doors.
4. Open electric outlets allow wind driven rain water to enter causing water intrusion at unknown conduit area in the building interior. This also causes conduit corrosion and possible grounding issues.

10. Water tight electric outlet covers should be installed where needed.
11. The elevator doors should be checked for wind driven water intrusion. New seals may be required.

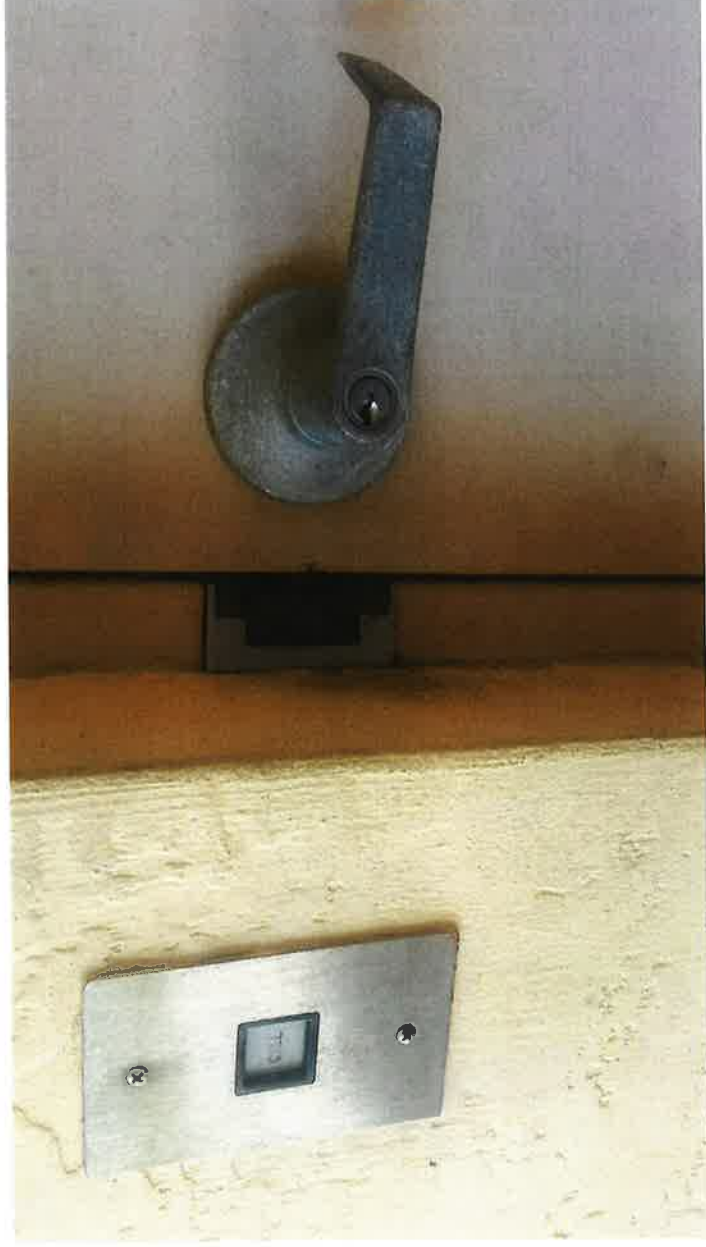
Another major problem with the elevator is that the doors doesn't meet the true ADA access requirements that is needed at the marina. Second major problem is that the door locking mechanism for the safe operation of the elevator is not reliable in the wet salty environment at the marina. Which means the elevator is out of commission most of the time. And the marina is spending a lot of money repairing it just so we can have special events on the second floor.
