**Minutes
Town of Lake Park, Florida
Virtual Regular Commission
Meeting Minutes
Wednesday, September 2, 2020, 7:00 PM
Via Zoom**

5. Notification of Priority Stormwater Pipe Issue: Analysis of the 72 inch “Southern Outfall” Condition and Criticality, and Old Lake Shore Bridge.

TECHNICAL MEMORANDUM
TOWN OF LAKE PARK
SOUTHERN 72-INCH OUTFALL PRIORITY REHABILITATION PROJECT

Subject: Analysis of the 72-inch Outfall Condition and Criticality
Date: August 6, 2020
To: Richard Scherle, Public Works Director
From: Raul Mercado, PE, CFM (WRMA)
Copy to: John Wylie, Stormwater Department

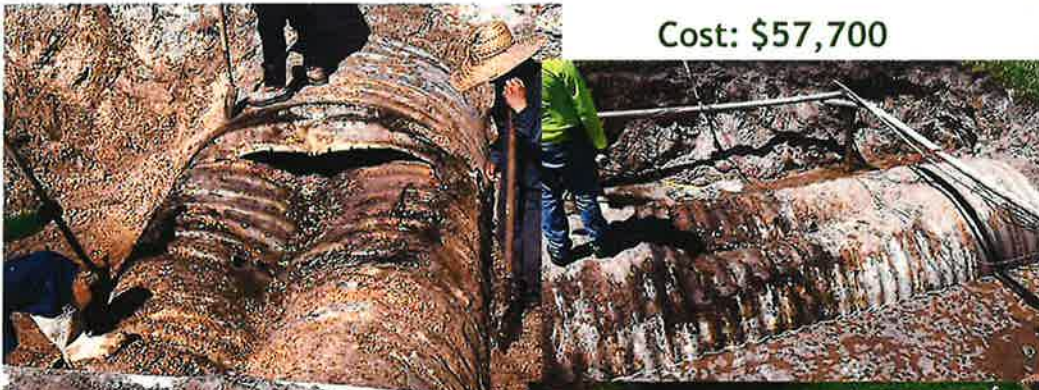
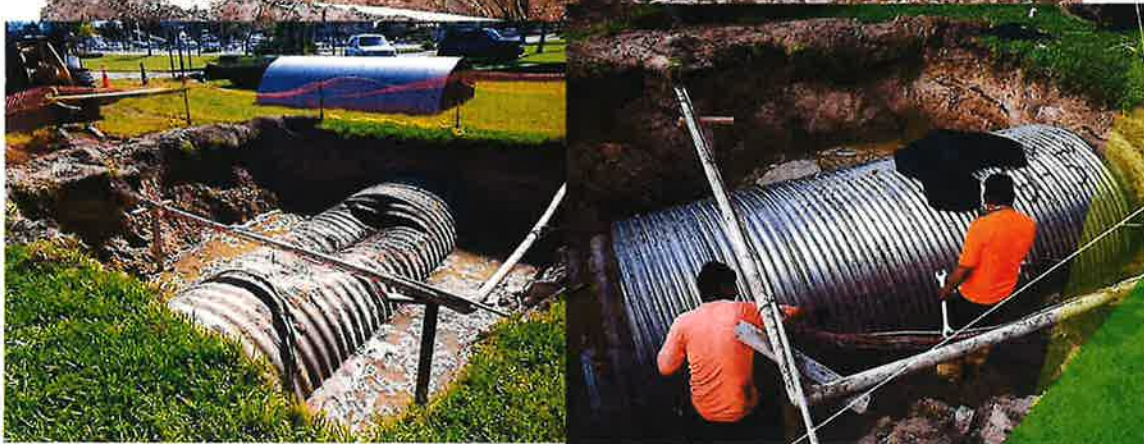
**72" CAP SOUTHERN OUTFALL
30-FEET SEGMENT POINT REPAIR @ MARINA
(March - April 2020)**

Results of the visual and camera condition assessment inspection indicated that the soil substance was found to occur proximately 50 feet from the seawall due to a 17-inch soffit pipe joint separation that

allowed the pipe to exfiltrate and create the wetness. This stormwater asset defect was considered to be a localized structural defect with medium risk that required a point repair. Figure 2 is a WRMA plan sheet showing the location and extent of the of the 72" CAP point repair.

The point repair was performed by replacement of the top quarter pipe with an in-kind corrugated metal pipe. The replacement section was bolted and welded to the existing pipe, overlaid with filter fabric, and backfilled to grade.

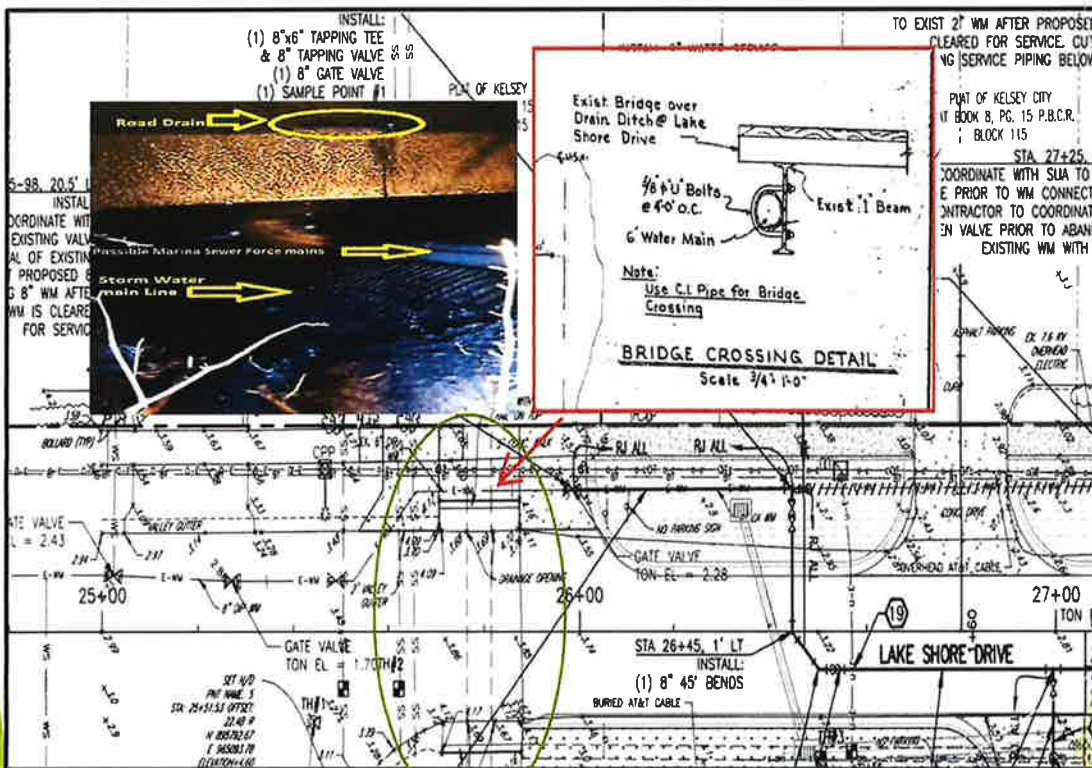
KNOWN RISKS - LAKE SHORE DRIVE BRIDGE REMNANTS

6" WATERMAIN "U" BOLTED TO I-BEAM

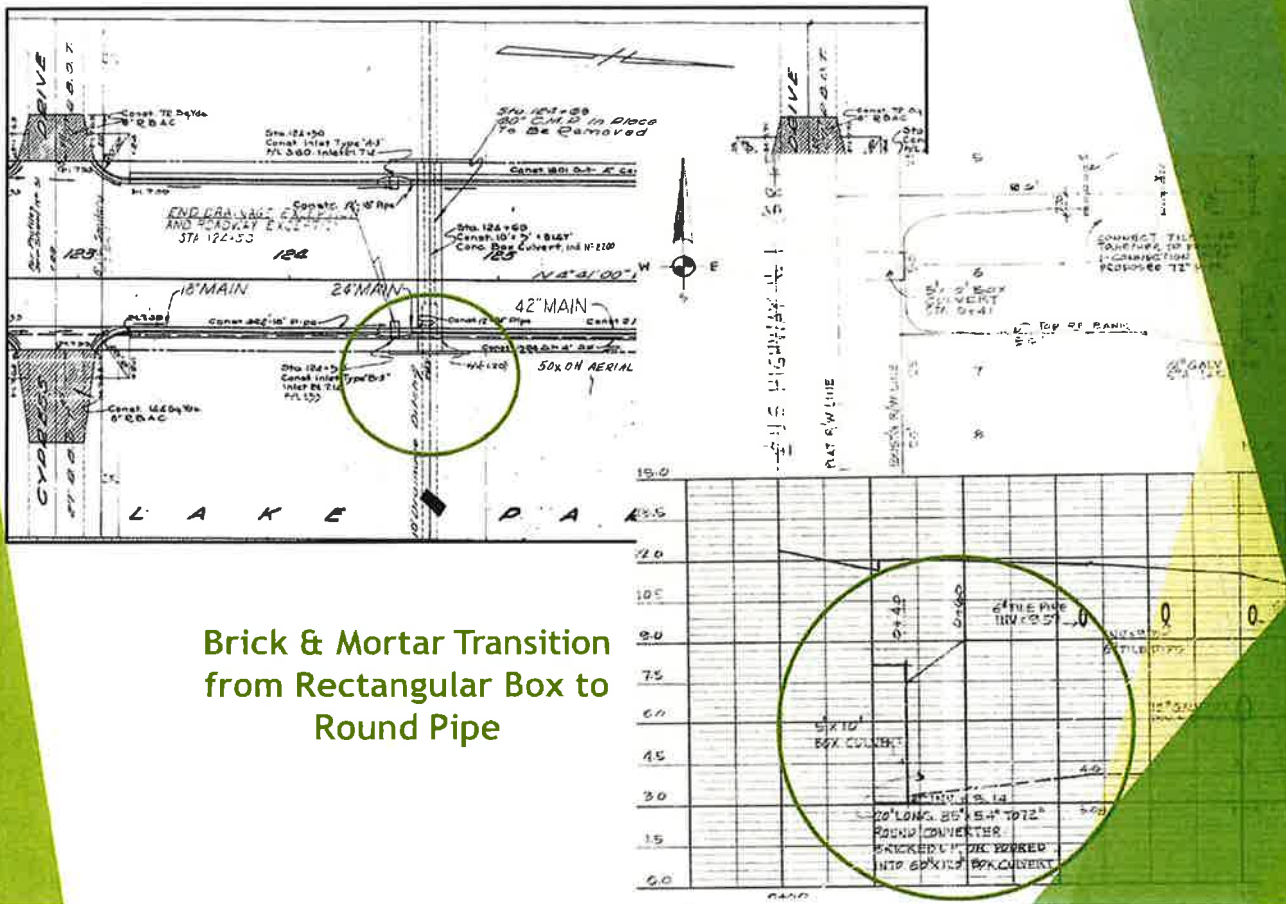
KNOWN RISKS - 72" CAP SOUTHERN OUTFALL CONNECTION TO FDOT BOX CULVERT

Brick & Mortar Transition
from Rectangular Box to
Round Pipe

- As previously indicated, the 10' x 7' Box Culvert under US Highway #1 is approximately 50 years and it has a hand-implemented brick and mortar connection to the 72" CAP conduit. The condition of this asset is unknown and WRMA is proposing to ascertain its condition by a CCTV/walkthrough as part of this project. A failure of this stormwater asset would present major challenges for bypass of upstream flows.

- **Subcontractor Cost: \$165,000**
 - (Includes Survey, Geotechnical engineering, Subsurface Utility Locations, CCTV inspection, landscape architecture design, mechanical/electrical engineering). The CCTV inspection of the US Highway #1 Box Culvert condition is included.

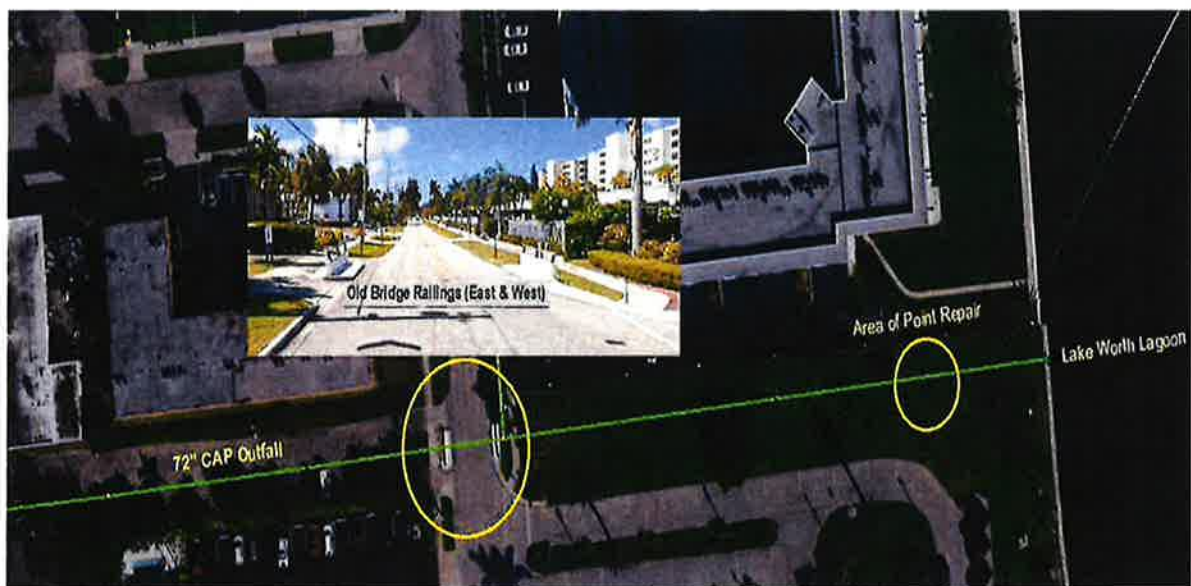
Figure 3. Old Bridge Railings at Buried Lake Shore Dr Bridge

A more significant stormwater asset defect was located at the pipe crossing of Lake Shore Drive. The pipe was initially classified as having a 21-inch longitudinal deflection just before the Lake Shore Drive crossing. Further, As-Built investigations indicated that the longitudinal deflection was instead an arch transition prior to entering the remnants of a bridge at Lake Shore Drive (i.e. from round to arch). **Figure 3** shows the location of the buried bridge at Lake Shore Drive.

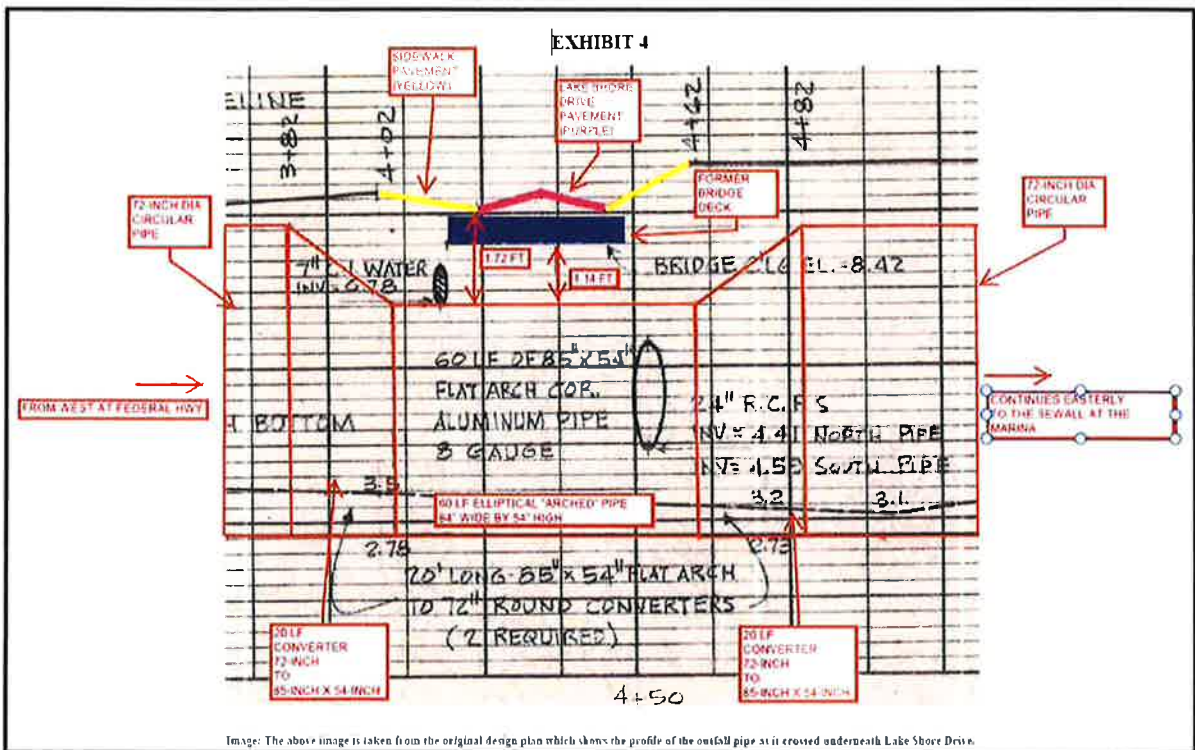
Figure 4. Round to Arch and Arch to Round Transitions at Lake Shore Drive Bridge Crossing

Originally, the bridge was placed at the Lake Shore Drive crossing of a ditch discharging to the Lake Worth Lagoon in the 1940's. At some point in the early 1970's the ditch was filled and the 72- inch round outfall pipe was fitted through the bridge abutments and low chord which necessitated a transition from round to arch. A similar arch transition was found exiting the old bridge to a round 72- inch CAP. **Figure 4** shows the transitions found on plans (Circa 1970's).

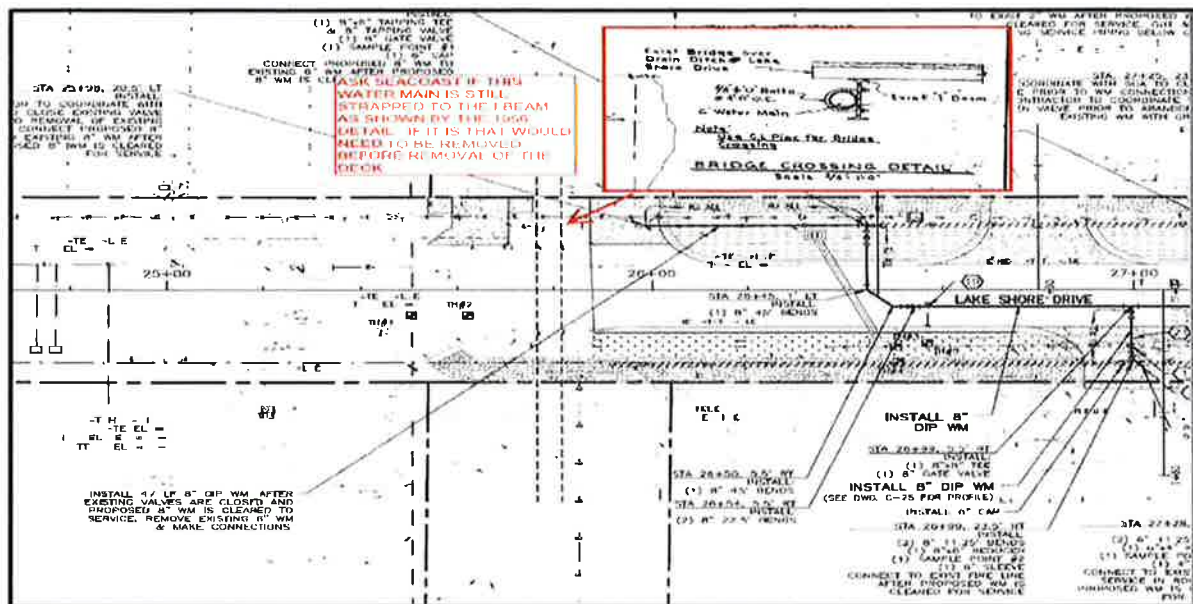
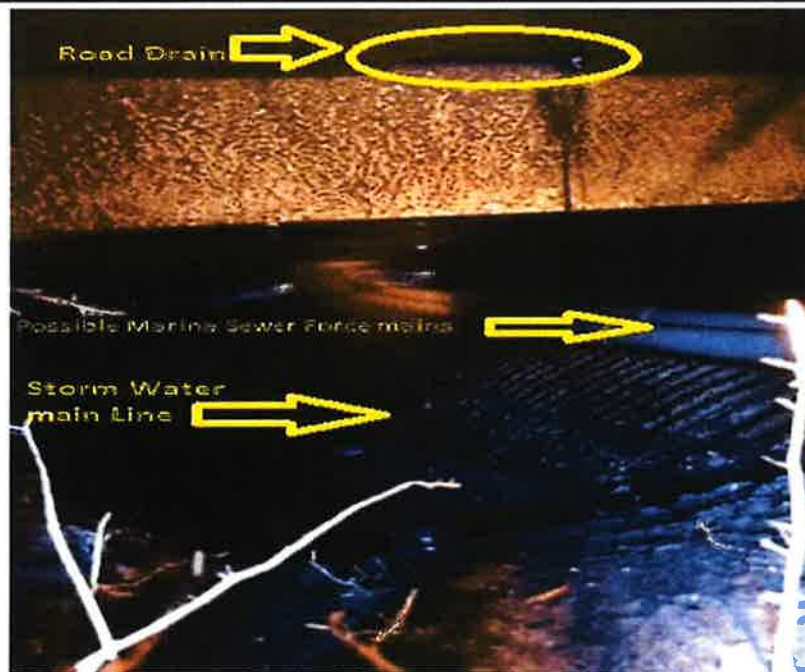
Figure 5. Undersize of old Lake Shore Drive Bridge

WRMA requested that the Town O&M perform a dig at the southeastern corner of the bridge abutment to observe the condition of the abutments and the deck. Results from the dig indicated that there was an empty space between the CAP crown and the low chord of the bridge. A 6" water utility main was observed fastened to the bridge low chord I-beam. There is a minimal 1.0 feet cover between the top of Lake Shore Drive and the bridge deck. **Figure 5** shows the water line in the empty space between the bridge low cord and the crown of the 72" CAP.

The high-risk determination does not mean that the asset is in immediate danger of failure. The buried Lake Shore Drive Bridge and the 72" CAP Outfall could last months. However, the analysis has identified that the original bridge I-beam precast deck placed just above or on top of the outfall pipe crown is at or beyond the useful (75 years) life of the steel and reinforced concrete material and presents a high risk of failure. Likewise, the 72" Corrugated Aluminum Pipe (CAP) is near its useful life and is experiencing rapid deterioration that could be accelerated by the construction of a multistory high rise immediately to the south. Then, there is the 50-year old 10'x7' Box Culvert under US Highway 1 that has not received any maintenance by FDOT since being connected to the outfall underground.

Based on the Asset Management based BRE analysis, WRMA recommends that the Town Management take immediate action to mitigate the known risk from this critical stormwater asset with a quantifiable likelihood of failure and financial threat to the Town.

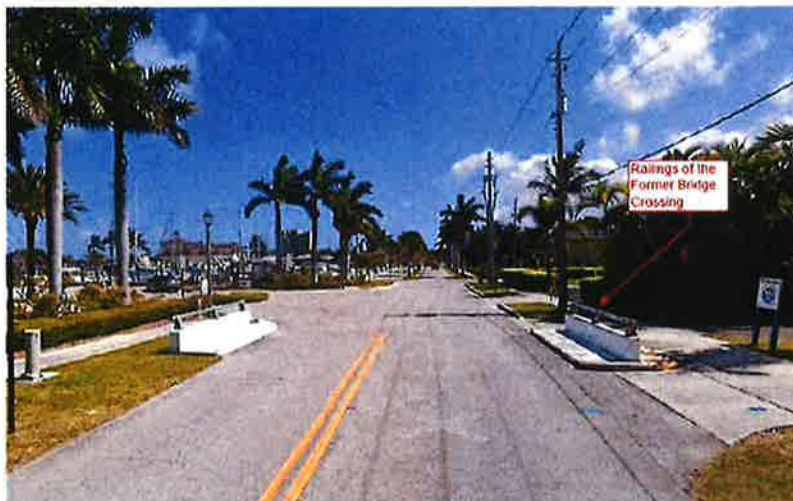
Existing Former Bridge on Lake Shore Drive

In addition to the replacement of the outfall pipe, there is an existing former bridge (circa 1930's) located on Lake Shore Drive, which is currently located on top of the outfall. The old bridge deck and guard railings will need to be removed during the construction of the replacement outfall.

The purpose of the Southern Outfall project, is to engineer a design plan, to open-cut (excavate) and replace the existing aged outfall pipe, and provide water quality treatment for the removal of pollutants and heavy metals prior to discharge into the Lake Worth Lagoon, which is a pristine water body. This will be accomplished through an open cut excavation along the existing pipe alignment, removal and replacement with new pipe materials, and in the installation of a bio-retention basin, prior to discharge into the Lake Worth Lagoon.
