# *Above the Flood:* **ELEVATING YOUR FLOODPRONE HOUSE**

**FEDERAL EMERGENCY MANAGEMENT AGENCY**

**MITIGATION DIRECTORATE**

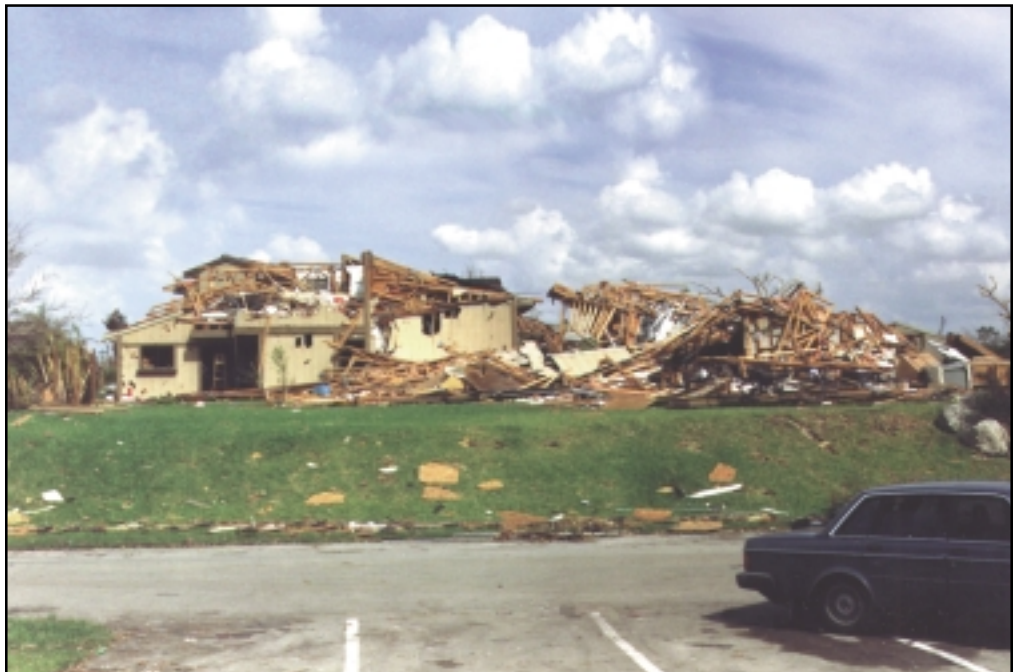
**Figure 4**

In low-lying areas, wind and rain damage to interior finishes and furnishings was exacerbated by flood waters.

The widespread destruction caused by Andrew was due primarily to high winds (Figure 3). However, flood waters contributed to the damage in low-lying coastal areas of central and southern Miami-Dade County (Figure 4).

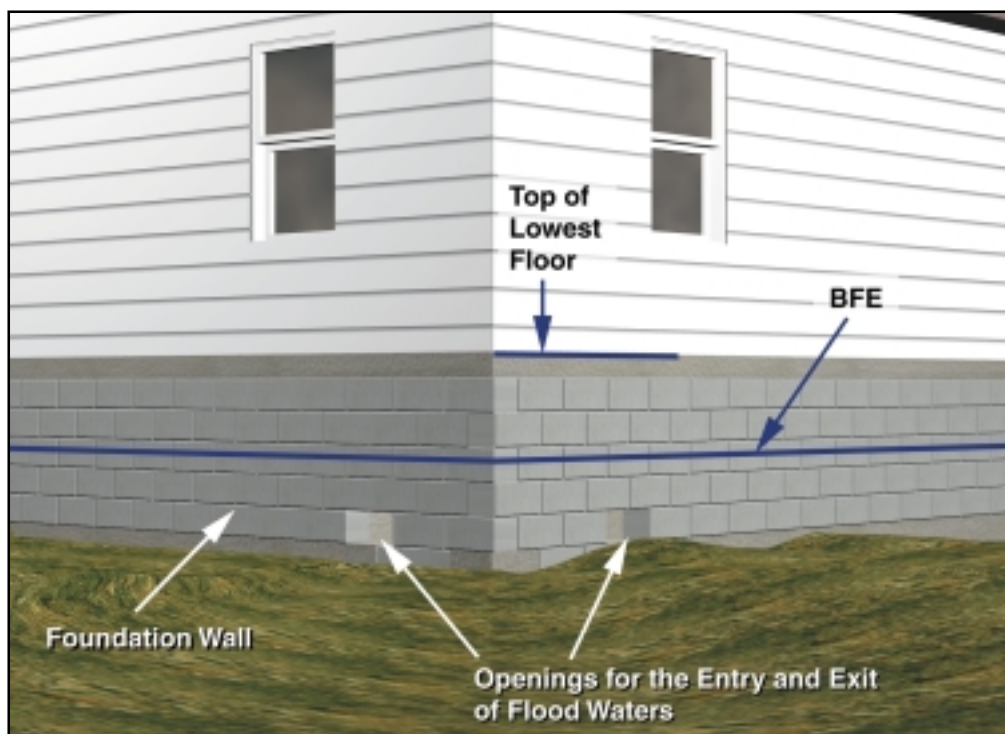
**Figure 6**

In a new, substantially improved, or substantially damaged building in an A zone, the elevation of the lowest floor must be at or above the BFE.

In A zones, where flood hazards are less severe, buildings may be elevated either on an open foundation or on continuous foundation walls below the BFE (Figure 6). Regardless of the type of foundation used, A-zone buildings must be elevated so that the **lowest floor** is at or above the BFE, as shown in Figure 6. If continuous walls are used below the BFE, they must be equipped with openings that allow flood waters to flow into and out of the area enclosed by the walls (Figure 6). Allowing the entry and exit of flood waters ensures that water pressures will be the same on both sides of the walls and reduces the likelihood that water pressure will cause the walls to fail.

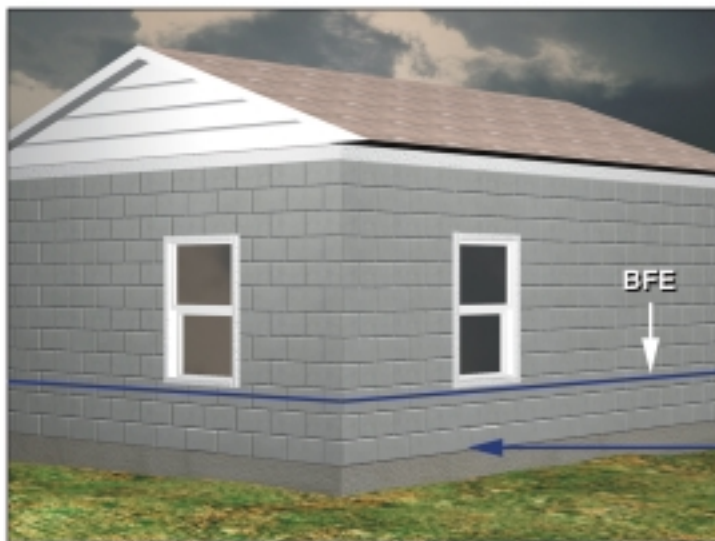
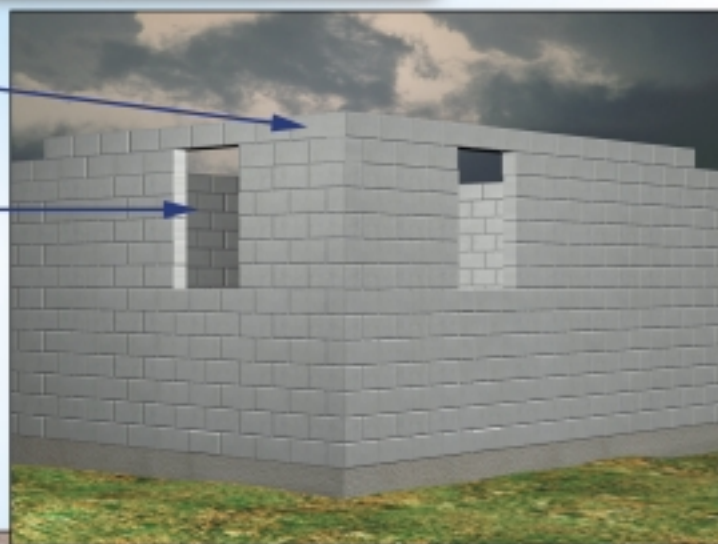
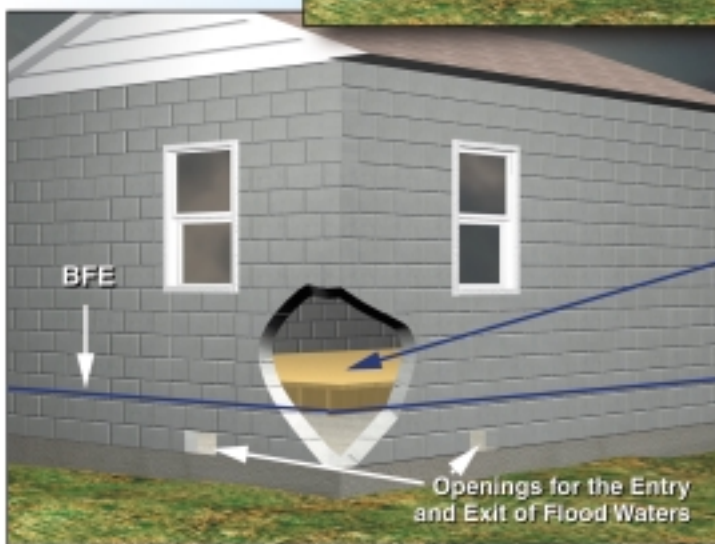
**Figure 7**  
Technique 1 –  
Extend the walls of the house upward and raise the lowest floor.

House at the time Hurricane Andrew struck

Original Level of the Lowest Floor

Extended Walls

Raised Window Opening

Substantially damaged house undergoing repairs that will bring it into compliance with Miami-Dade County floodplain management requirements

New, Raised Floor

House after completion of repairs

1. Extend the walls of the house upward and raise the lowest floor (Figure 7).
2. Convert the existing lower area of the house to non-habitable space and build a new second story for living space (Figure 8).
3. Lift the entire house, with the floor slab attached, and build a new foundation to elevate the house (Figure 9).

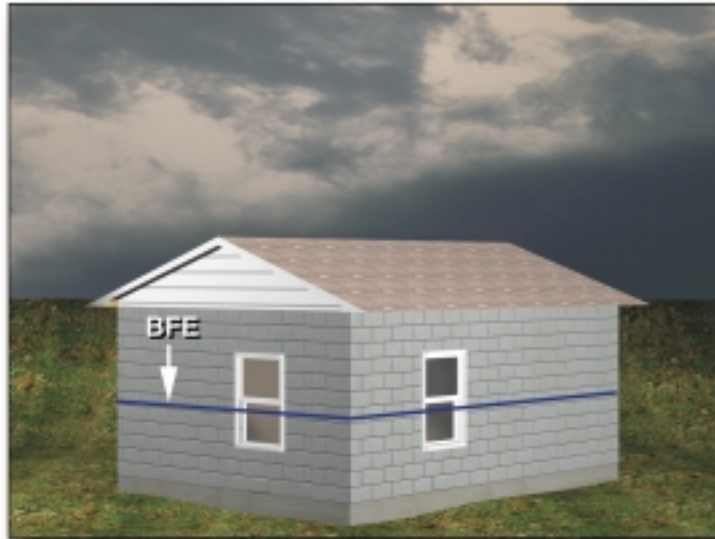
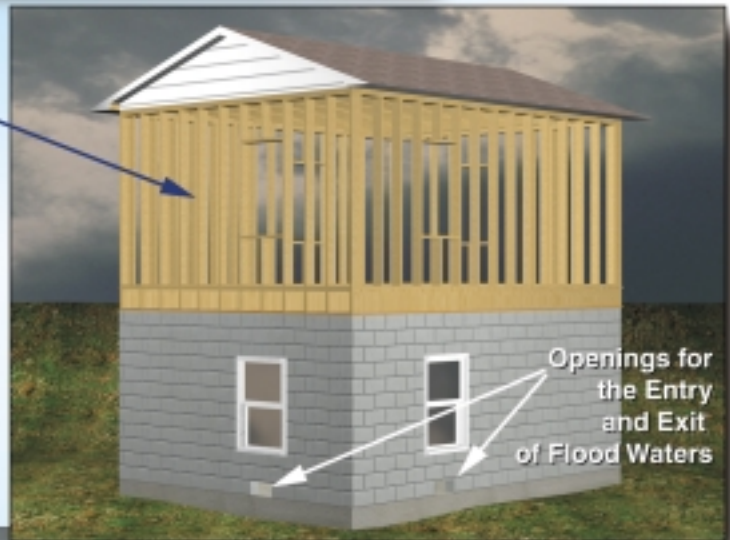
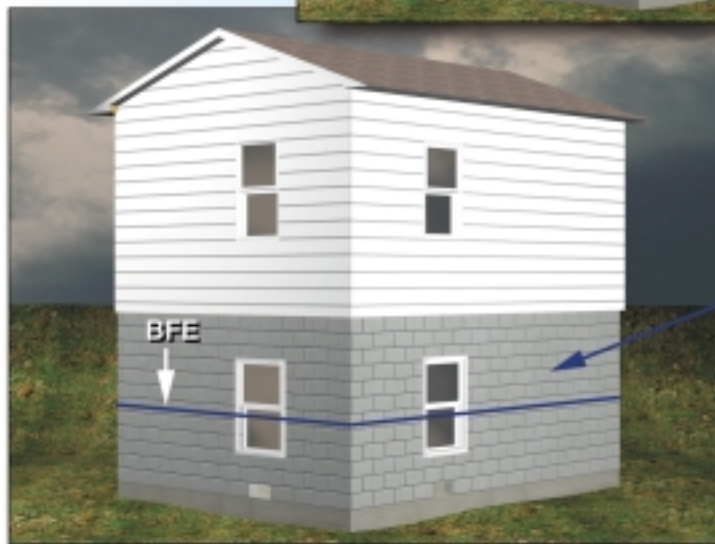
**Figure 8**  
Technique 2 –  
Convert the existing  
lower area of the  
house to non-  
habitable space and  
build a new second  
story for living space.

**House at the  
time Hurricane  
Andrew struck**

**New Second  
Story Above  
BFE**

**Substantially damaged house  
undergoing repairs that will bring it into  
compliance with Miami-Dade County  
floodplain management requirements**

**House after  
completion of  
repairs**

**Lower Area  
Converted to  
Non-Habitable  
Space for  
Storage,  
Parking, or  
Building  
Access**

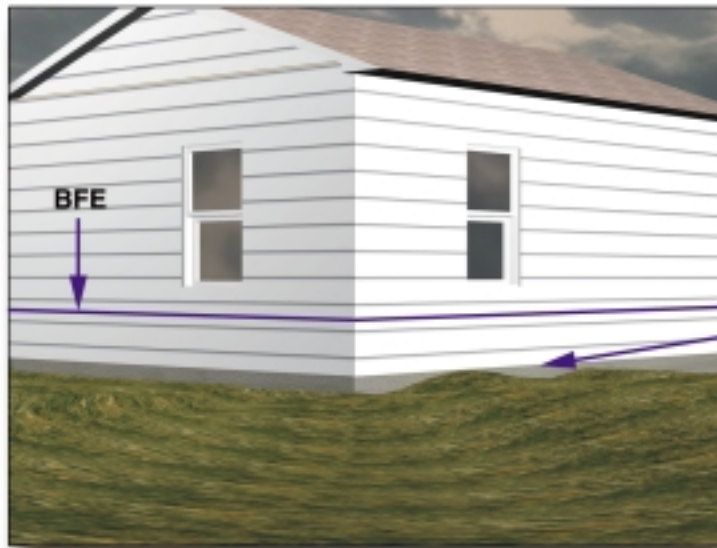
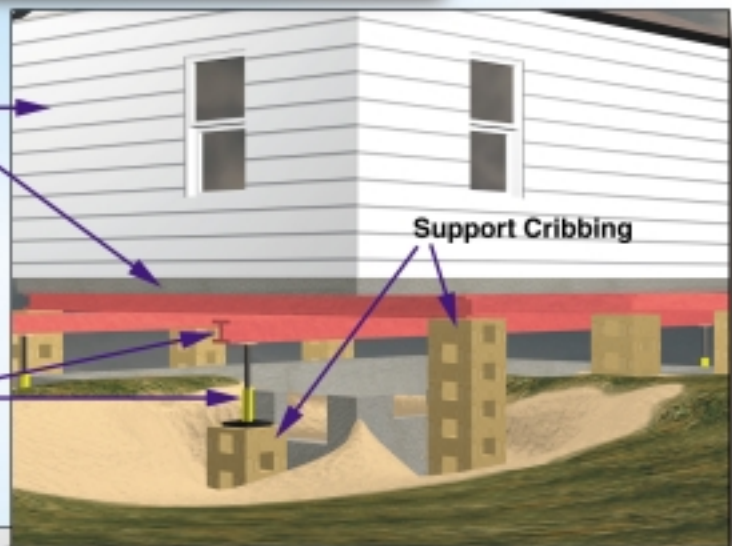
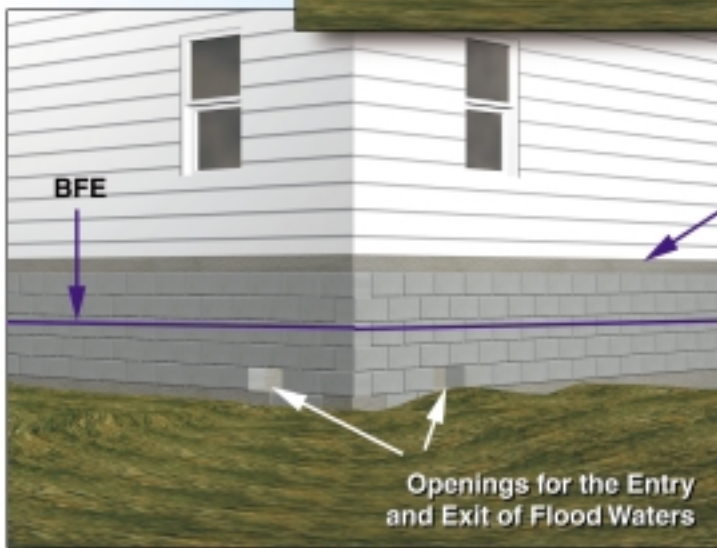
**Figure 9**  
Technique 3 –  
Lift the entire house,  
with the floor slab  
attached, and build a  
new foundation to  
elevate the house.

House at the  
time Hurricane  
Andrew struck

Original Level  
of the Lowest  
Floor

House and  
Floor Slab  
Lifted  
Together

House Lifted  
on Jacks and  
I-Beams

Support Cribbing

New Level  
of the Raised  
Lowest Floor

House after  
completion of  
repairs

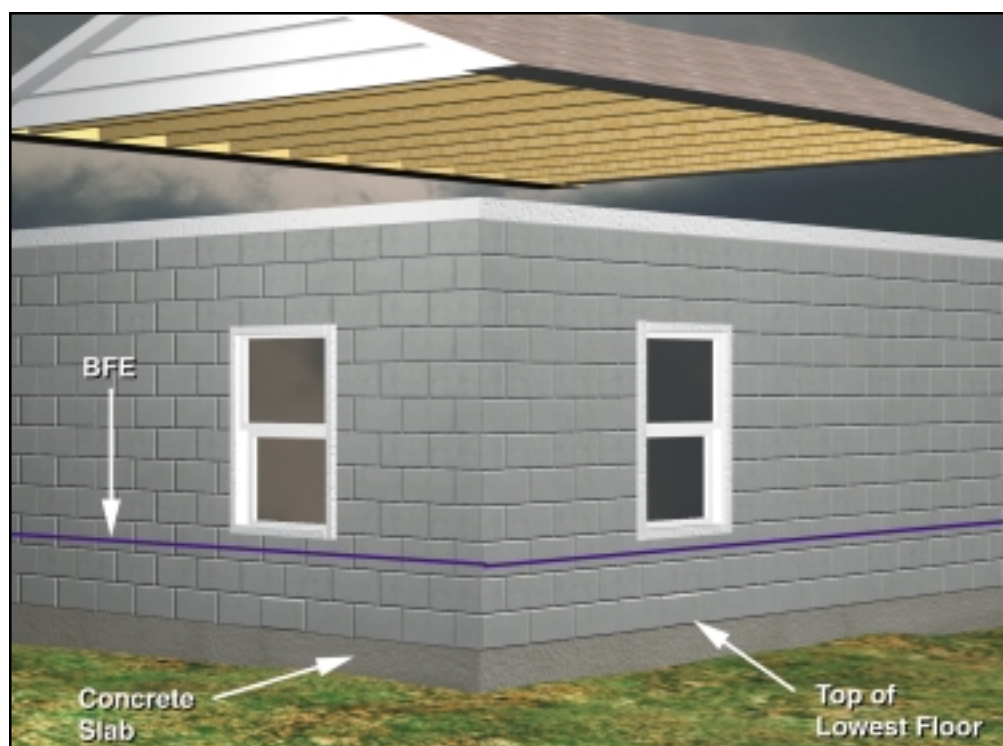
**Figure 10**  
The first step in Technique 1 is removing the roof.

Technique 1 is appropriate for houses with concrete or masonry walls, but not for houses with other types of walls, such as those framed with wood studs, which would be more vulnerable to flood damage. This technique is usually appropriate when the depth of the base flood at the house is no more than 4 or 5 feet above grade. The elevation process begins with the temporary removal of the roof and roof framing, in a single piece if possible (Figure 10). This is commonly done with a crane. The roof is then stored on site so that it can be reinstalled later. The next step is to remove the windows and doors.

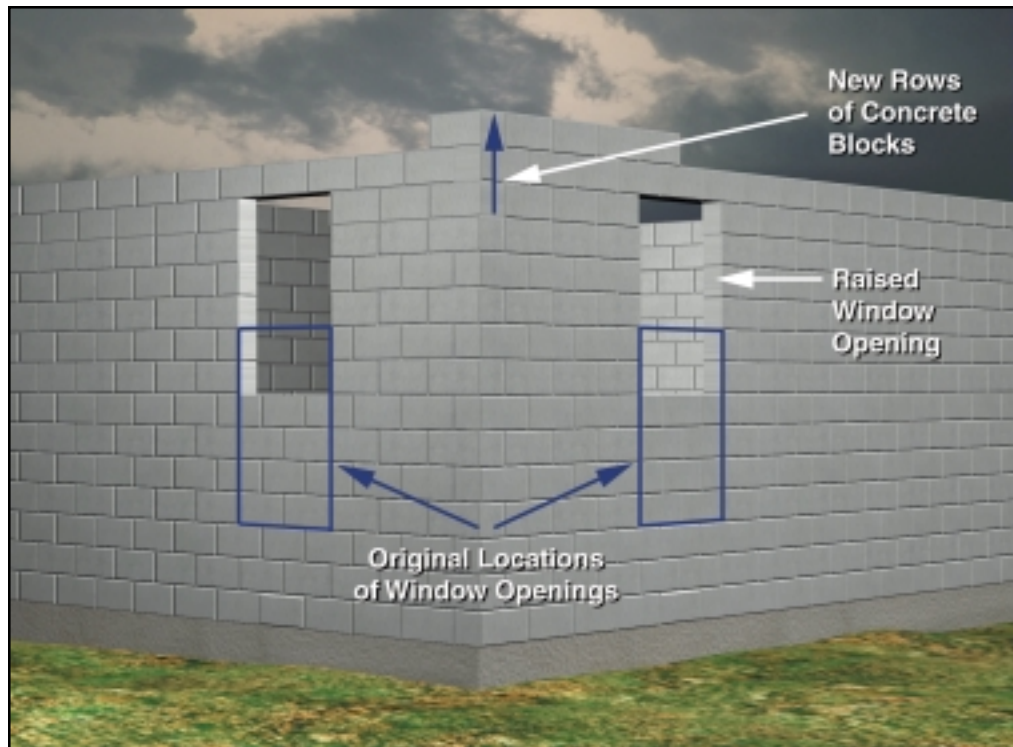
**Figure 11**

The tops of the walls and bottoms of the window openings are raised with concrete blocks.

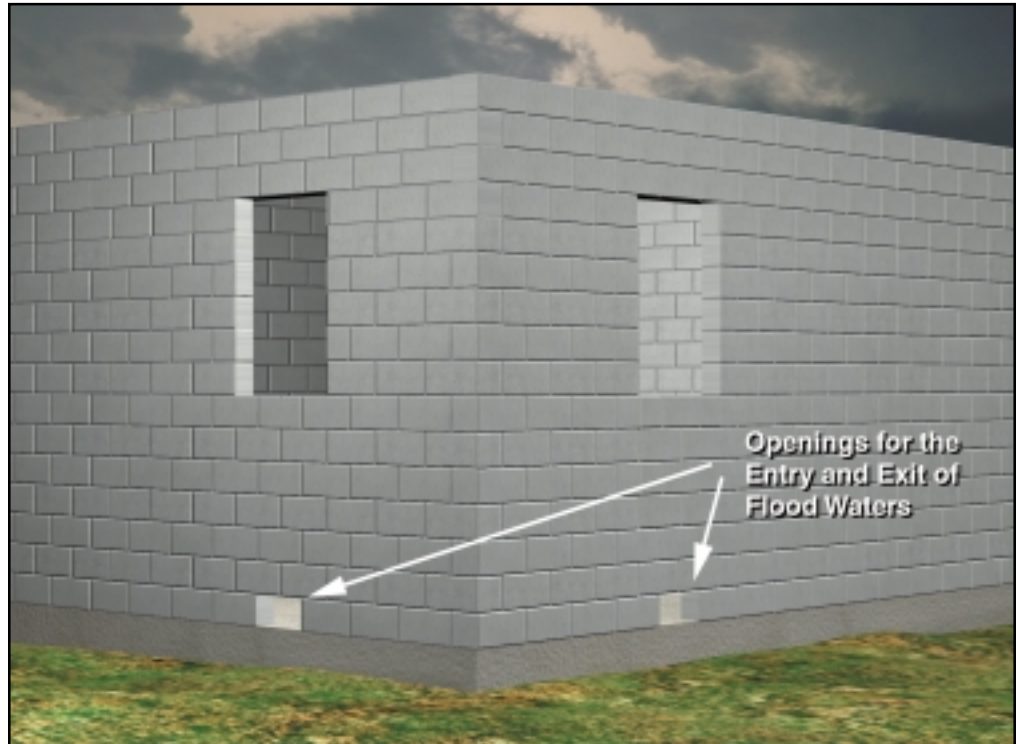
**Figure 12**  
Openings are created in the walls near the ground.

Blocks are removed from the walls of the house at selected locations within 1 foot of the ground (Figure 12). The resulting openings will allow flood waters to flow into and out of the lower area of the house so that the water pressures on both sides of the walls will remain the same. The roof and windows are then replaced, and a new wood-frame floor is constructed above the flood level (Figure 13).

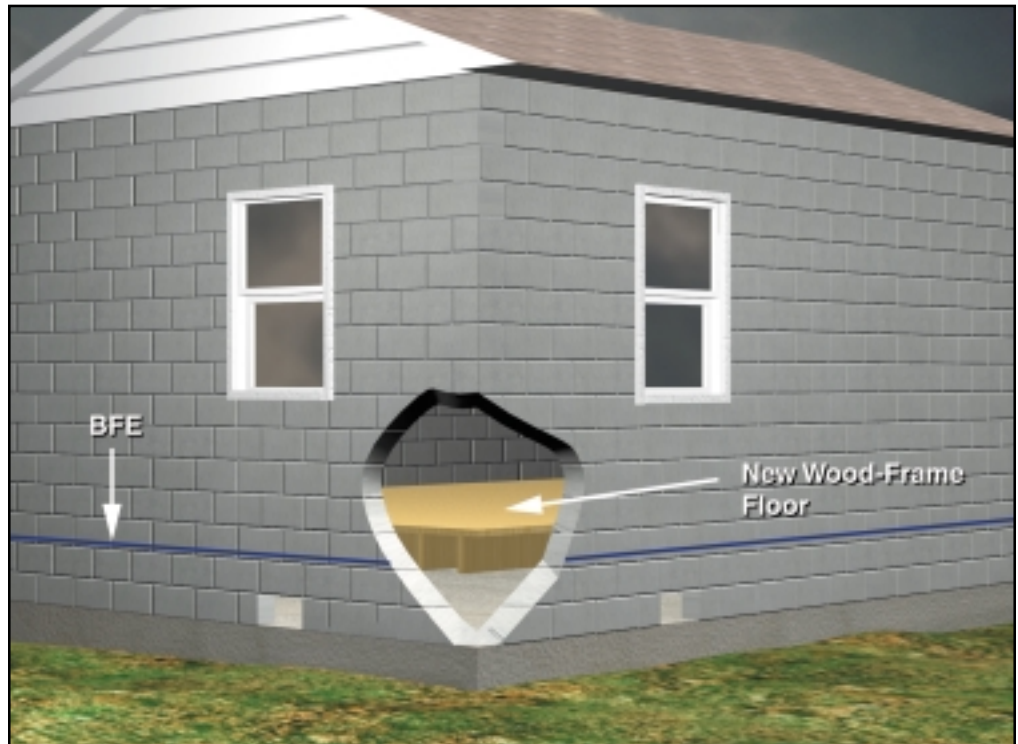
**Figure 13**  
A new wood-frame lowest floor is constructed above the flood level, and the roof, windows, and doors are reinstalled.

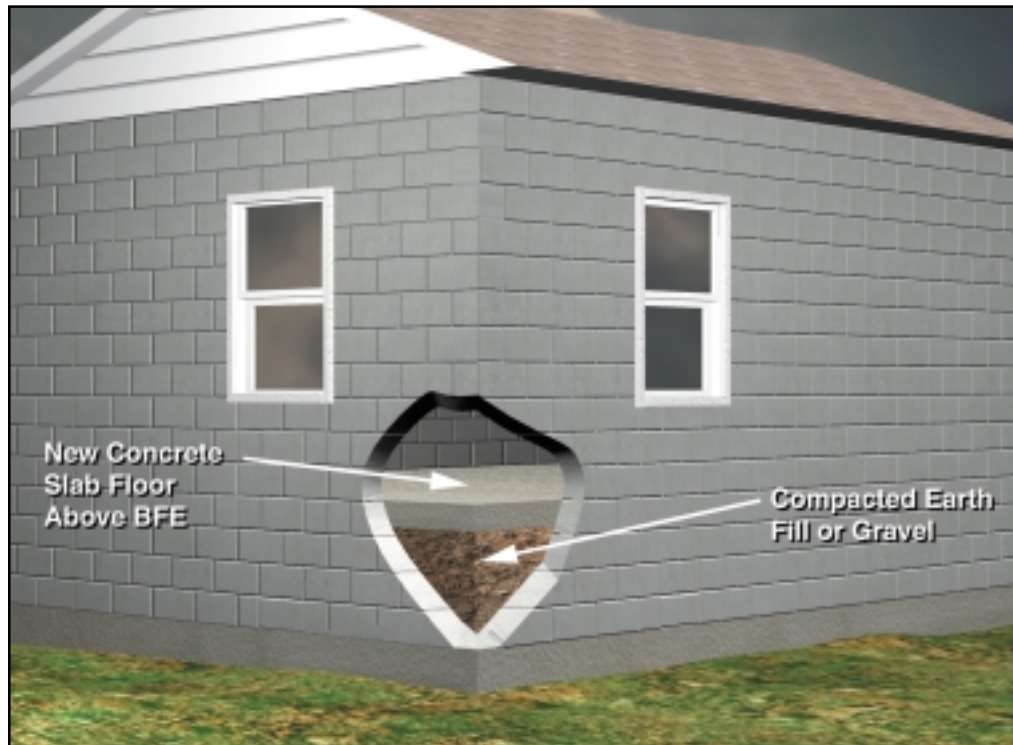
**Figure 14**  
An alternative to building an elevated wood-frame floor is installing a new, elevated concrete slab floor on fill placed over the old slab.

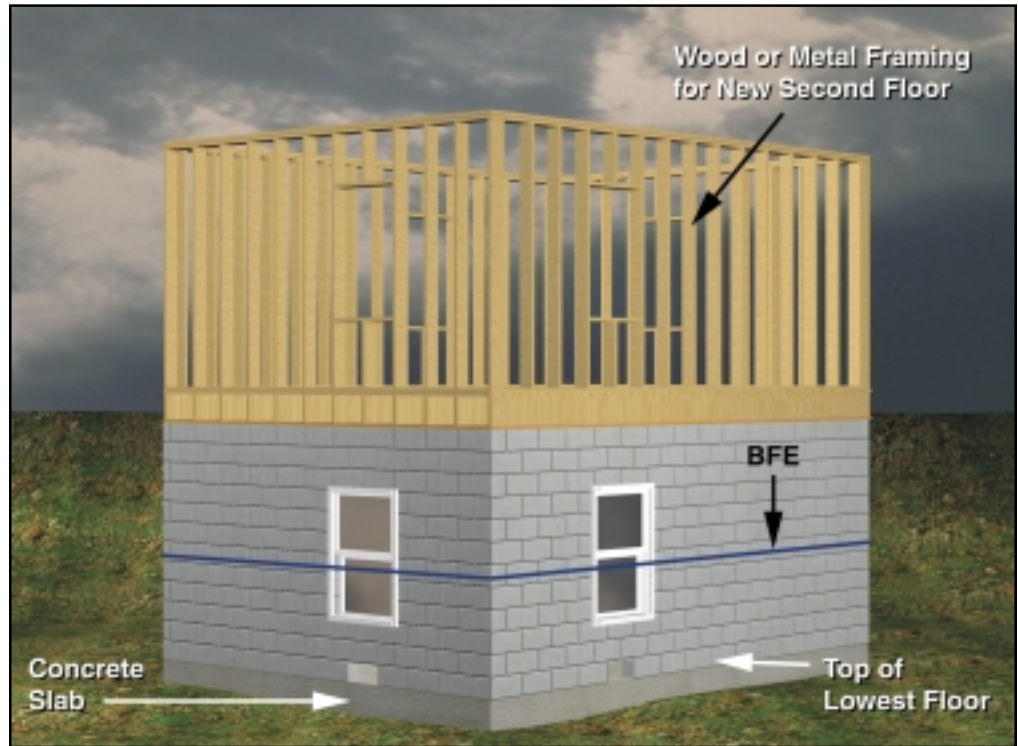
**Figure 15**  
The new second-story floor and walls are built on top of the existing lower story.

As in Technique 1, the repairs begin with the temporary removal of the roof and roof framing (Figure 10). After the roof is removed, construction of the new second story begins. First, a new wood-frame floor is built on top of the existing lower-story walls. The second-story walls are framed with metal or wood studs and set in place on the floor (Figure 15).

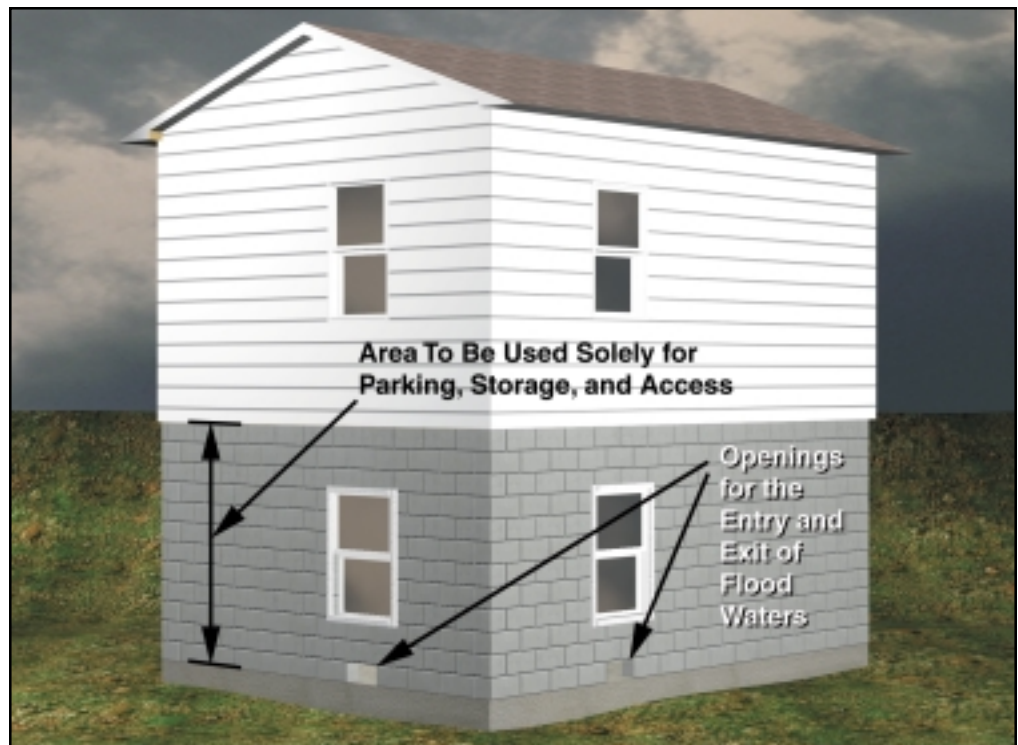
**Figure 16**  
The new second-story walls are covered with siding or stucco.

Some homeowners prefer that the second story be constructed of masonry, but wood- or metal-framing is more common, primarily because it is lighter and less expensive. The roof is replaced, and blocks are removed from the walls to allow flood waters to enter and exit. Exterior sheathing is then added to the framed walls of the second story, the new windows are installed, and siding or stucco is applied to the sheathing (Figure 16).

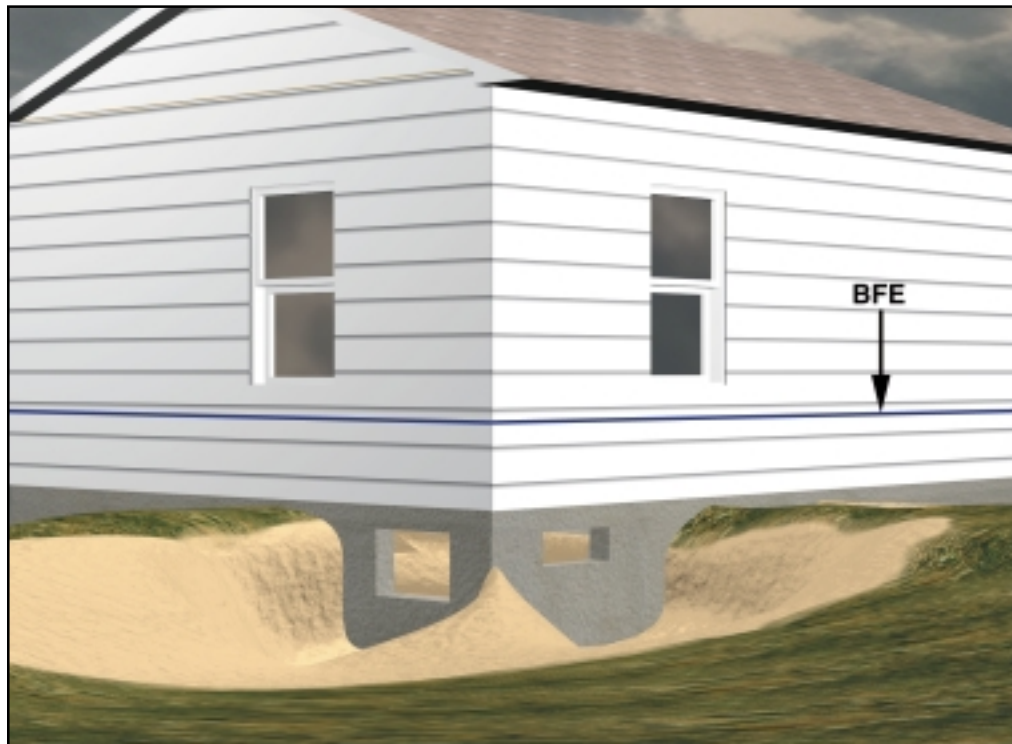
**Figure 17**  
Trenches and tunnels under the slab provide access for the jacks and I-beams that will lift the house.

Technique 3 can be used for houses with wood-frame or masonry walls and is appropriate for a wide range of flood levels. This technique is very different from Techniques 1 and 2. Here, the entire house, including its slab floor, is lifted above the flood level and new masonry foundation walls are built below it. The most common method of lifting the house is to place metal I-beams below the slab and raise the house with jacks.

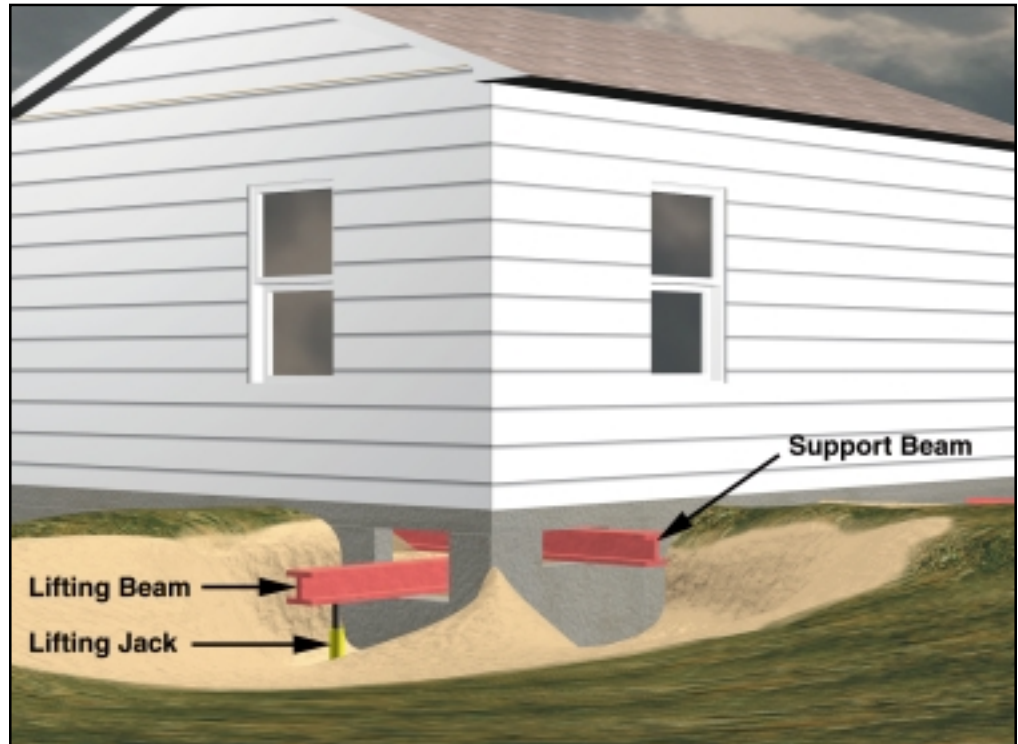
**Figure 18**  
With I-beams and jacks in place, the house is ready to be lifted.

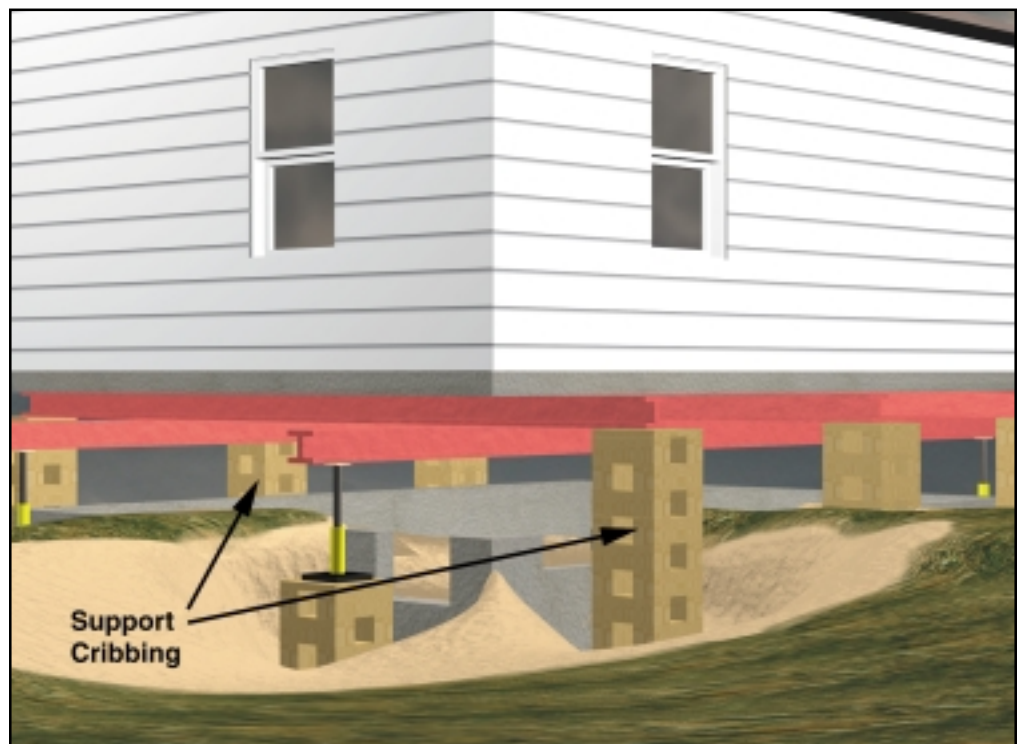
**Figure 19**  
The house is temporarily supported on cribbing.

The house is then jacked up. When the jacks have extended as far as possible, the house must be supported temporarily while the jacks are raised. Both the house and the jacks are usually supported on “cribbing”—temporary piles of crisscrossed timbers (Figure 19). The jacks are then used to raise the house higher.

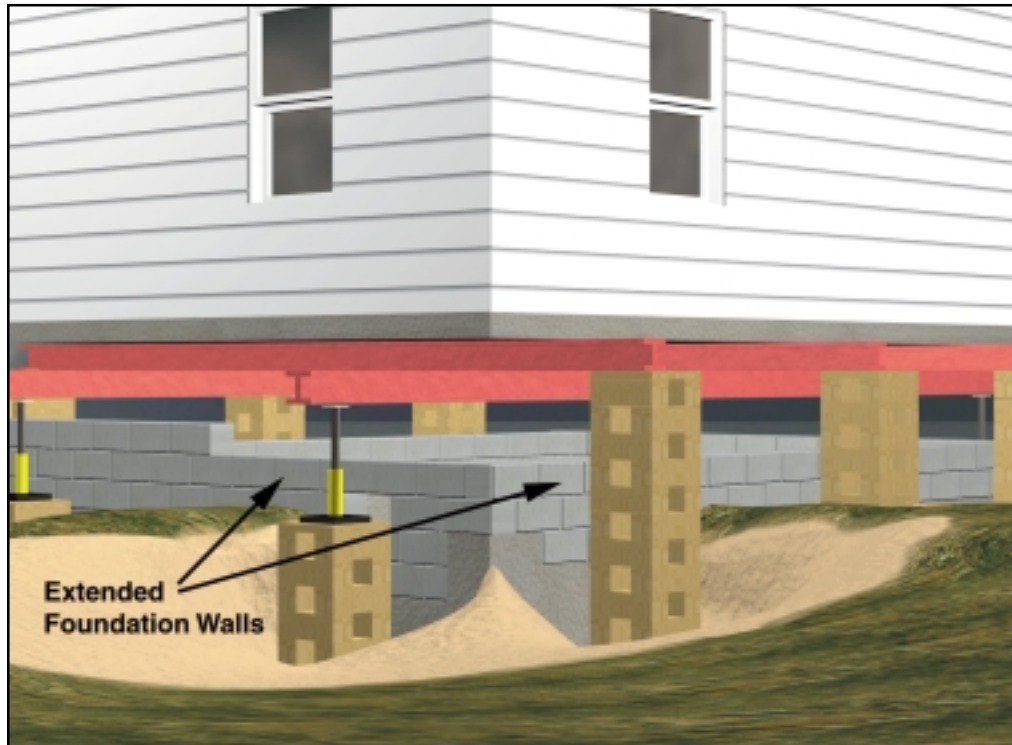
**Figure 20**  
New, extended  
foundation walls are  
constructed with  
concrete blocks.

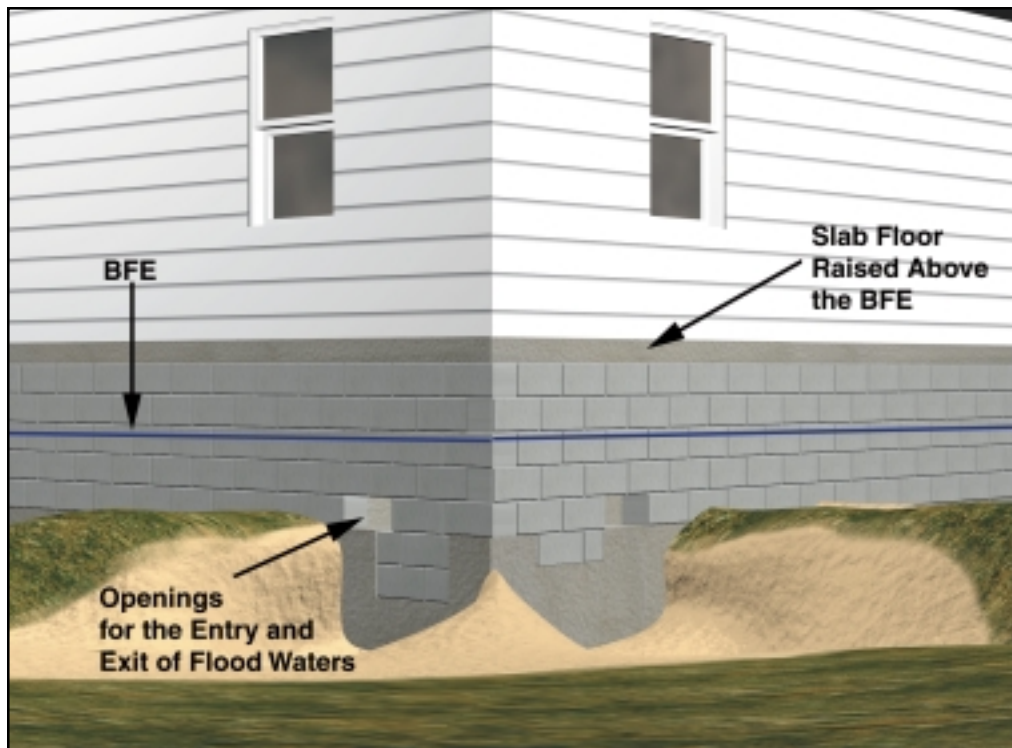
**Figure 21**  
Elevated house and  
slab on new, extended  
foundation walls.

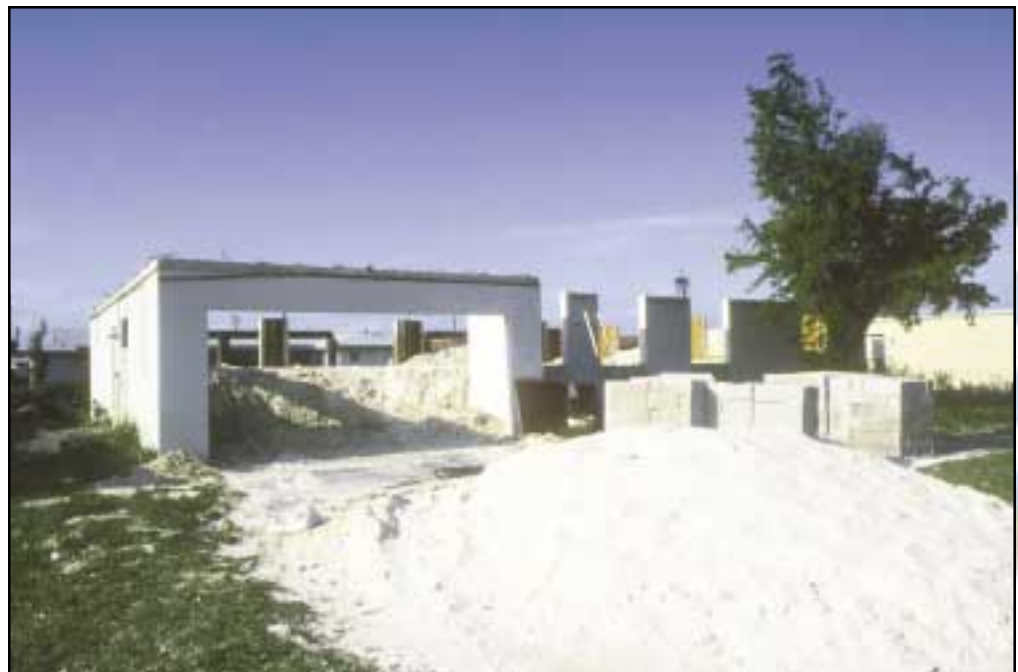
**Figure 22**

The front of the house at the beginning of the project. The interior walls and contents, which were destroyed or severely damaged by flood waters, wind, and rain, have been removed. Sand has been placed on top of the old slab to provide the base for the elevated lowest floor. The concrete blocks that will be used to extend the walls can be seen stored in the foreground.

The first case study house (Figures 22–32) has masonry walls and a slab-on-grade foundation. The roof of this house was severely damaged by high winds during Hurricane Andrew, and the interior walls suffered extensive damage from flood waters and rain. The owner decided to raise the lowest floor above the BFE by extending the walls upward, placing sand fill on top of the original slab floor, and pouring a new, elevated concrete slab on top.

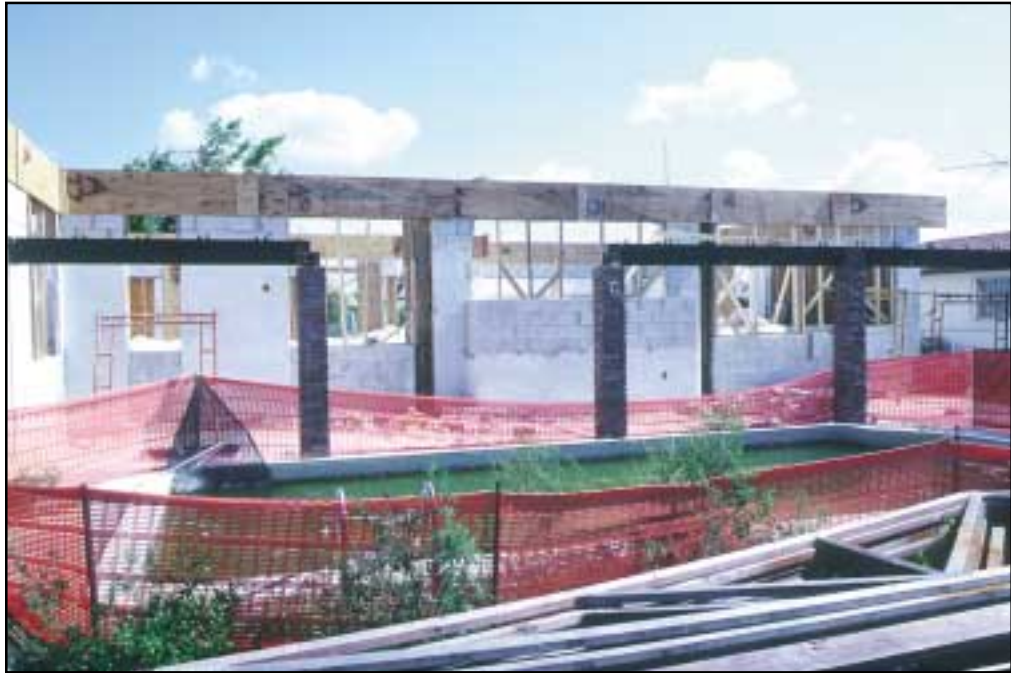
**Figure 23**

View from the back of the house. The walls have been extended upward with concrete blocks. The plywood visible at the tops of the walls is used to form cast-in-place concrete bond beams that will strengthen the extended walls. The roof trusses shown in the foreground were salvaged for reinstallation. The owner of this house decided to replace the original roof sheathing and shingles with new materials.

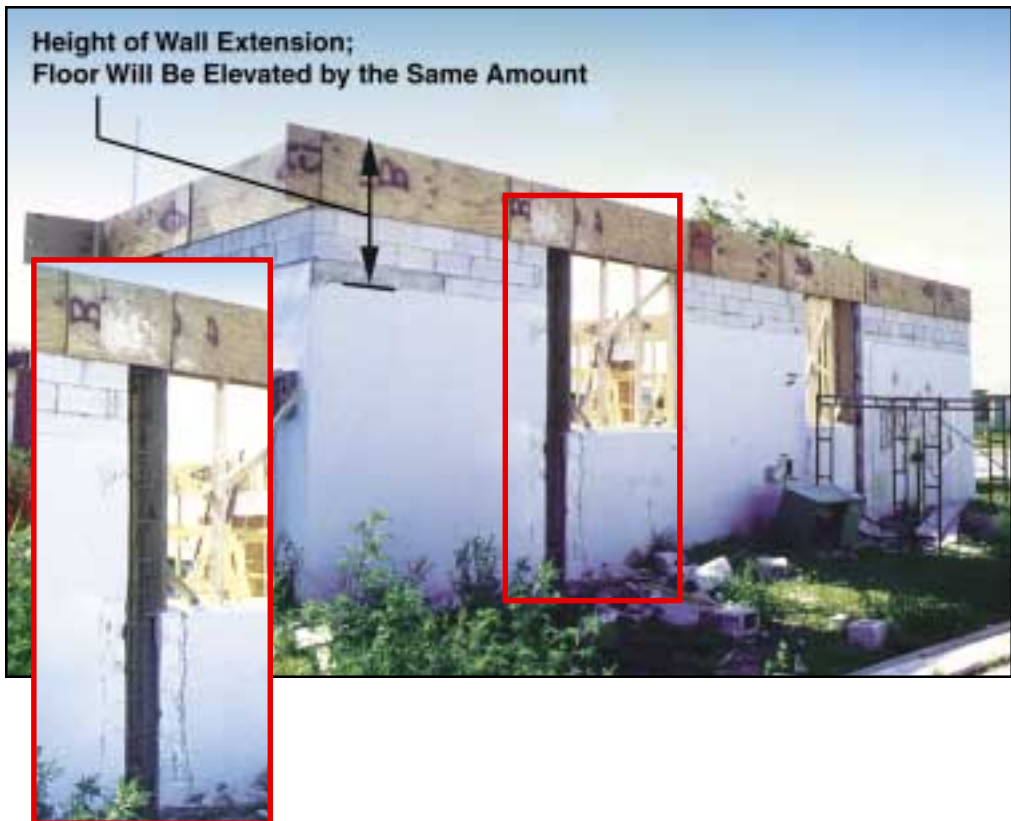
Another view of the extended walls. The vertical cuts in the walls next to the windows are for concrete tiedown columns that will be cast in place to further strengthen the extended walls against wind loads. The owner of this house was able to meet the elevation requirement by raising the floor only a few feet, as indicated by the amount that the walls have been extended.

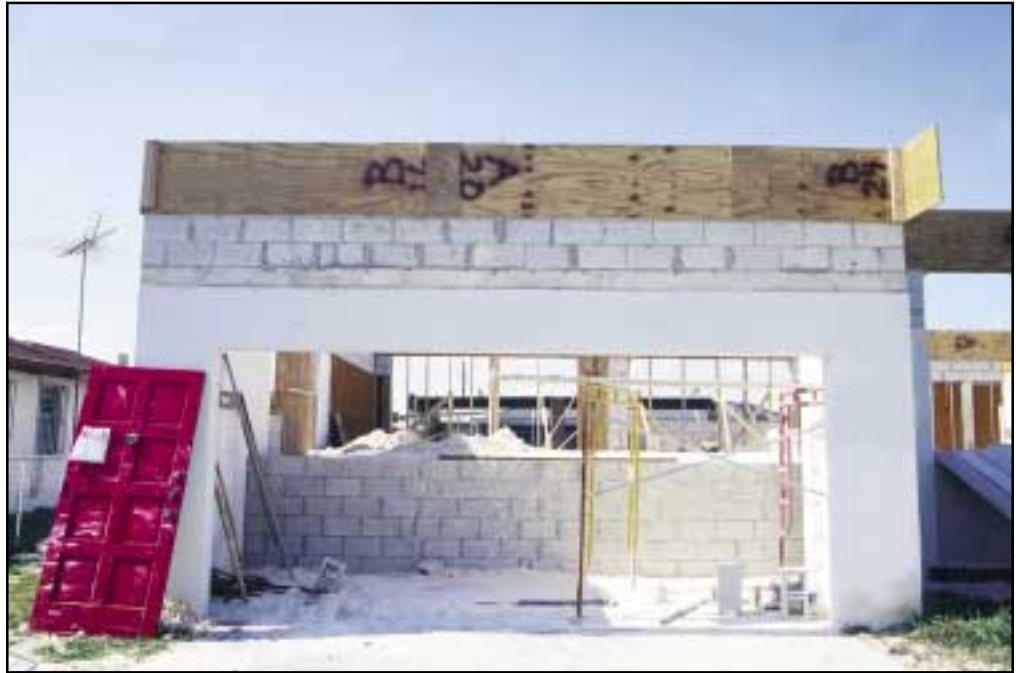
**Figure 25**

This view through the garage door reveals the different levels of the elevated slab floor, in the background, and the unelevated garage floor.

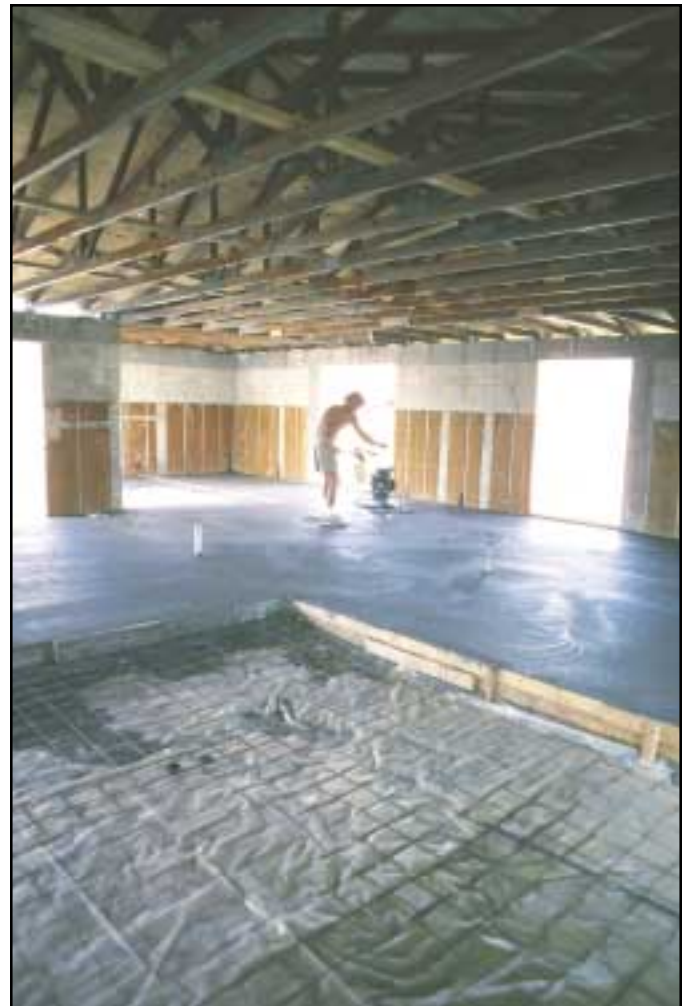
**Figure 26**

The roof has been rebuilt with the salvaged trusses, and most of the new concrete slab has been poured on top of the sand fill. The open area in the foreground, where plastic sheeting and wire reinforcement can be seen on top of the sand fill, is where the remaining part of the slab will be poured.

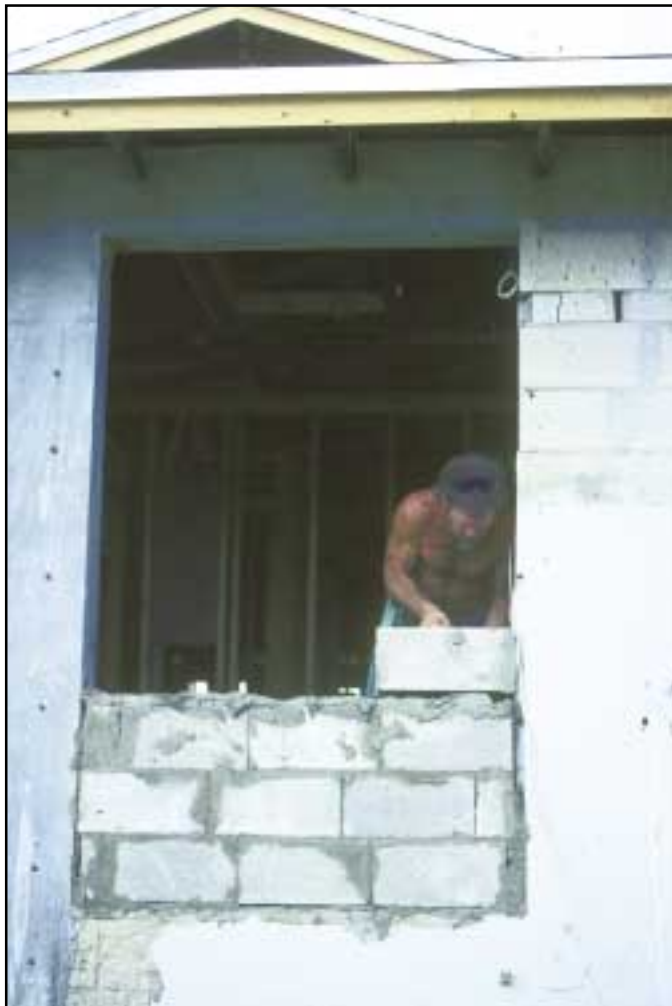
**Figure 28**

The bottoms of the original window openings are raised with concrete blocks.

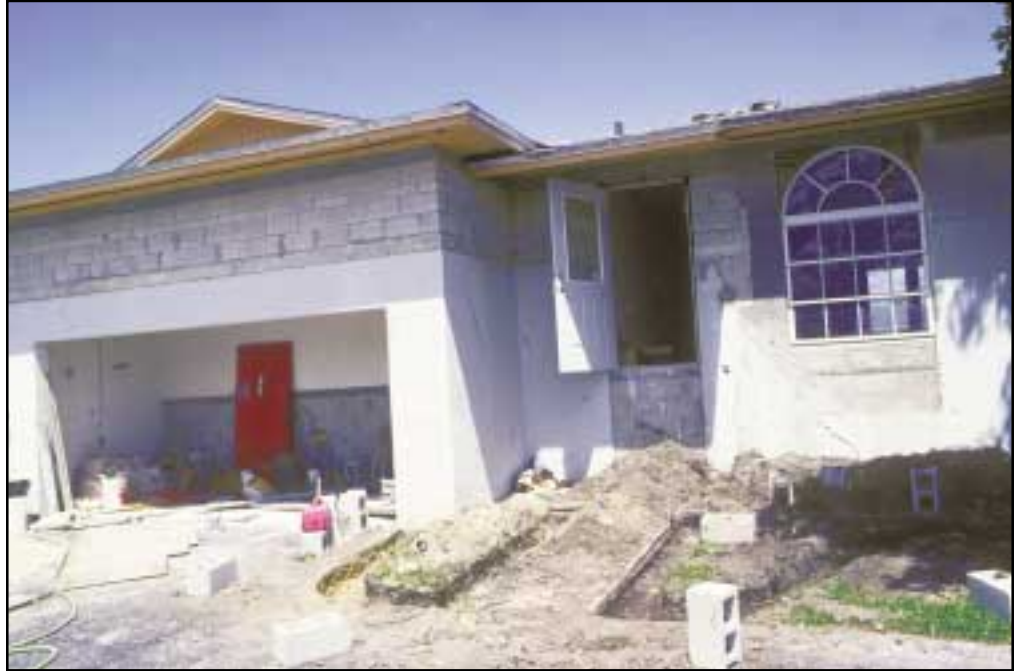
**Figure 29**

Windows and doors are added. The height of the raised front door shows the amount of elevation.

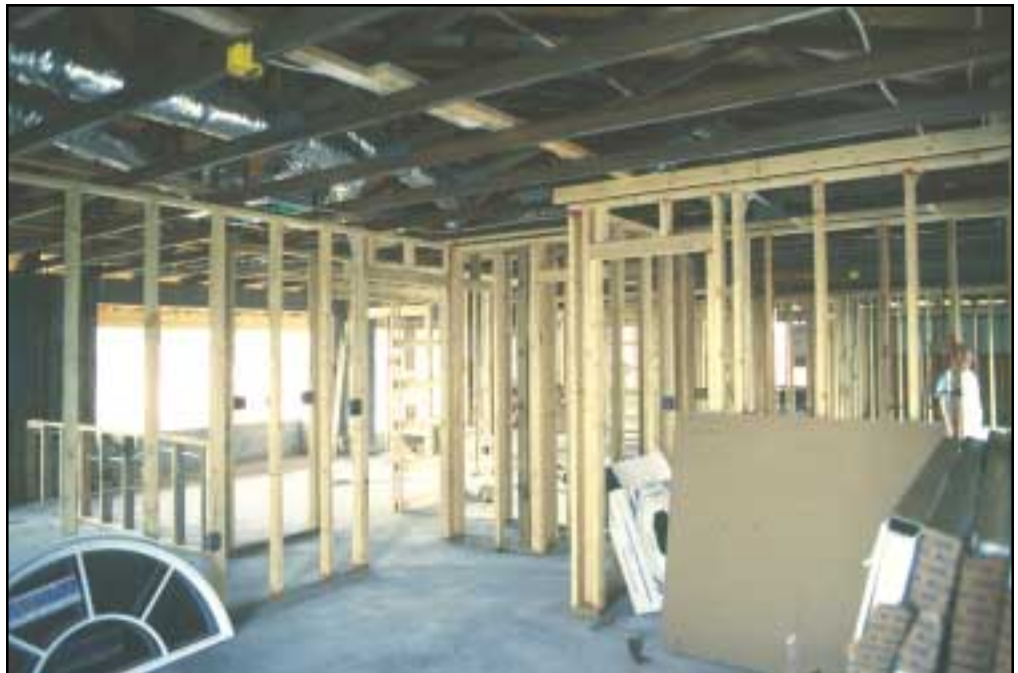
**Figure 30**

Interior partition walls and utilities are added.

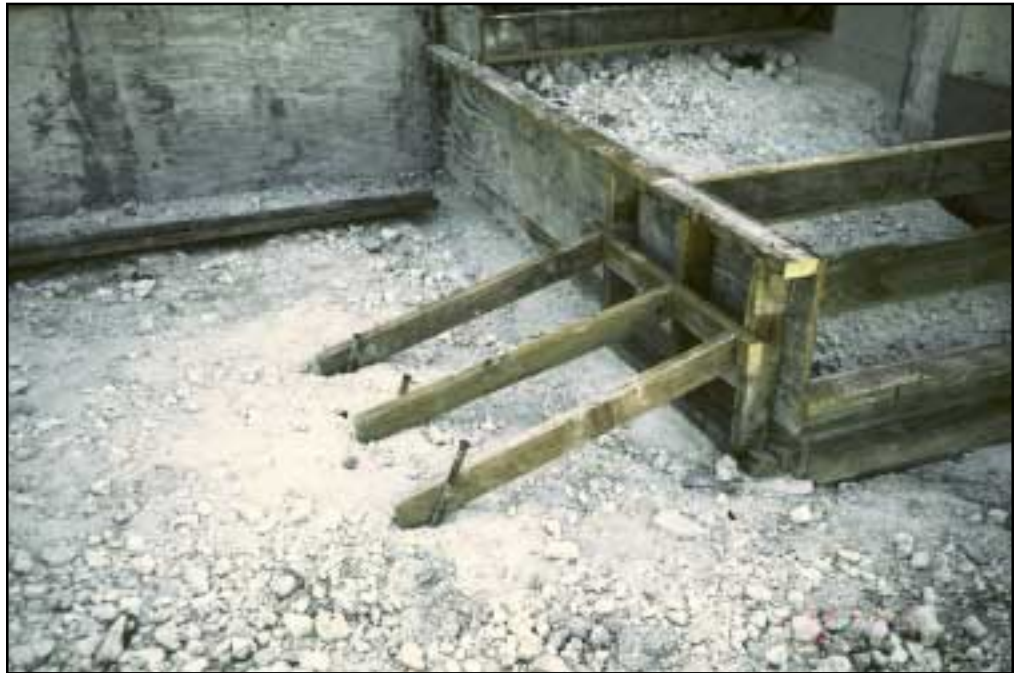
**Figure 33**

Wood framing for a new concrete staircase that will provide access to the elevated floor.
