# *Above the Flood:* **ELEVATING YOUR FLOODPRONE HOUSE**

**FEDERAL EMERGENCY MANAGEMENT AGENCY**

**MITIGATION DIRECTORATE**

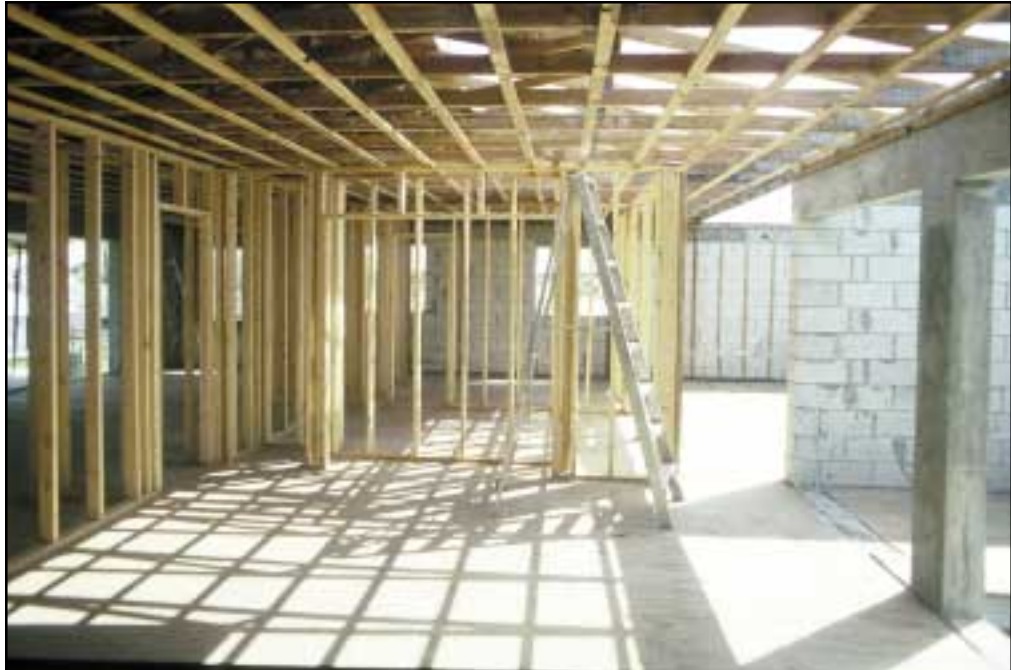
**Figure 34**

After the new concrete slab is poured, wood framing for interior walls is added.

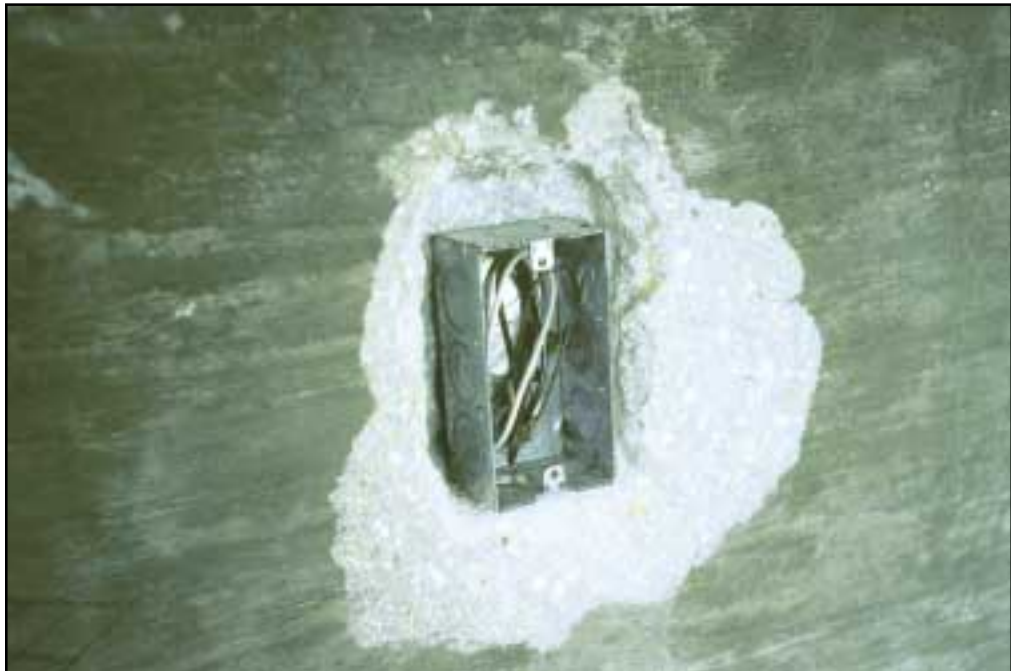
**Figure 35**

The electrical system is upgraded to meet current code requirements.

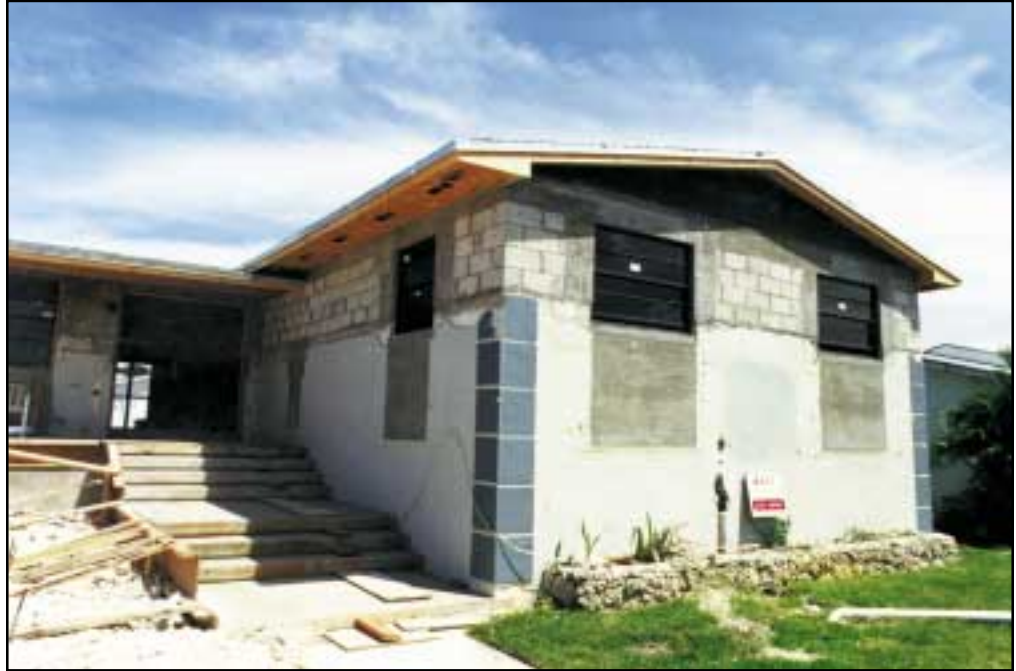
**Figure 36**

In this view from the front of the house, the amount of elevation is shown by the rows of concrete block on the tops of the original walls and by the raised window openings.

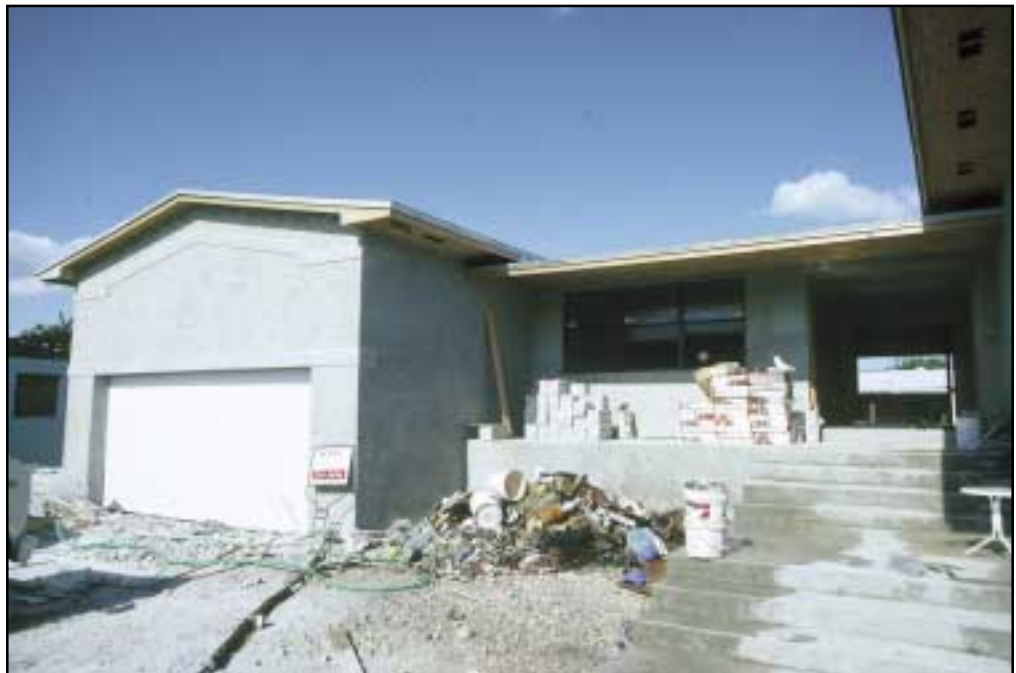
**Figure 37**

The project nears completion. In this house, as in Case Study 1, the level of the garage floor remains unchanged.

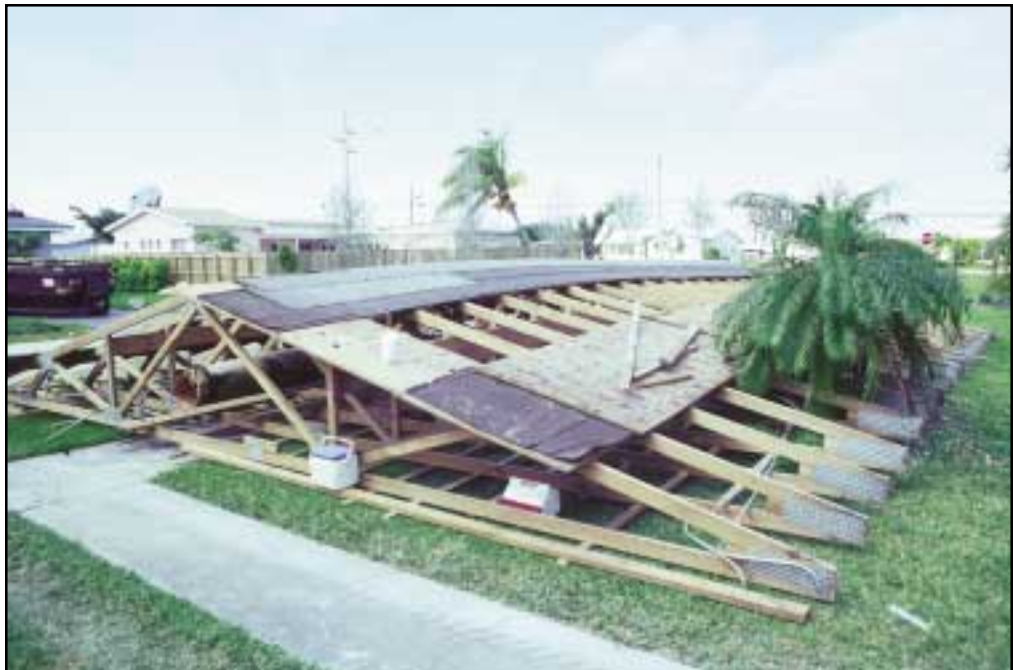
**Figure 39**

The roof of this house was removed as a single piece; the trusses were held together with bracing and portions of the original roof sheathing. This approach made it easier to reinstall the roof at the end of the project.

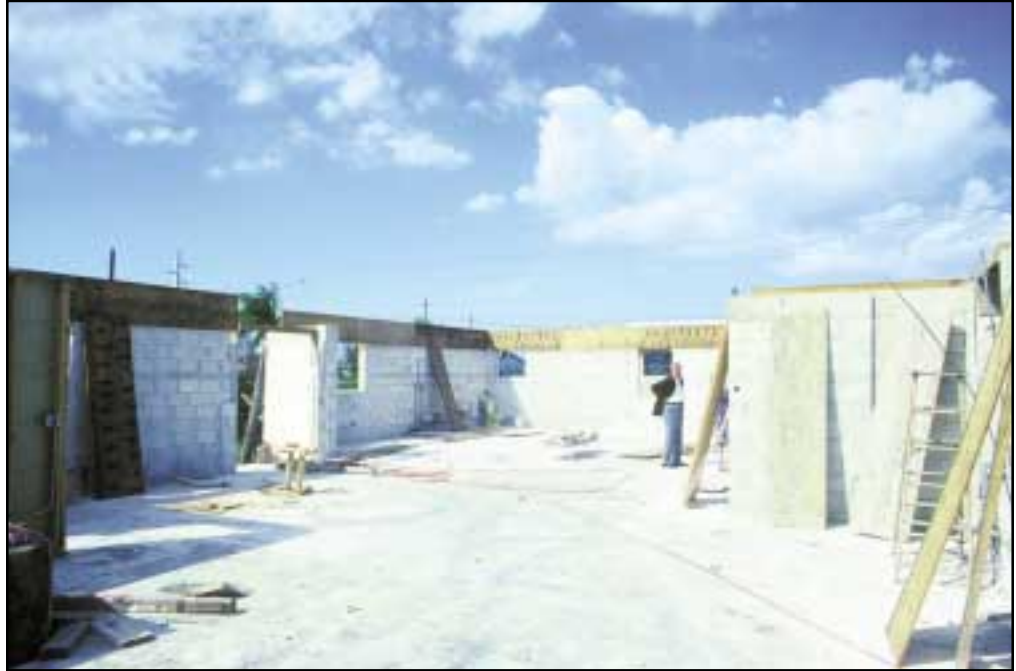
After the roof was removed and the storm-damaged interior gutted, the walls of the house were extended upward and a new bond beam added at the top.

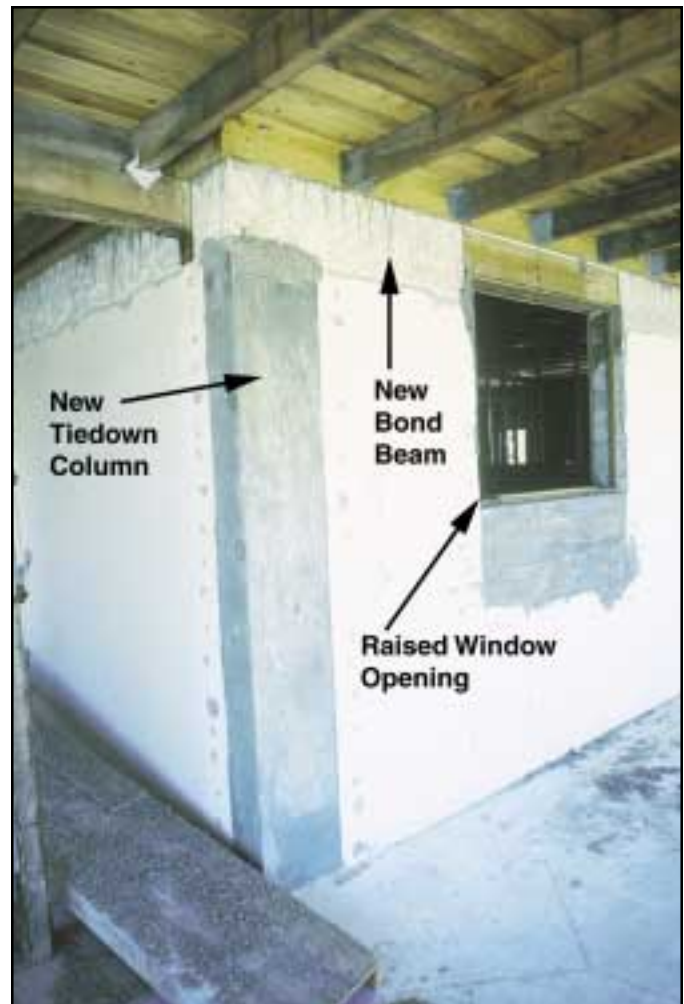
**Figure 41**

Note the new bond beam at the top of the extended wall, the new concrete tiedown column at the corner, and the raised window opening.

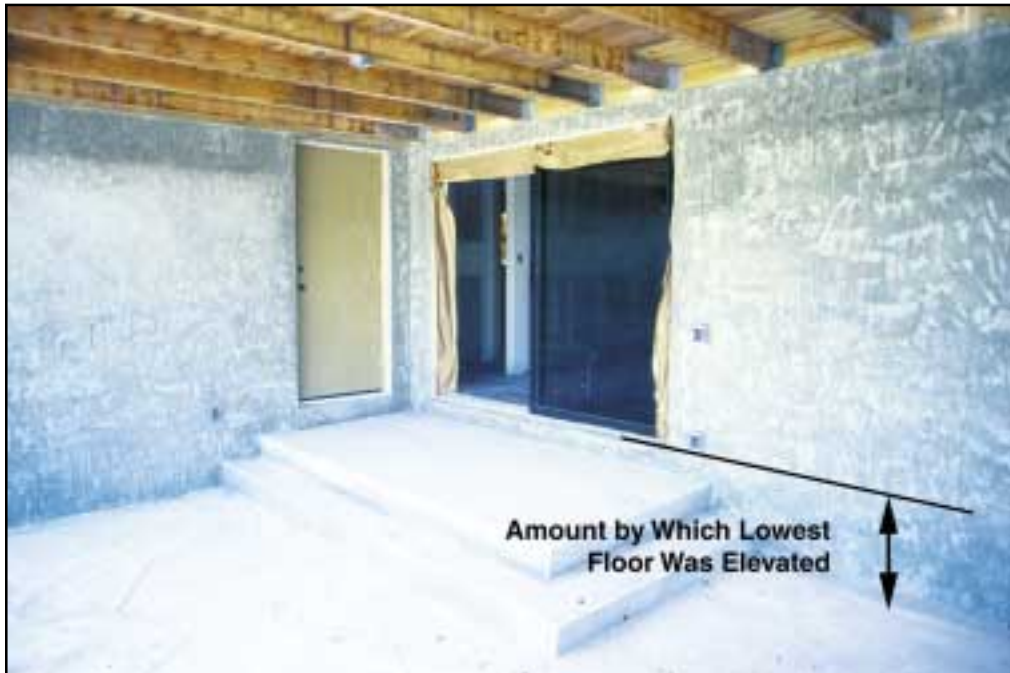
**Figure 42**

This view from the back of the house shows the height of the elevated slab floor.

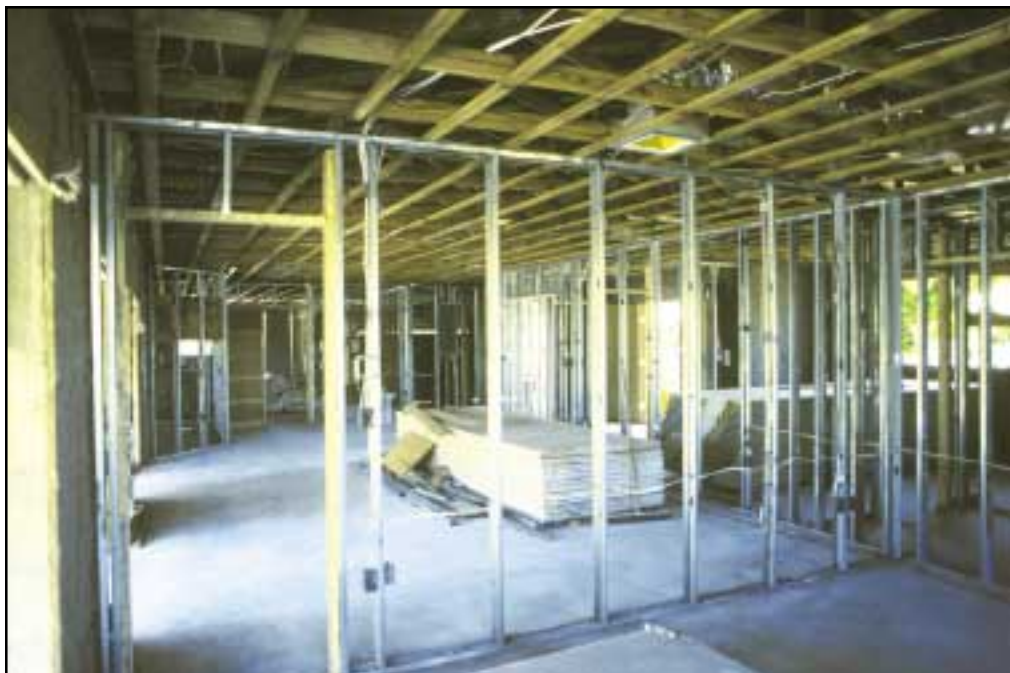
**Figure 43**

The owner of this house decided to use light-gauge metal framing for the new interior walls.

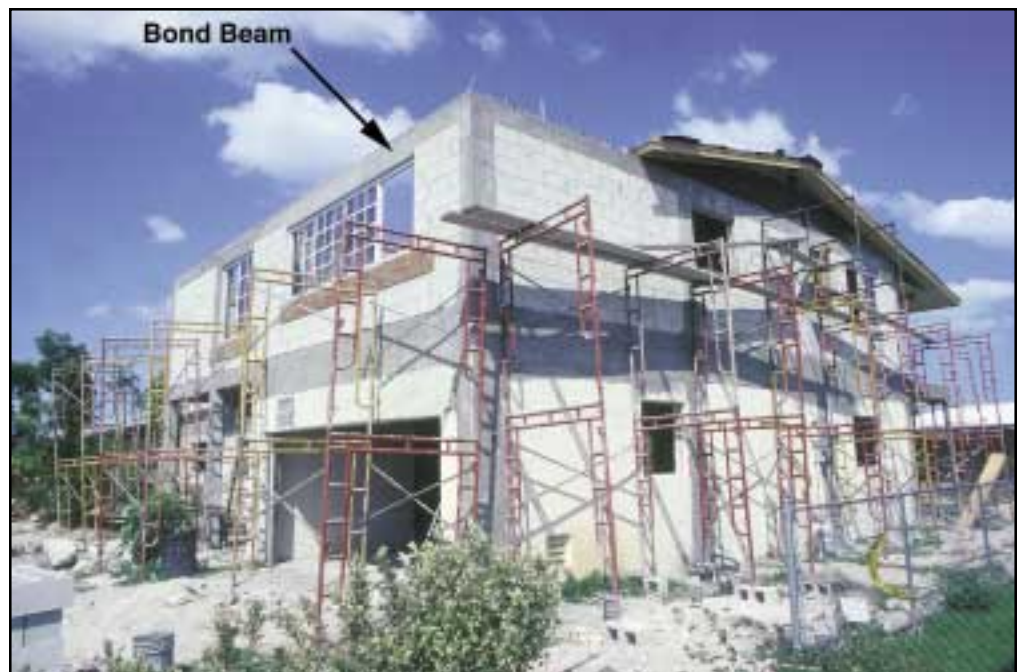
**Figure 45**

Concrete bond beams similar to those shown earlier were used in this house, but here they were installed on the tops of both the original first-story walls and the new reinforced concrete block second-story walls.

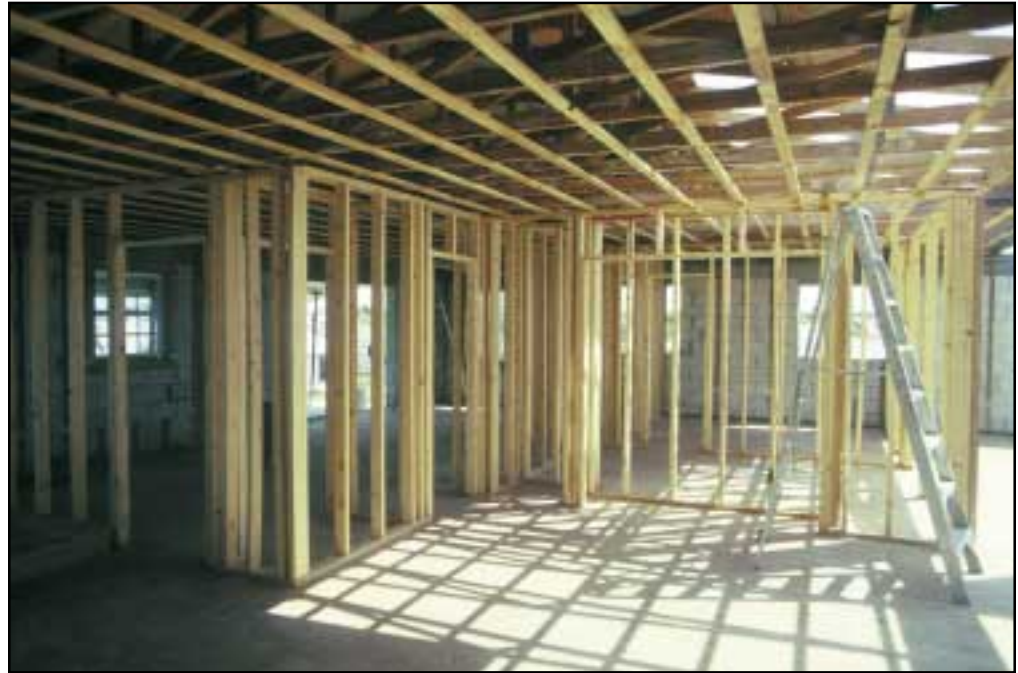
**Figure 48**  
Wood 2 by 4 studs were used to frame the interior walls of the second story.

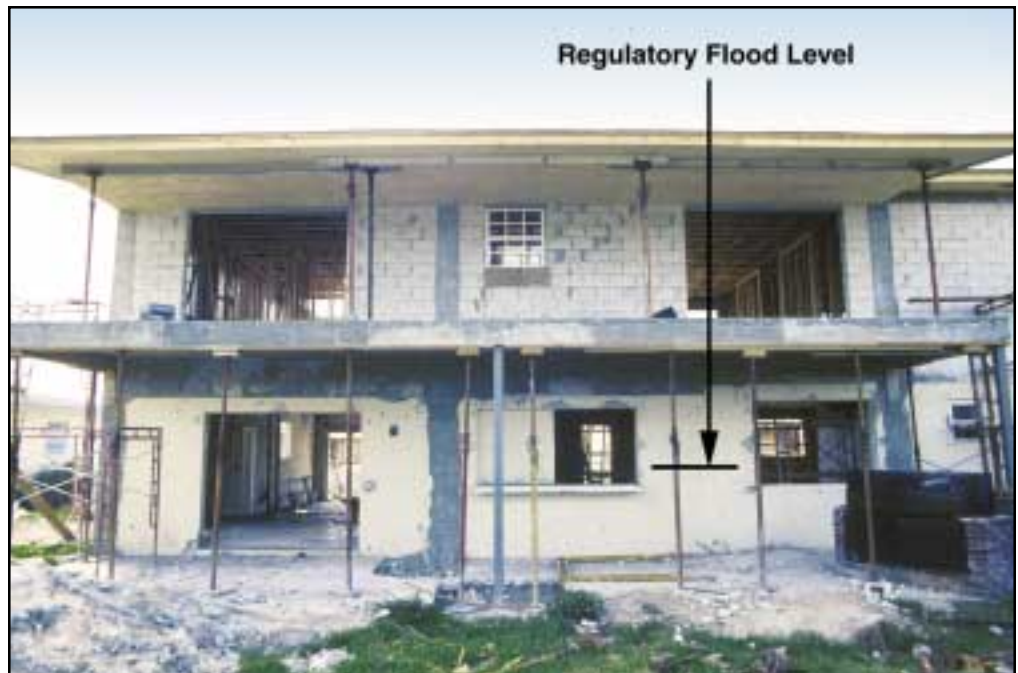
**Figure 50**

Not only does the completed house meet the requirements of local codes and the NFIP regulations, it now includes a substantial amount of parking and storage space below the new living level. In addition, because the lowest floor is now over 4 feet above the regulatory flood elevation, the house is eligible for NFIP flood insurance at a greatly reduced rate of coverage.

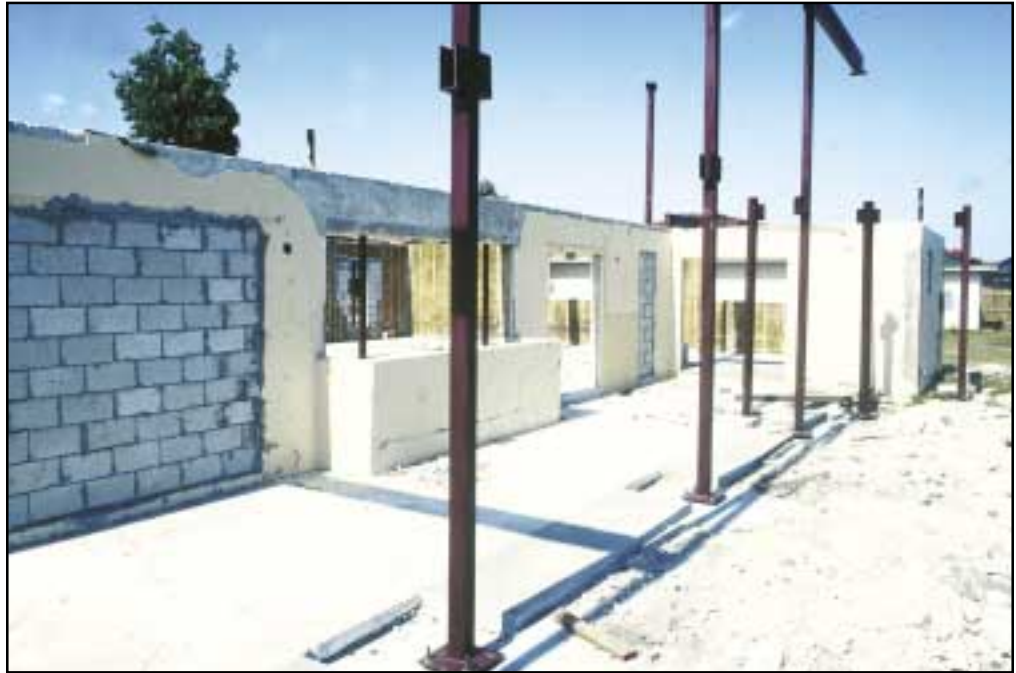
The existing first-story walls have been strengthened by the addition of concrete block. Metal columns and beams have been added to help support the new second story.

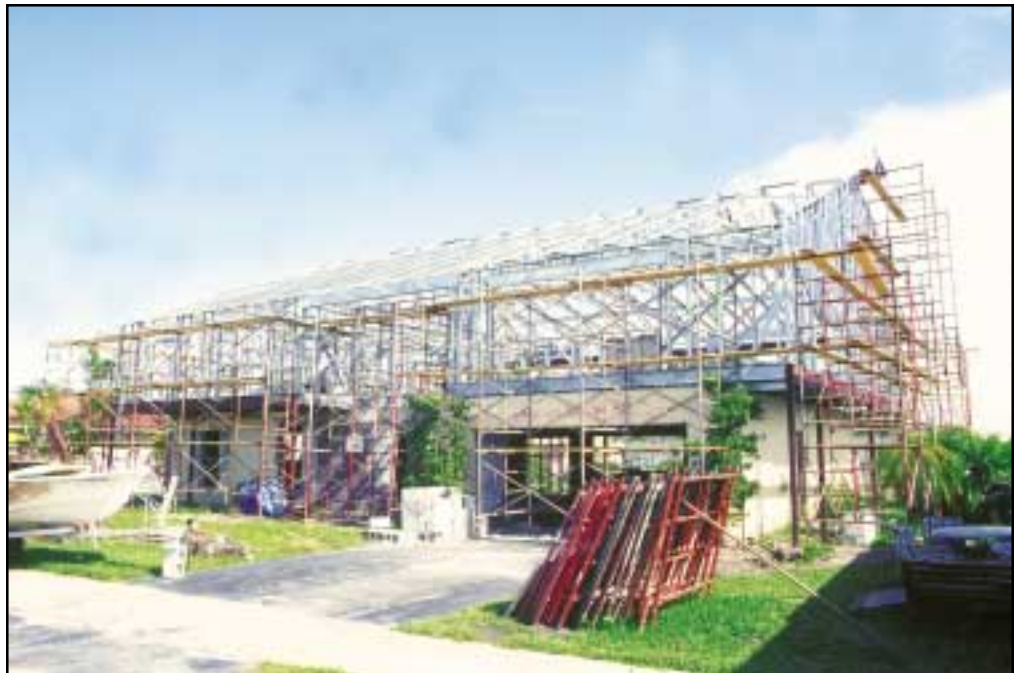
**Figure 54**

Metal framing is used for the new second story, including the walls and roof support system.

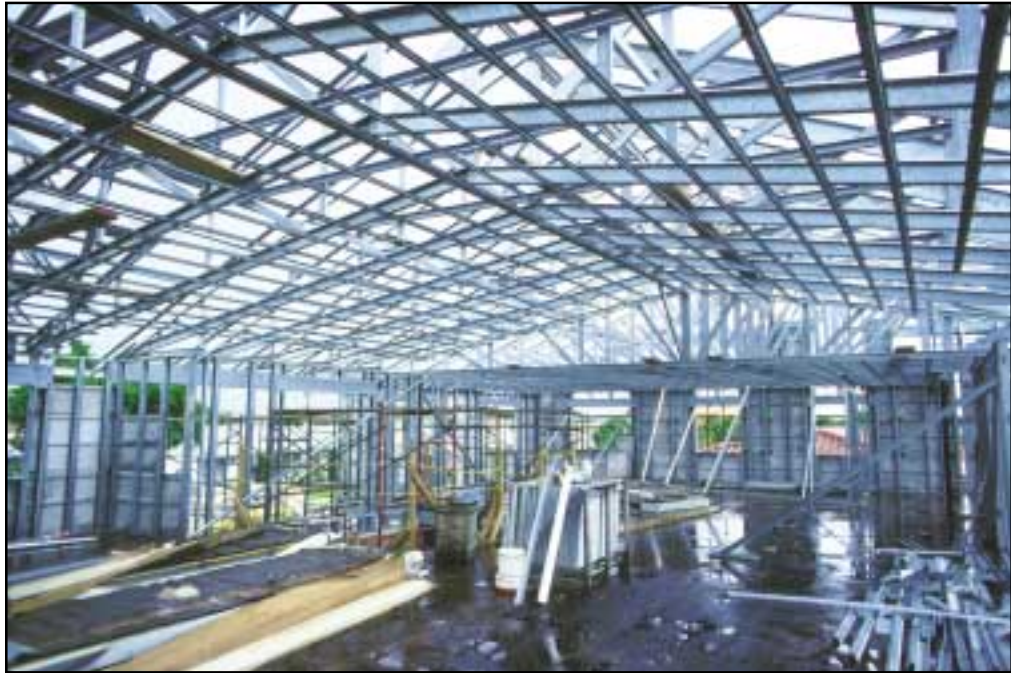
**Figure 55**

Metal framing also supports the floor of the new second story.

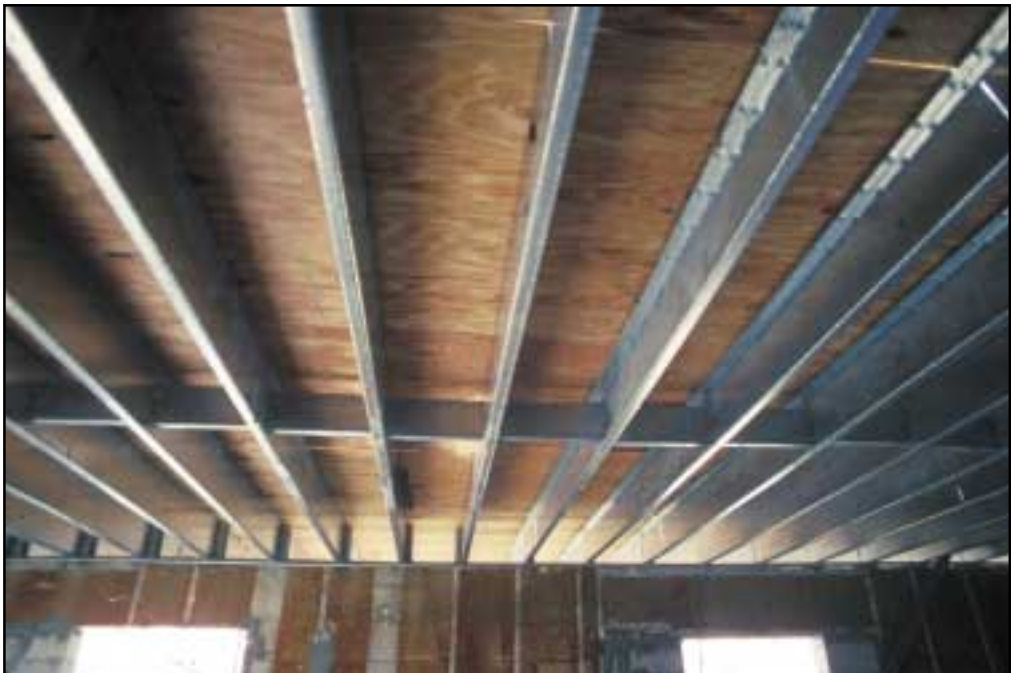
**Figure 56**

One advantage of metal framing is its relatively light weight. An additional advantage is that the screws used to attach metal-frame components provide strong connections.

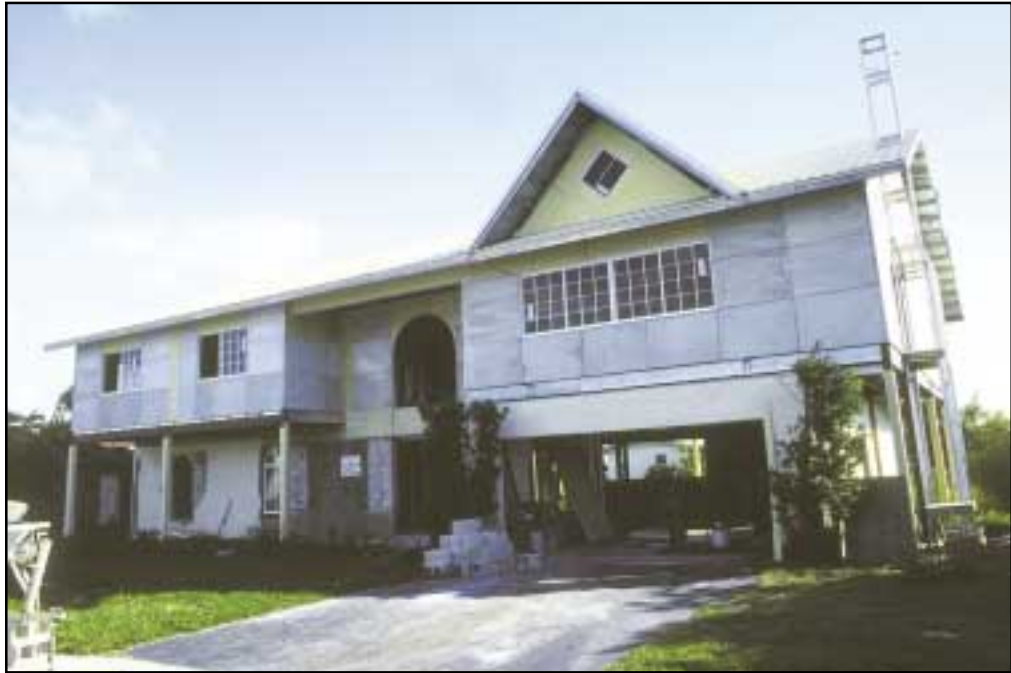
**Figure 59**

The exterior walls  
consist of  
prefabricated  
concrete panels.  
Innovative techniques  
such as those  
employed in this  
project are helping  
homeowners who  
need practical and  
economical methods  
of repairing and  
protecting their  
houses.

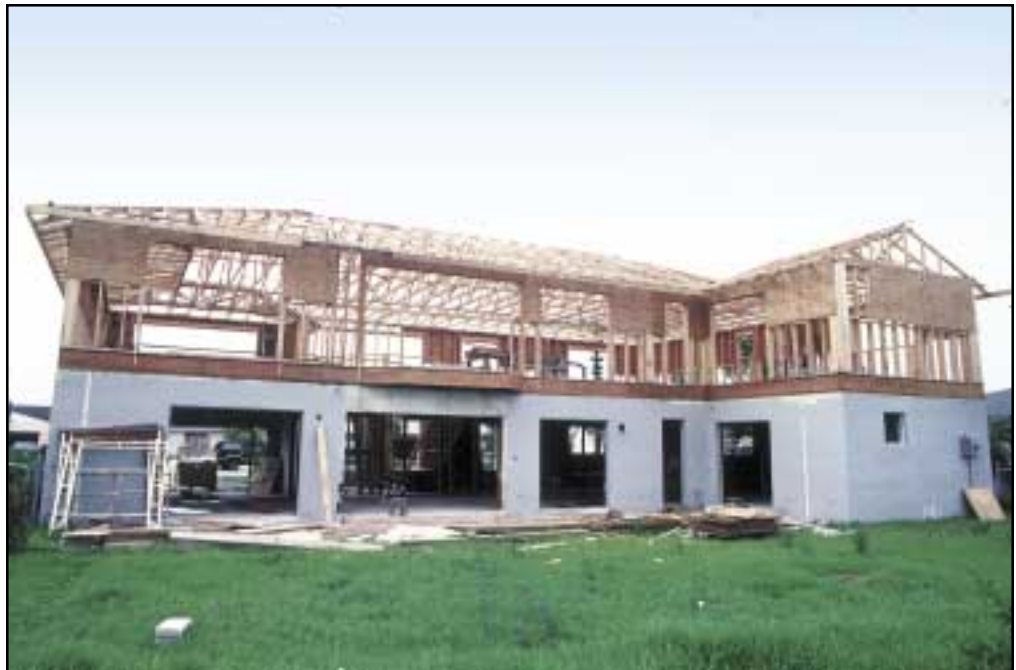
**Figure 61**

The wood-frame second story takes shape.

The third house for which Technique 2 was used (Figures 61–64) differs from the first two in that the owner decided to build a wood-frame second story.

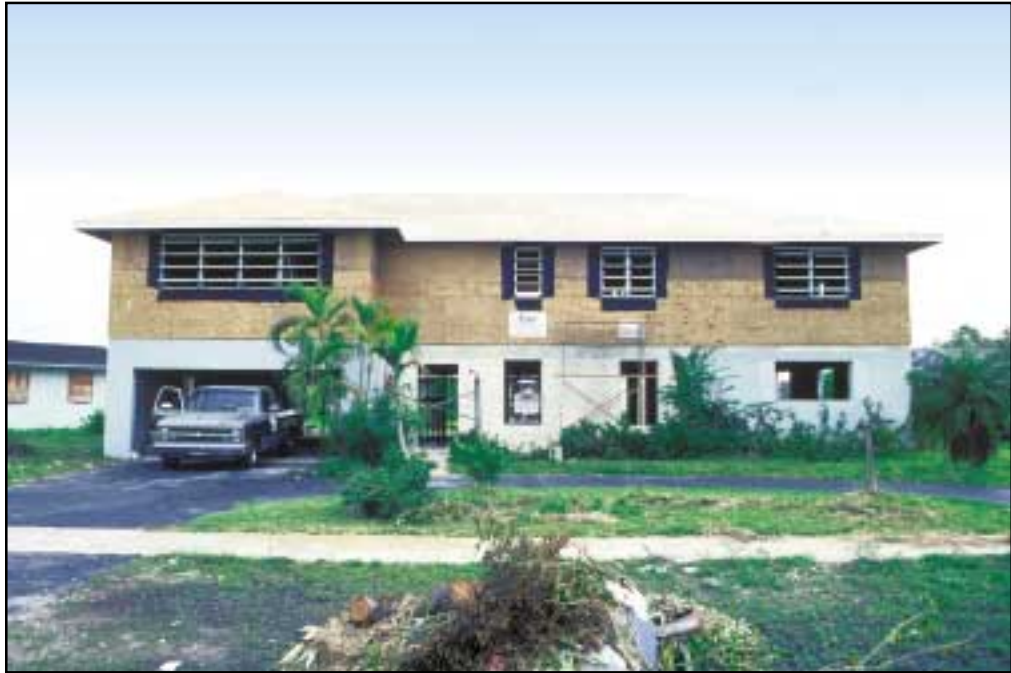
**Figure 62**

After the wood framing was completed, the roof and exterior wall sheathing were added.

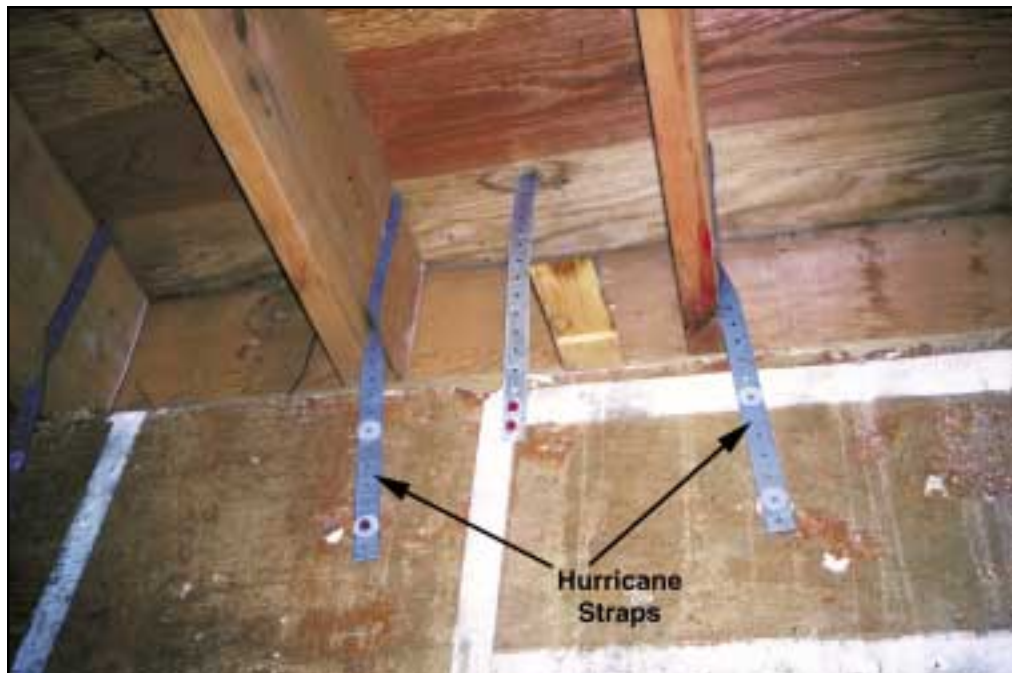
**Figure 63**

The new second-story walls are securely connected to the original first-floor walls with galvanized metal hurricane straps.

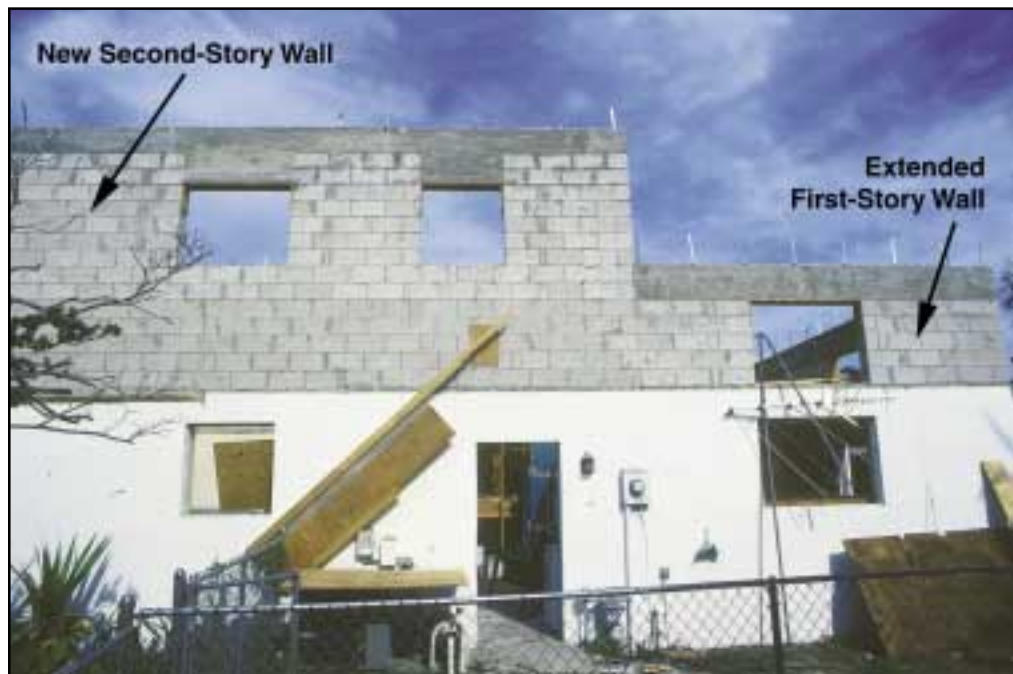
**Figure 65**

After the house was gutted, the walls were extended upward with reinforced concrete block. In this view from behind the house, the rear wall of the new second story can be seen on the left and the extended first-story wall on the right. Note the new raised window opening in the extended wall, just above the original opening.

Many owners of substantially damaged houses in the areas affected by Hurricane Andrew took advantage of the opportunities afforded by their elevation projects to make additional improvements. For example, the owner of the next house (Figures 65–72) used a combination of Techniques 1 and 2. In addition to extending the walls of the house upward and raising the lowest floor above the BFE, he built a new second-story addition over the garage. The addition was not a necessary part of the elevation process, but it does provide additional living space well above the flood level.

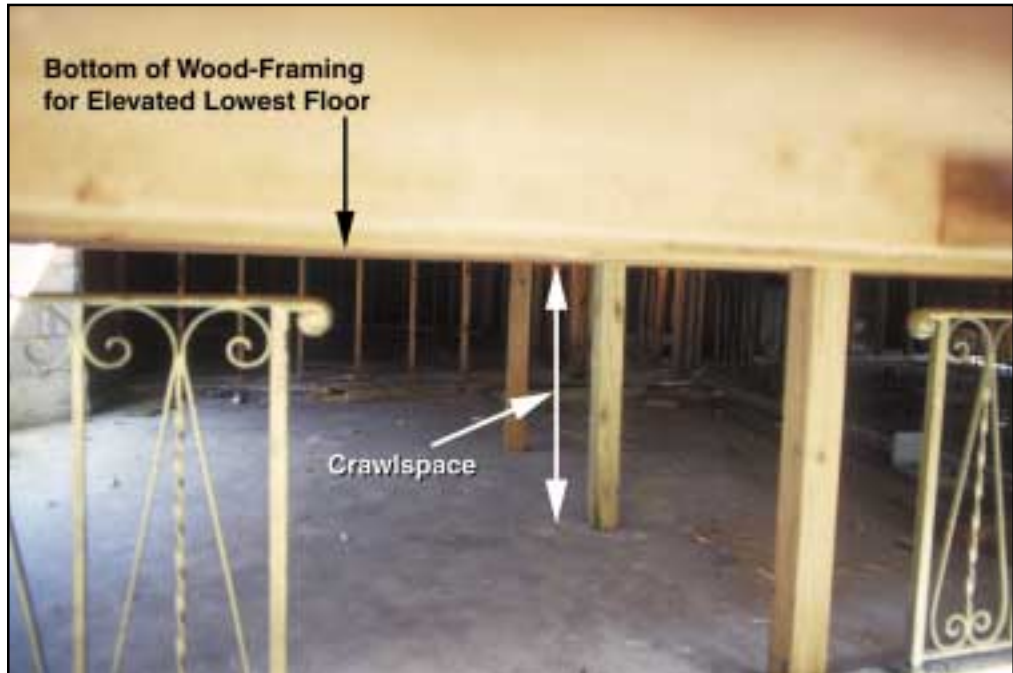
**Figure 68**

Rather than install a new concrete slab on compacted fill, the owner of this house chose to build a new wood-frame floor above the old concrete slab. This method creates a crawlspace below the new floor.

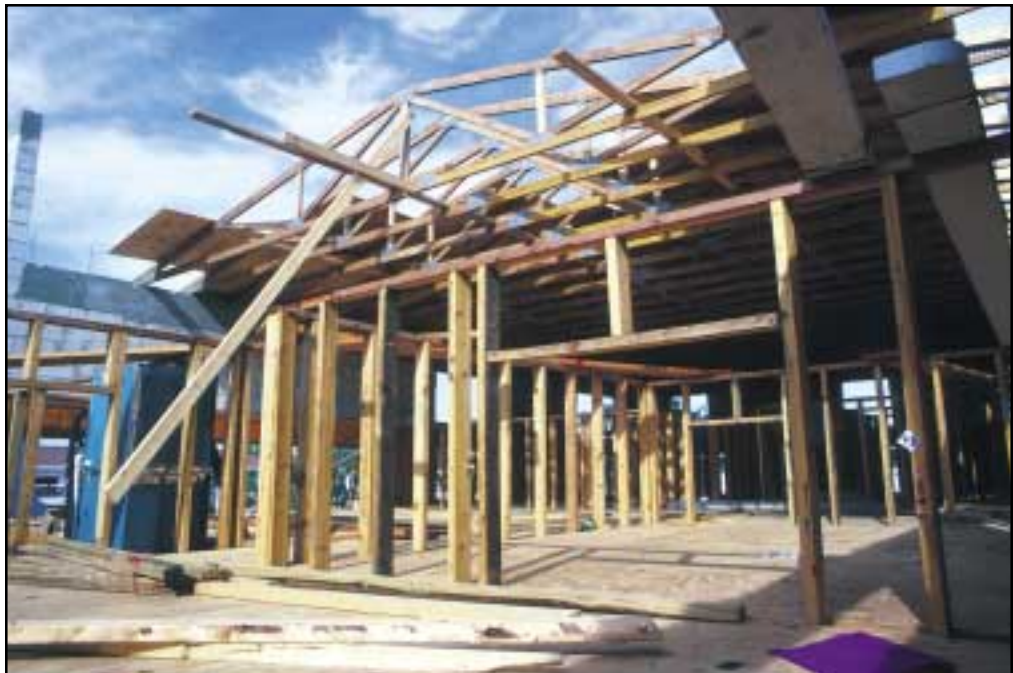
**Figure 69**

Wood framing is used for the new second story.

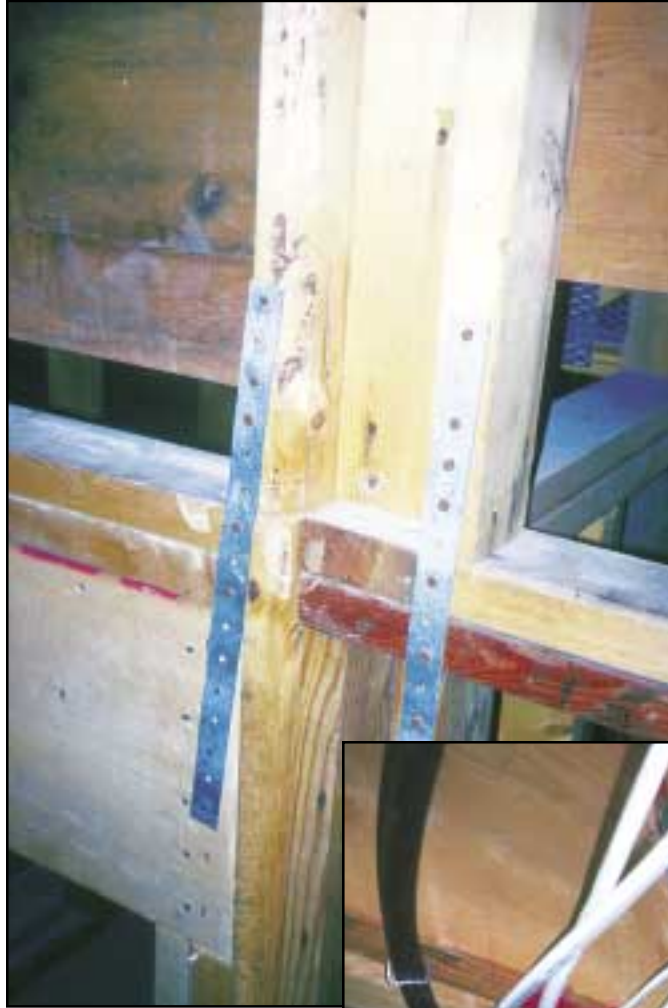
Metal hurricane straps are used to tie the structural members together and create a continuous load path from the roof to the foundation.

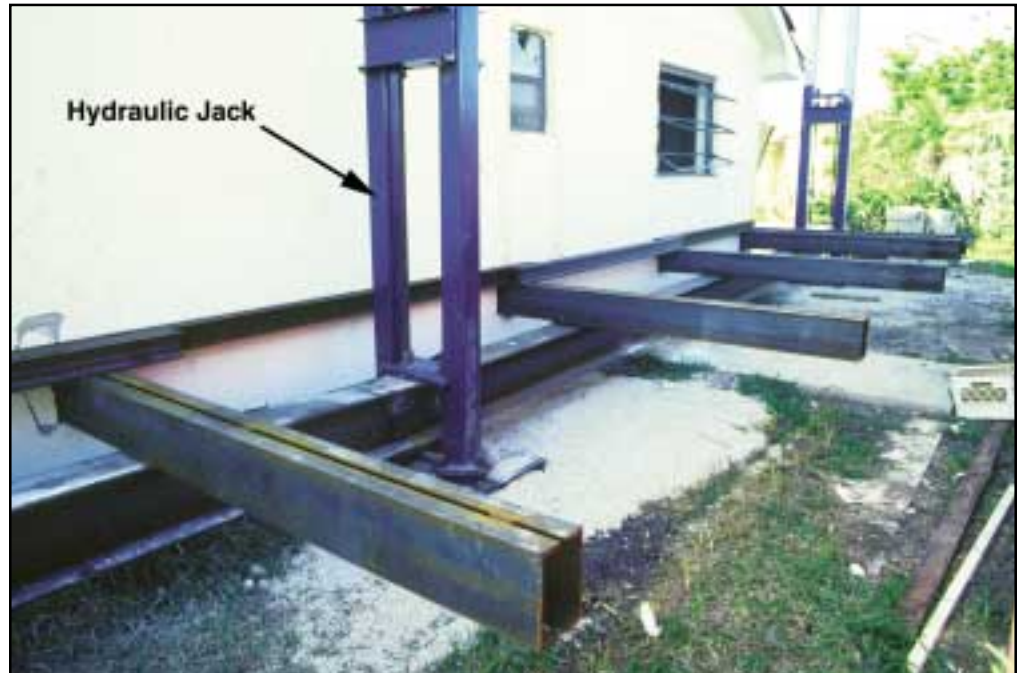
In this variation of Technique 3, steel beams are inserted through the walls of the house rather than under the slab. The beams span the length and width of the house and cross one another inside to create a grid. Outside the house, the beams rest on larger beams that will be raised with hydraulic jacks.

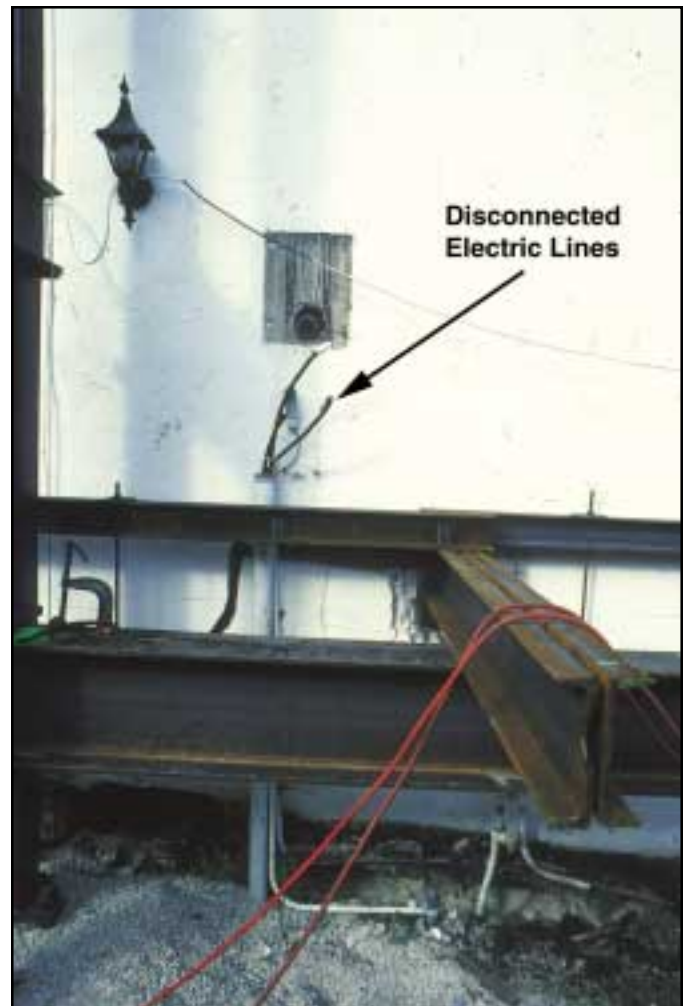
**Figure 75**

Electrical lines and other utilities were disconnected early in the project.

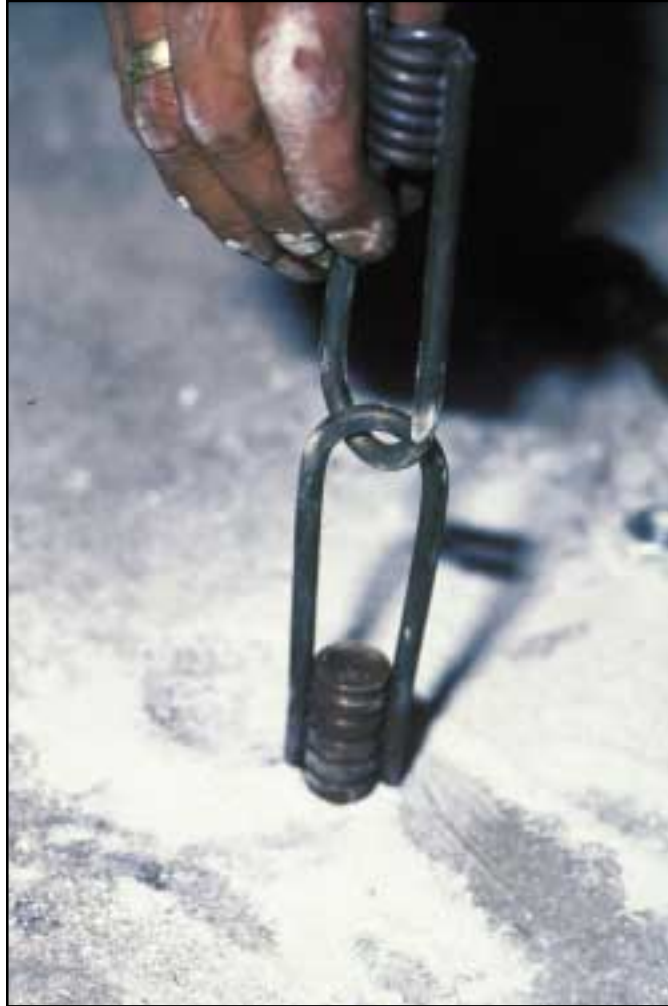
**Figure 78**

... and use hangers to attach the anchors to the grid of steel beams.

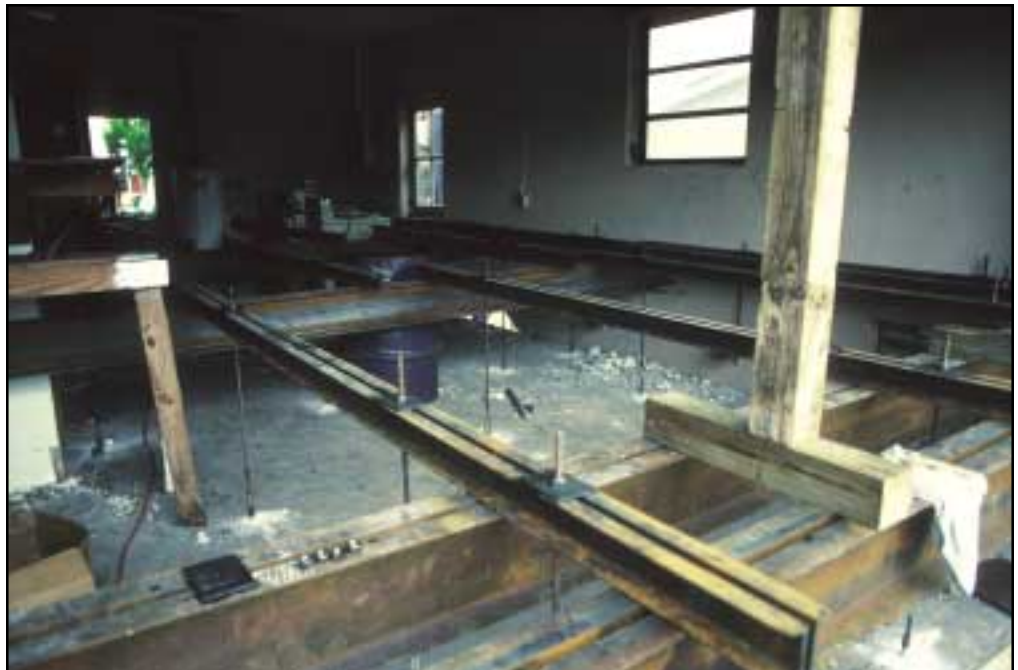
**Figure 79**

The anchors and hangers connect the slab securely to the beams, enabling the beams to raise the slab along with the rest of the house.

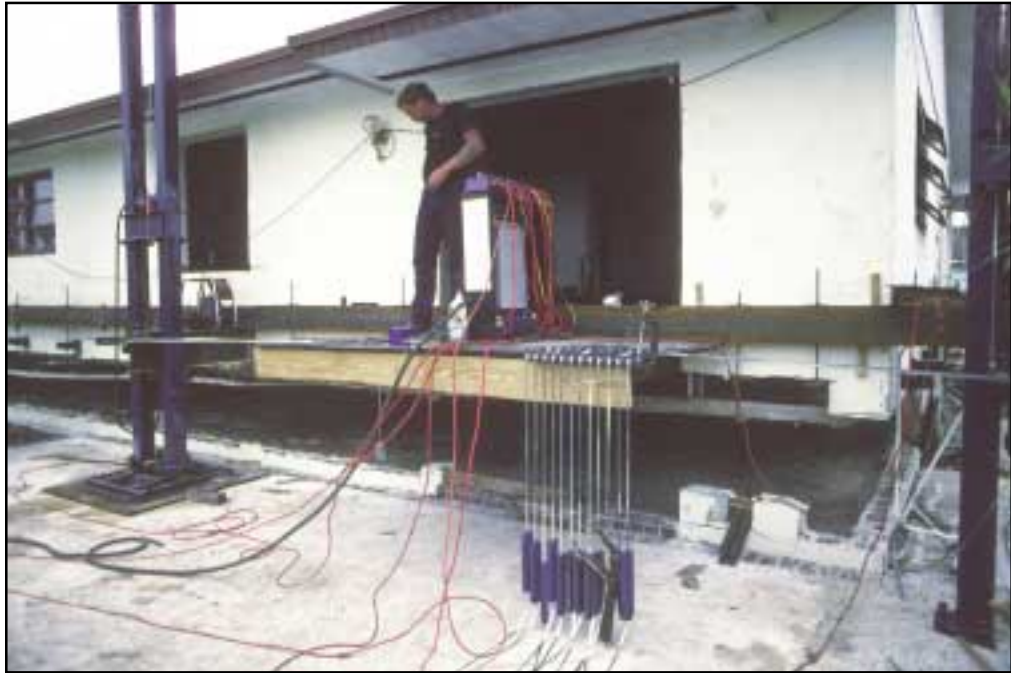
**Figure 80**

Lifting the house, while simple in theory, is complicated by the need to ensure an equal amount of lift at each jack throughout the process. Too much or too little lift at even one jack can cause the slab and walls to crack. The elevation contractor for this project used a sophisticated jacking system that provided the required level of control.

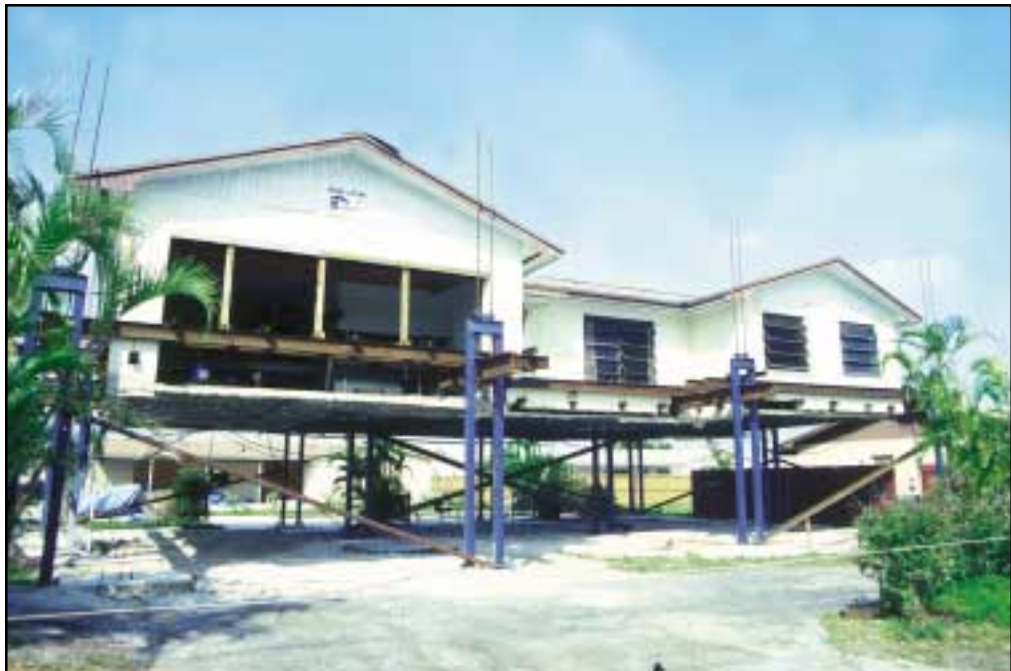
**Figure 81**

The house and slab were raised one full story.

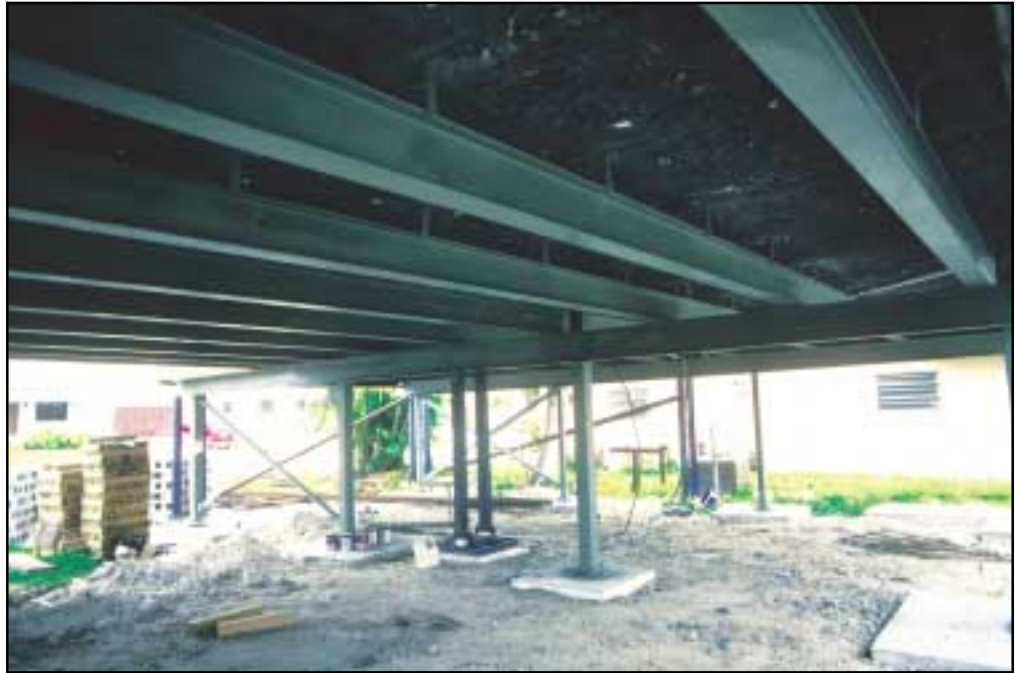
While the jacks and beams supported the house, new steel foundation members were installed below.
