# *Above the Flood:* **ELEVATING YOUR FLOODPRONE HOUSE**

**FEDERAL EMERGENCY MANAGEMENT AGENCY**

**MITIGATION DIRECTORATE**

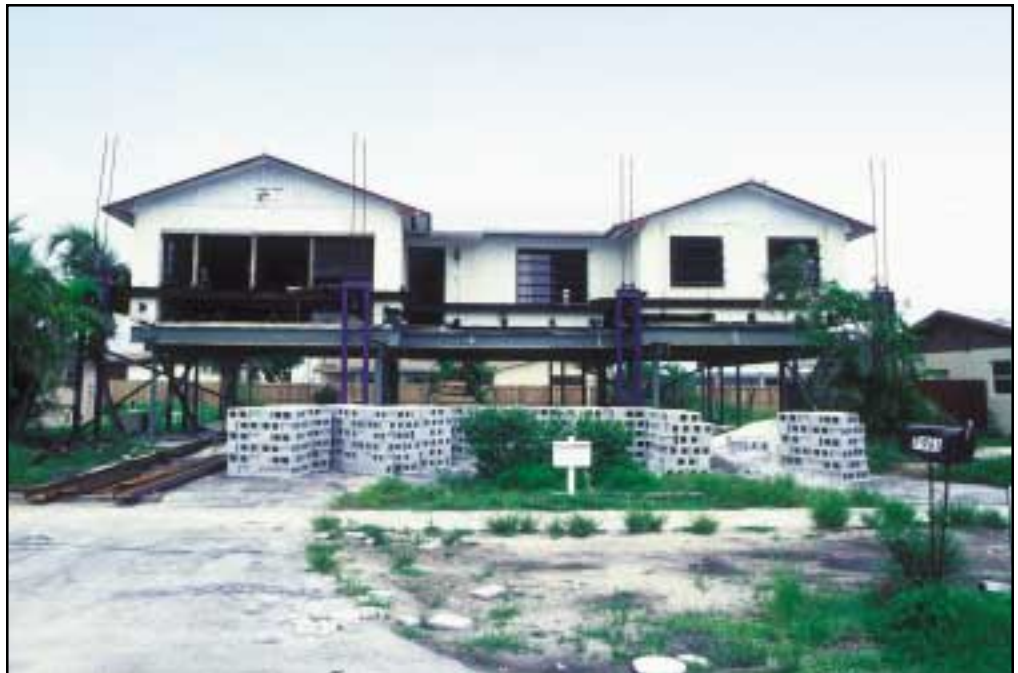
**Figure 83**

Concrete blocks were brought to the site ...

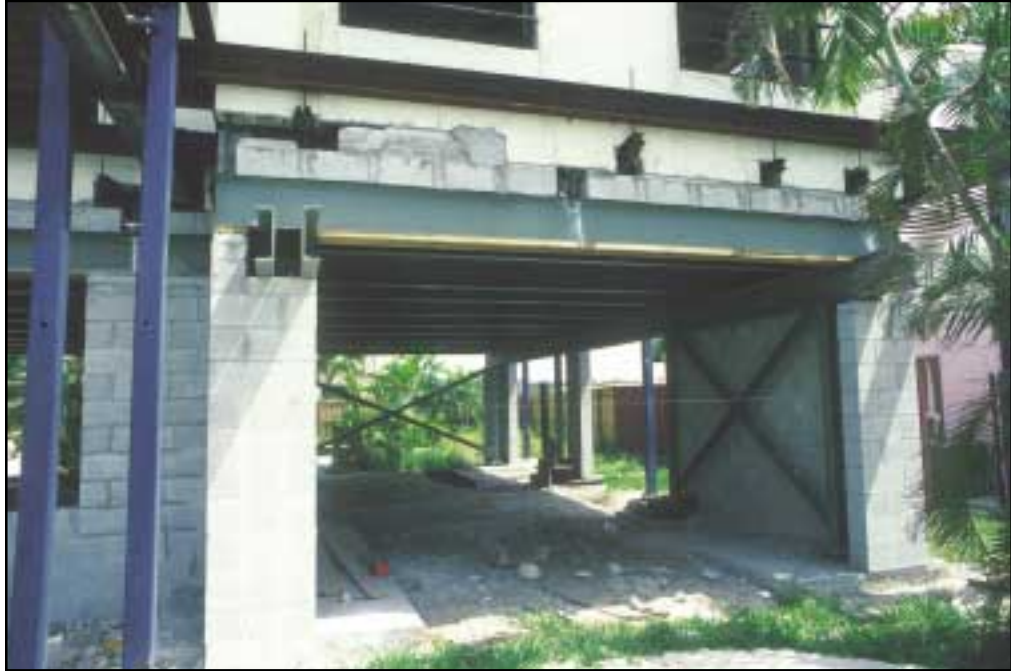
**Figure 84**

... and used to build the lower-level walls.
