# MARINA BUILDING DEFICIENCIES 2019

LPHM 4-27-19

Re: Engineering Inspection

For: Lake Park Marina Building  
103 / 105 Lake Shore Drive  
Lake Park, FL 33403

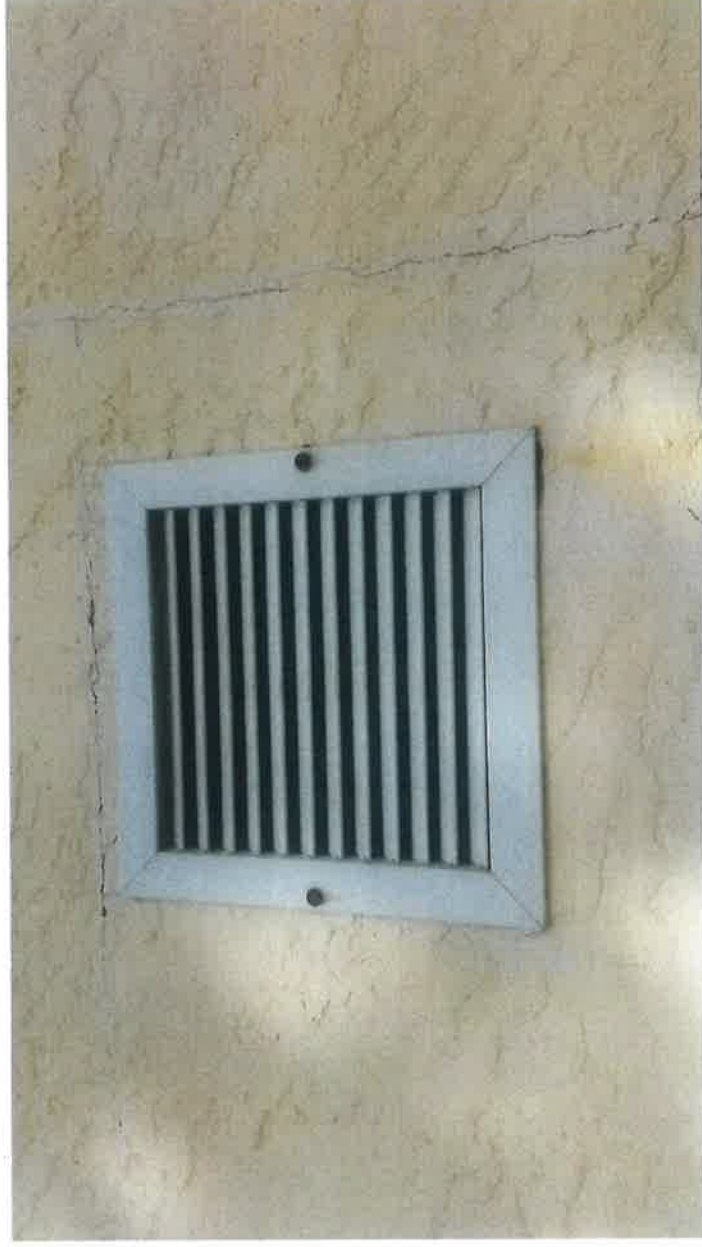
The building leaks.....

These pictures  
are from the  
men's shower  
room ceiling on  
the first floor.

It is leaking in  
second floor  
office.

It is also  
leaking  
through the  
ceiling tiles in  
the ship's  
store.

After investigating the source of all the leaking, it comes down to the delamination of the stucco at the transition point between the second floor balcony and the first floor exterior wall. This gap is allowing water to seep behind the wall. It is then finding it's way between the tongue and groove joints in the second floor concrete planks and ultimately this water is ending up getting into the interior spaces of the building.

12. The building will need crack repairs, waterproofing and painting project approximately over 5 years. In between paint projects any news cracks that appear should be filled in with caulking to prevent water intrusion. This maintenance needs to be done on an ongoing basis.

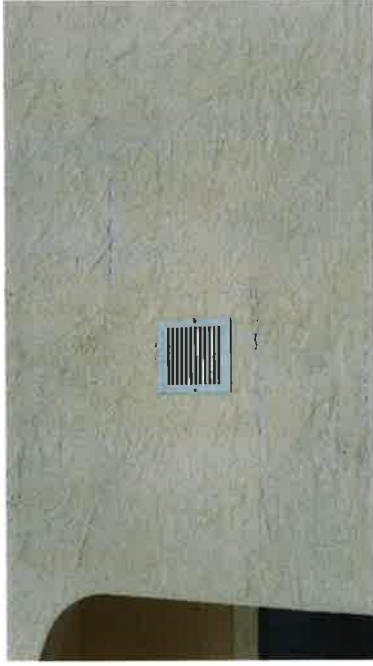
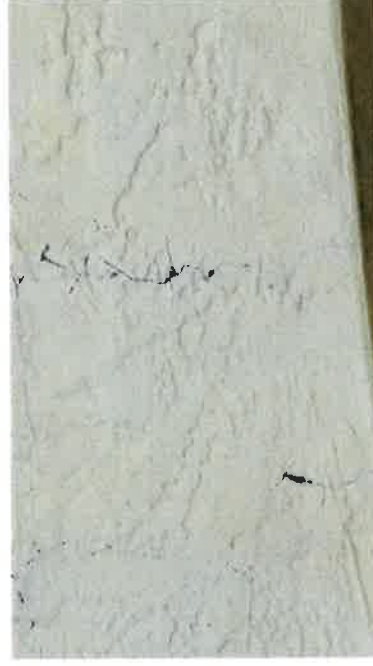
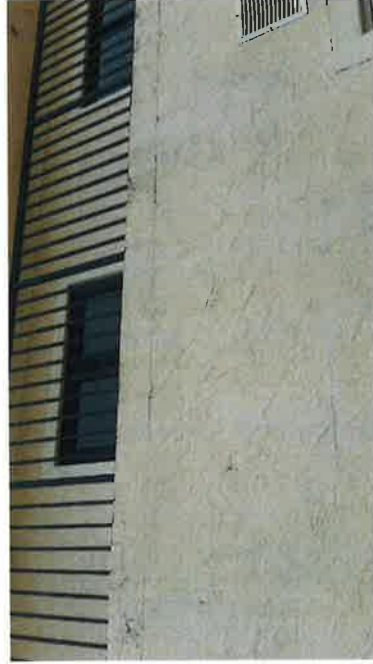
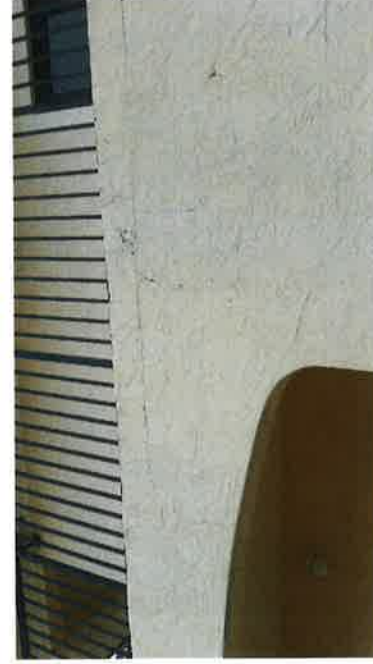
Still moving  
around the  
building on the  
south side.
