**Minutes
Town of Lake Park, Florida
Virtual Regular Commission
Meeting Minutes
Wednesday, September 2, 2020, 7:00 PM
Via Zoom**

5. Notification of Priority Stormwater Pipe Issue: Analysis of the 72 inch “Southern Outfall” Condition and Criticality, and Old Lake Shore Bridge.

TECHNICAL MEMORANDUM
TOWN OF LAKE PARK
SOUTHERN 72-INCH OUTFALL PRIORITY REHABILITATION PROJECT

Subject: Analysis of the 72-inch Outfall Condition and Criticality
Date: August 6, 2020
To: Richard Scherle, Public Works Director
From: Raul Mercado, PE, CFM (WRMA)
Copy to: John Wylie, Stormwater Department

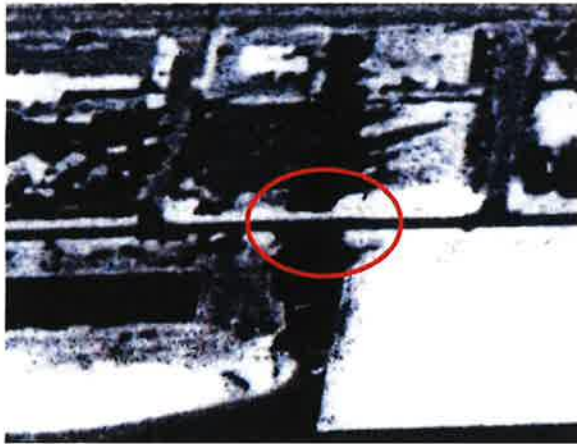
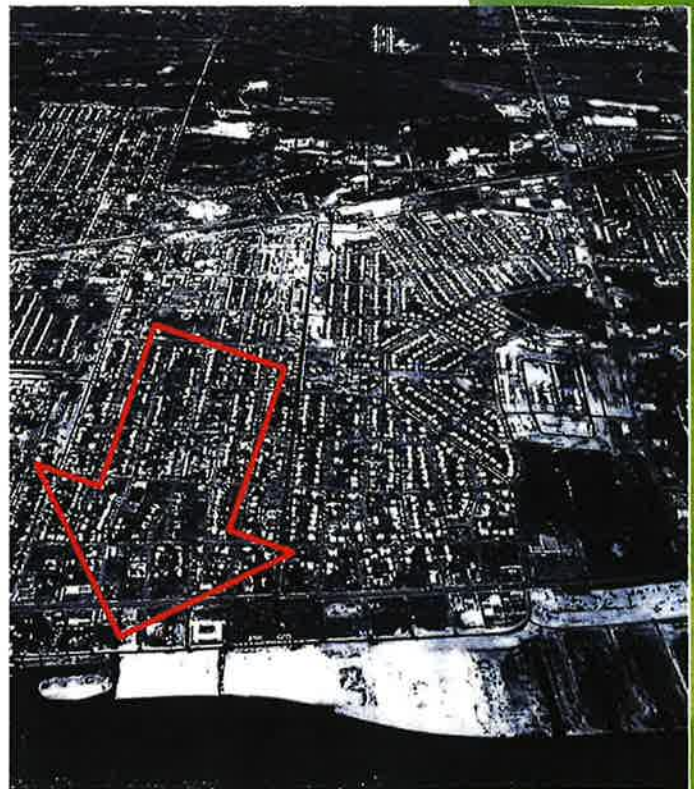
**Lake Shore Drive Bridge
Ditch Crossing**

HOW OLD IS THE BRIDGE?
72" CAP SOUTHERN OUTFALL
MARINA BACKFILLING (1950's -1960s)

KNOWN RISKS - LAKE SHORE DRIVE BRIDGE REMNANTS

6" WATERMAIN "U" BOLTED TO I-BEAM

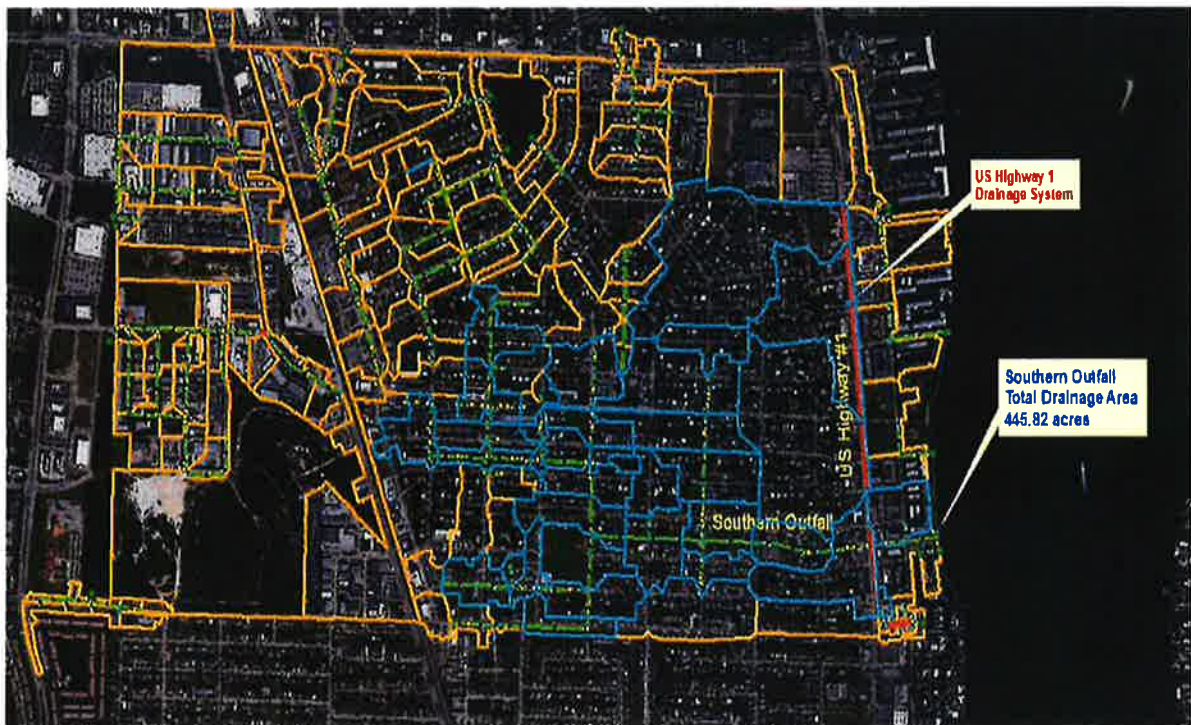
Figure 1. Southern Outfall and Drainage Area

Figure 1 indicates that the Southern Outfall discharges untreated runoff from a 445.82-acre catchment area. The 72" CAP outfall drains approximately 45% of the Town's watershed area to the Lake Worth Lagoon.

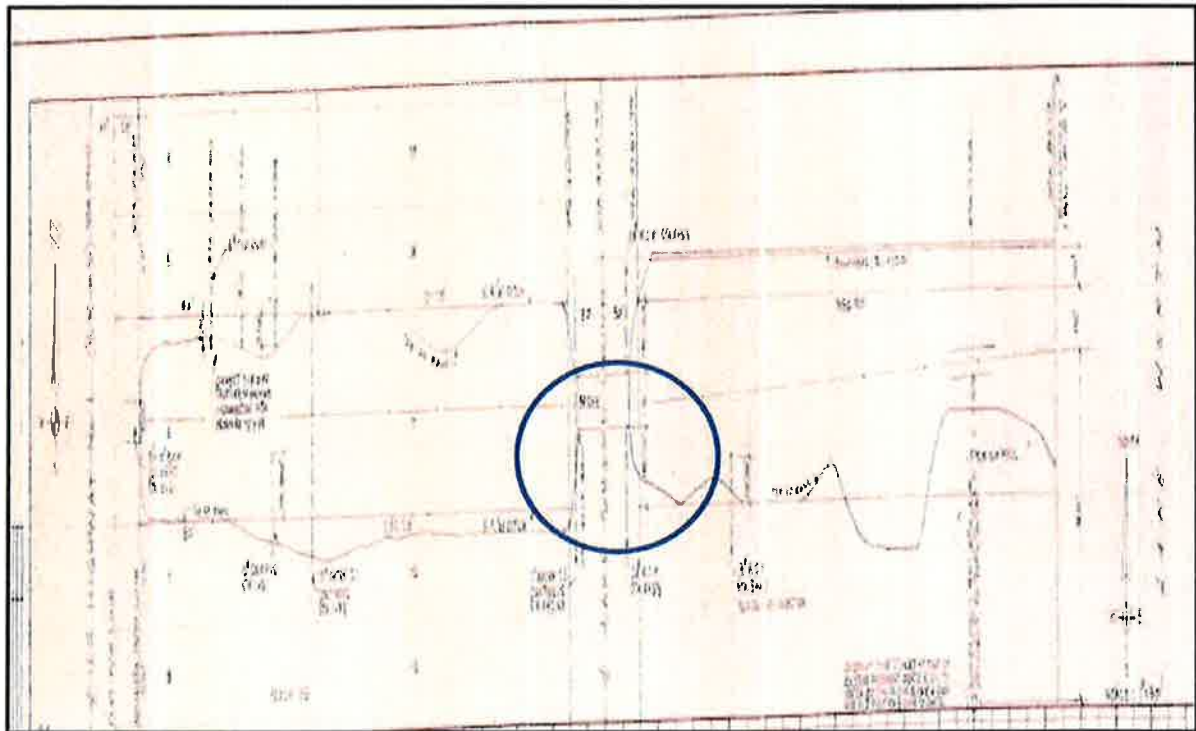
Figure 8. Bridge at Ditch Crossing of Lake Shore Drive

The Southern Outfall segment was built at the time of enclosure of a ditch extending between US Highway 1 and the Lake Worth Lagoon (LWL) seawall in the early 1970's (Approximately 50 years). As best as it can be determined from historical records, the Lake Shore Drive Bridge was built between 1940 and 1950.

The oldest As Built plans record of the Town Marina, from the early 1970's, already show the buried Lake Shore Bridge over the ditch subsequently enclosed with the 72" CAP. Regardless, the bridge age is approximately 75 years (2020-1945), or at the end of the life of a steel I-beam with precast concrete deck bridge. **Figures 8 and 9** show the bridge and the ditch in the early 1970's.

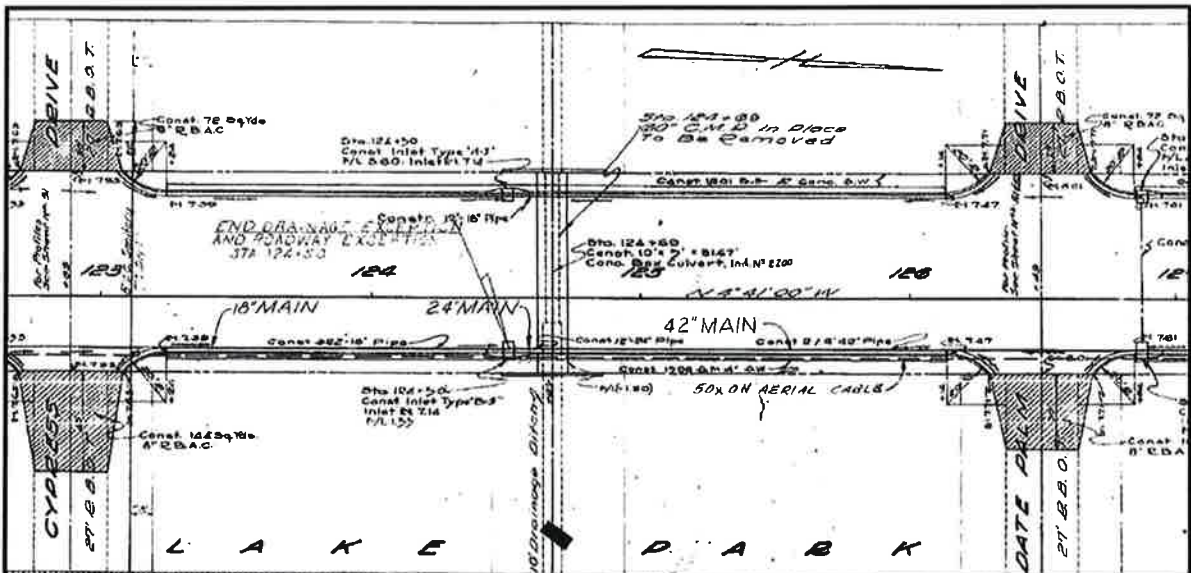
Figure 10. FDOT 1969 Plans for US Highway#1 Drainage Installation along Town of Lake Park

Further examination of Florida Department of Transportation (FDOT) As Built plans for US Highway#1 along the Town of Lake Park jurisdiction were requested to assess the crossing of the Southern Outfall through the US Highway 1 Right-of Way (ROW). Two sets were reviewed. A 2003 set of plans for resurfacing of the US Highway throughout the Town showed a 60" CMP outfall crossing the US Highway 1 ROW. However, a 1969 set of plans for the placement of stormsewers and inlets along US #1 along the Town of Lake Park jurisdiction indicates the removal of an existing 60" CMP and the construction of a 10' x 7' reinforced concrete box culvert with headwalls at the ditch location. Figure 10 shows the notation for the box culvert installation.

The FDOT 1969 plans confirmed that a box culvert was placed across US Highway #1 to discharge the Southern Outfall flows into an existing ditch. The age of the FDOT box culvert asset would be approximately 50 years (2020-1969).

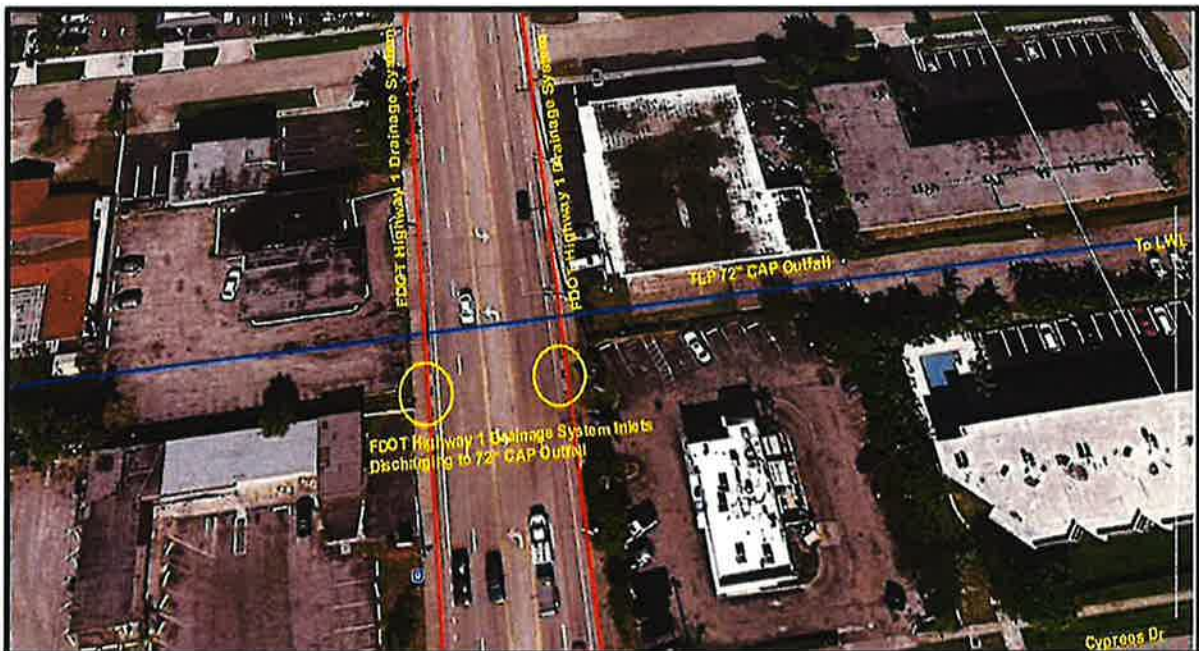
Figure 11. US Highway #1 Discharge Inlets at the 72" CAP Outfall

The consequence of failure also includes the avoided environmental impact benefit opportunity loss to retrofit known and documented pollutants loads to the Lake Worth lagoon for the stormwater asset. The current 72" Outfall discharges untreated runoff to the LWL from the contributory catchment area. The US Highway#1 ROW, discharging through the 72" CAP outfall at four inlets 200 feet north of Cypress Drive also does not currently include any treatment facilities and none are proposed for the upcoming FDOT resurfacing plans. **Figure 11** shows the location of the US Highway #1 discharge into the Southern Outfall.

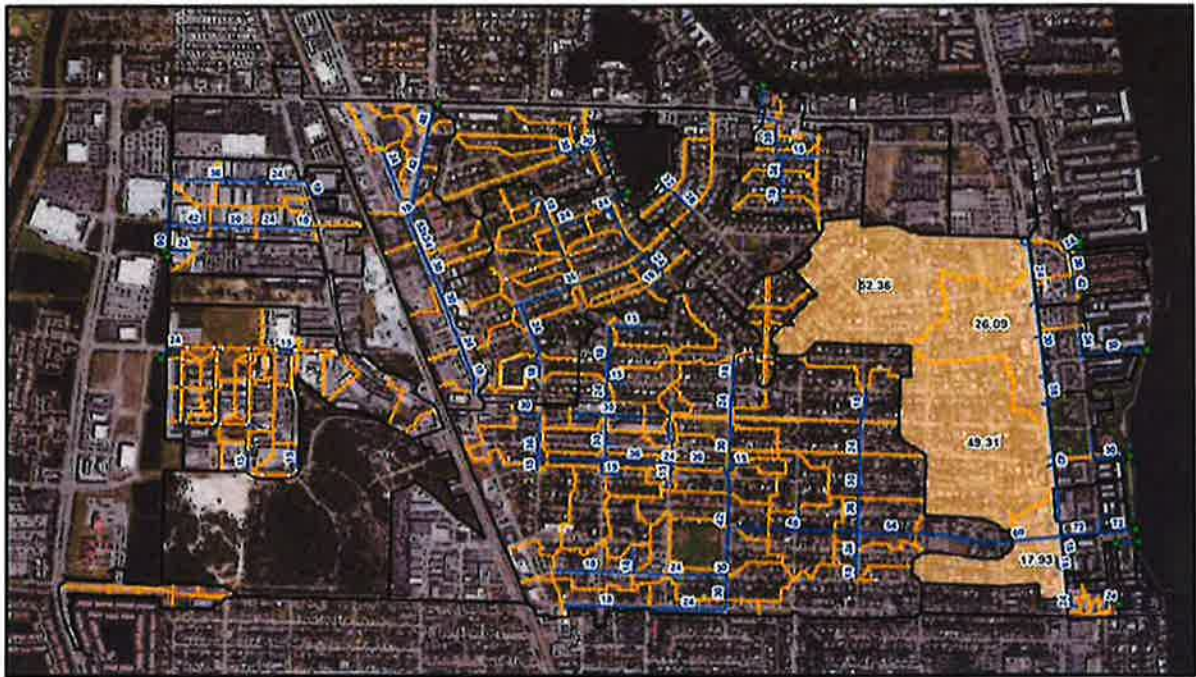
Figure 13. FDOT/US Highway 1 ROW Drainage Area Discharging to 72" CAP Outfall

The US Highway #1 drainage system discharging to the 72" CAP outfall flushes untreated runoff first as it is located the closest to the LW (i.e. Less than 800 feet). **Figure 13** shows the US Highway#1 drainage area discharging to the LWL via the 72" CAP outfall. FDOT relies on the Town of Lake Park NPDES to address pollutant discharges from its US Highway #1 ROW (i.e. The 72" CAP outfall is not part of the FDOT NPDES permit).

Figure 13 indicates that the FDOT/US Highway 1 drainage area discharging to the 72" CAP Outfall is a significant portion of the entire 72" CAP Outfall 445.82 acres watershed area. Furthermore, the US Highway #1 ROW does not include any water quality treatment facilities.

For these reasons, and to mitigate any avoided environmental opportunity loss as a consequence of failure, a Biodetention facility is proposed as part of this priority stormsewer asset rehabilitation project.

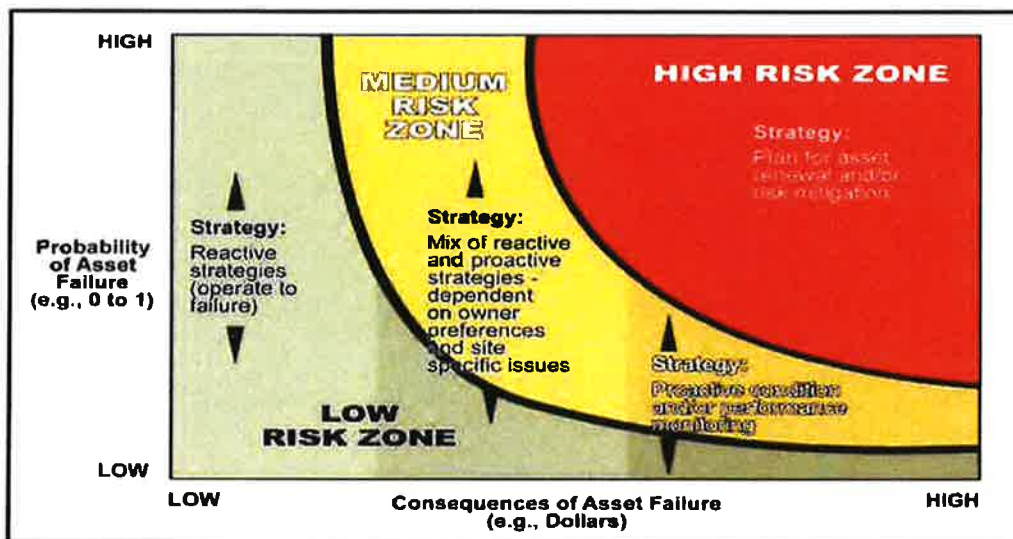
Figure 15. Criticality Strategy Model

Asset Business Risk Exposure (BRE) = Condition x Criticality
 Asset Risk = 4.225 x 3.95 = 16.69

The C vs. C BRE analysis Matrix indicate that the 72- inch outfall pipe asset has a **high risk** of failure and in need of immediate action (High Risk Zone). **Figure 15** is a criticality model that indicates the actions or strategy to be taken based on the BRE analysis results.

Assets within the low risk zone can be maintained reactively (postponed), assets in the medium zone require more proactive maintenance, and assets in the red zone require immediate action (typically replacement).
