**Minutes**  
**Town of Lake Park, Florida**  
**Marina Site Tour Workshop**  
**Saturday, April 27, 2019, 10:00 AM**  
**Lake Park Harbor Marina, 105 Lake Shore Drive**

# MARINA BUILDING DEFICIENCIES 2019

Re: Engineering Inspection

For: Lake Park Marina Building  
103 / 105 Lake Shore Drive  
Lake Park, FL 33403

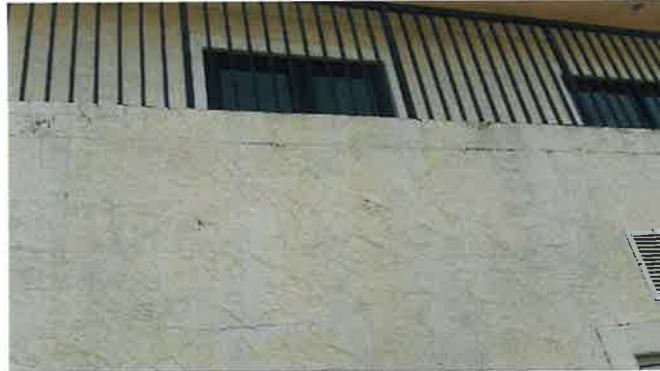
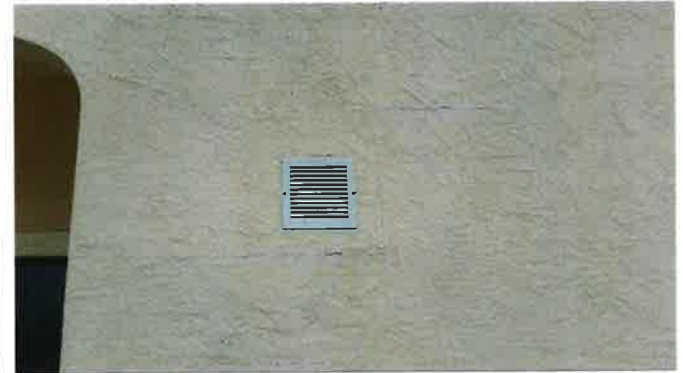
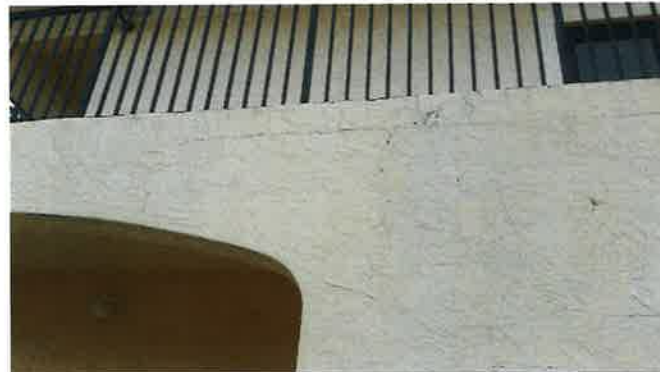
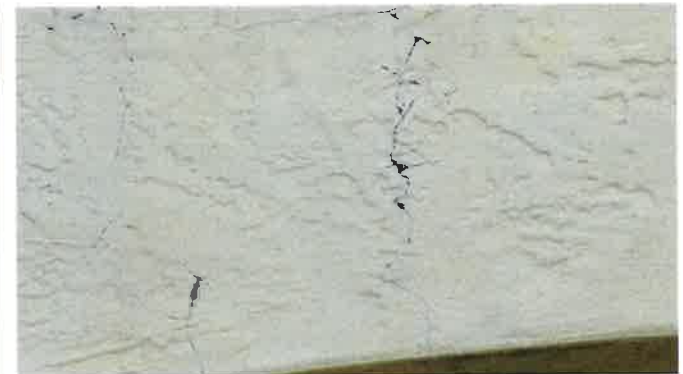
Still moving  
around the  
building on the  
south side.
